**Mount Albert Water Supply Upgrades Class
Environmental Assessment
System Capacity Optimization Study**

Final Draft
April 30, 2020

Regional Municipality of York

Project No: CE731500
 Document Title: System Capacity Optimization Study
 Revision: Final Draft
 Date: April 30, 2020
 File Name: System_Capacity_Report_Final_20200430.docx

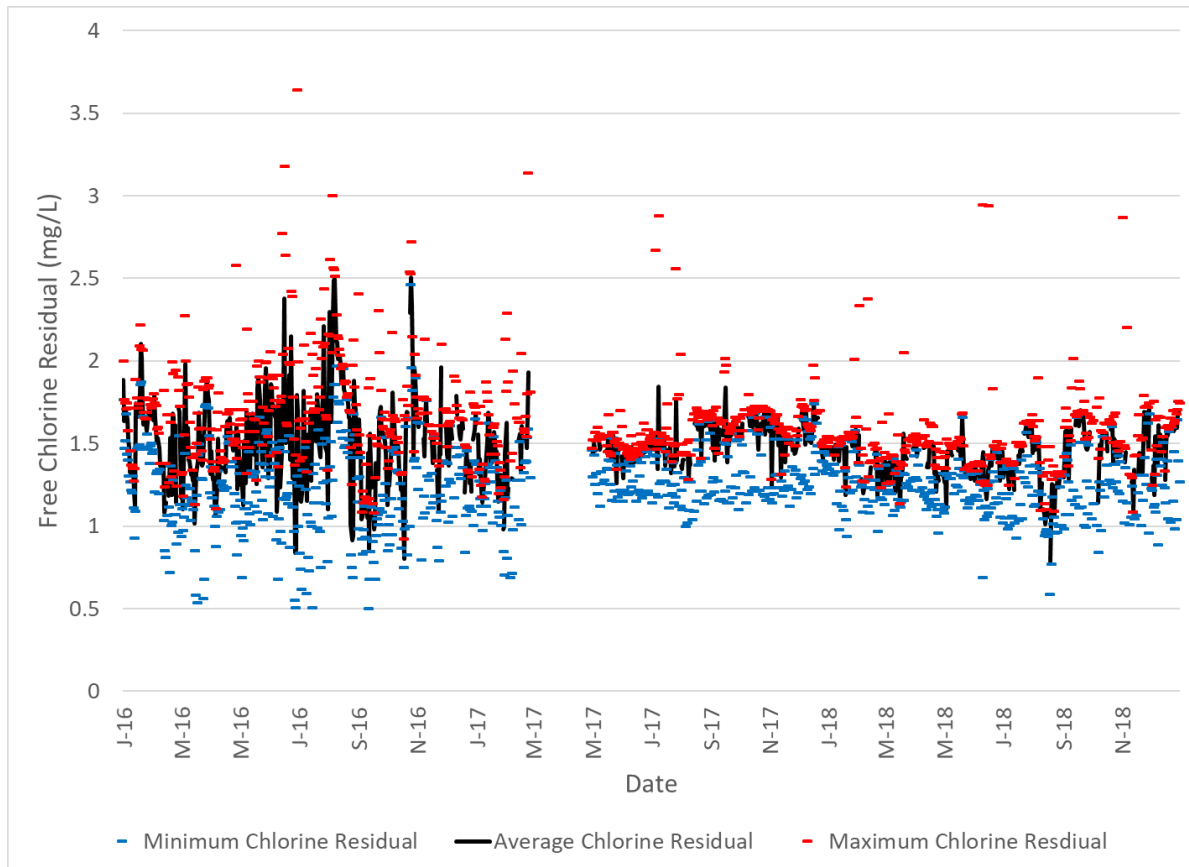
Figure 2-3. Free Chlorine Residual – Chlorine Contact Tank Effluent – Wells 1&2 Treatment Facility

The free chlorine residuals entering the distribution system from the Well 1&2 Treatment Facility (as measured downstream of the chlorine contact tank, where disinfection contact time is achieved) for the historical period from January 2016 through to December 2018 (excluding March and April 2016, as data was missing for this time period) are presented in Figure 2-3.

Between January 2016 to early 2017, the daily average chlorine residual leaving the facility was 1.51 mg/L with maximum variability of 1.7 mg/L day to day (minimum average day to maximum average day, where 90% of the values fell within 0.88 mg/L of each other). The data shows that the treated water free chlorine residual has been maintained within a tighter band since the Region completed upgrades to the control system at the facility in late November 2016 to incorporate the residual feedback control on the chlorine dose as measured upstream of the chlorine contact tank. From May 2017 to December 2018, the average chlorine was 1.46 mg/L with a maximum variability of 1.1 mg/L day to day (minimum average day to maximum average day, where 90% of the values fell within 0.44 mg/L of each other).

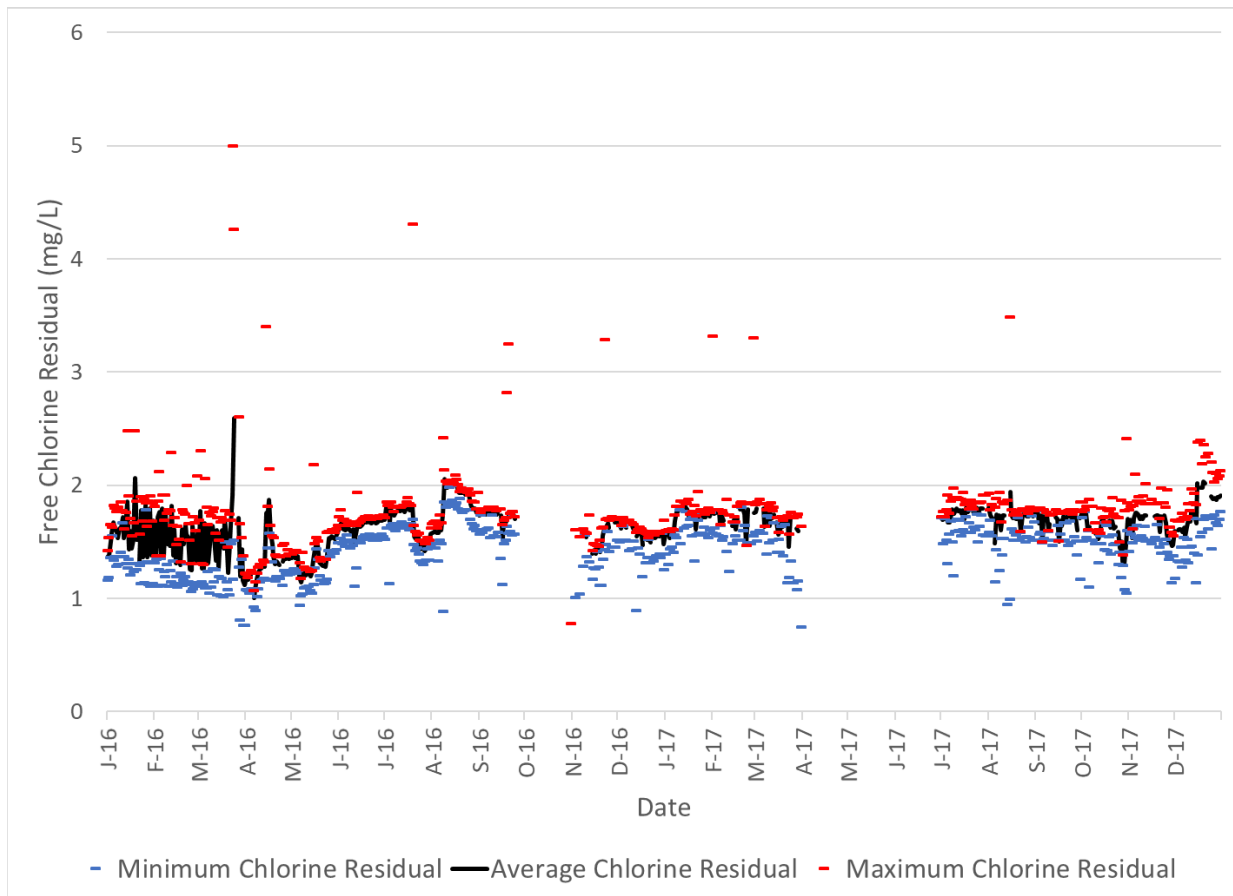
Figure 2-6. Free Chlorine Residual – Chlorine Contact Tank Effluent – Well 3 Treatment Facility

Over the historic period shown in the graph, the daily average chlorine residual leaving the facility was 1.62 mg/L. From January 2016 to May 2016, the average chlorine was 1.59 mg/L with maximum variability of 1.9 mg/L (minimum average day to maximum average day for this period, where 90% of the values fell within 0.68 mg/L of each other). The average maintained since June 2016 has been 1.70 mg/L with a maximum variability of 0.7 mg/L day to day (minimum average day to maximum average day, where 90% of the values fell within 0.39 mg/L of each other).

At this facility, a free chlorine residual of approximately 1.7 mg/L is targeted entering the distribution system (at the chlorine contact tank effluent). The target residual of 1.7 mg/L is based on maintaining free chlorine residuals above the regulatory minimum of 0.05 mg/L and above the minimum operating target of 0.4 mg/L throughout the distribution system. The target residual for the secondary disinfectant residual is based on experience in the system to maintain the residual throughout the distribution system above the regulatory minimum at the ends of the distribution system after allowing for chlorine decay due to water age, to suppress the potential for regrowth in the drinking water system and provide disinfection should contaminants enter the distribution system.

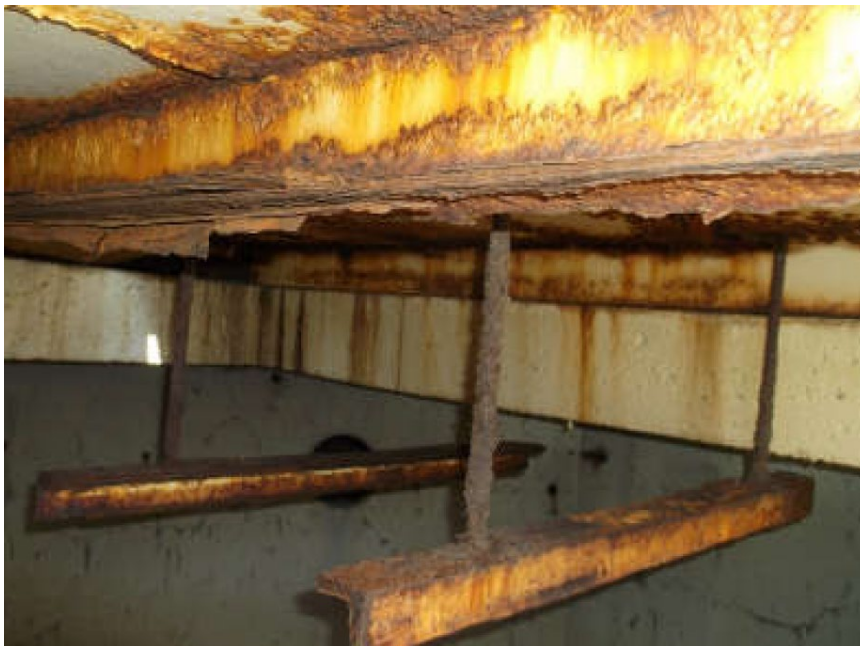
Figure 2-11. Condition of Interior Roof of South Elevated Tank

A condition assessment was completed for South ET in 2015. The report rates the elevated tank as “Very Poor” (bad physical condition and/or asset cannot be operated safely without refurbishment or replacement) and is not currently fit for use as the interior lining system has failed beyond any appreciable service life (Figure 2-11).

The report states that although the tank is 40 years old, there is opportunity for rehabilitation and return to service after significant refurbishment of exterior coatings and interior linings. It is understood that a subsequent structural condition assessment has been completed in November 2019, although results are not available at this time.

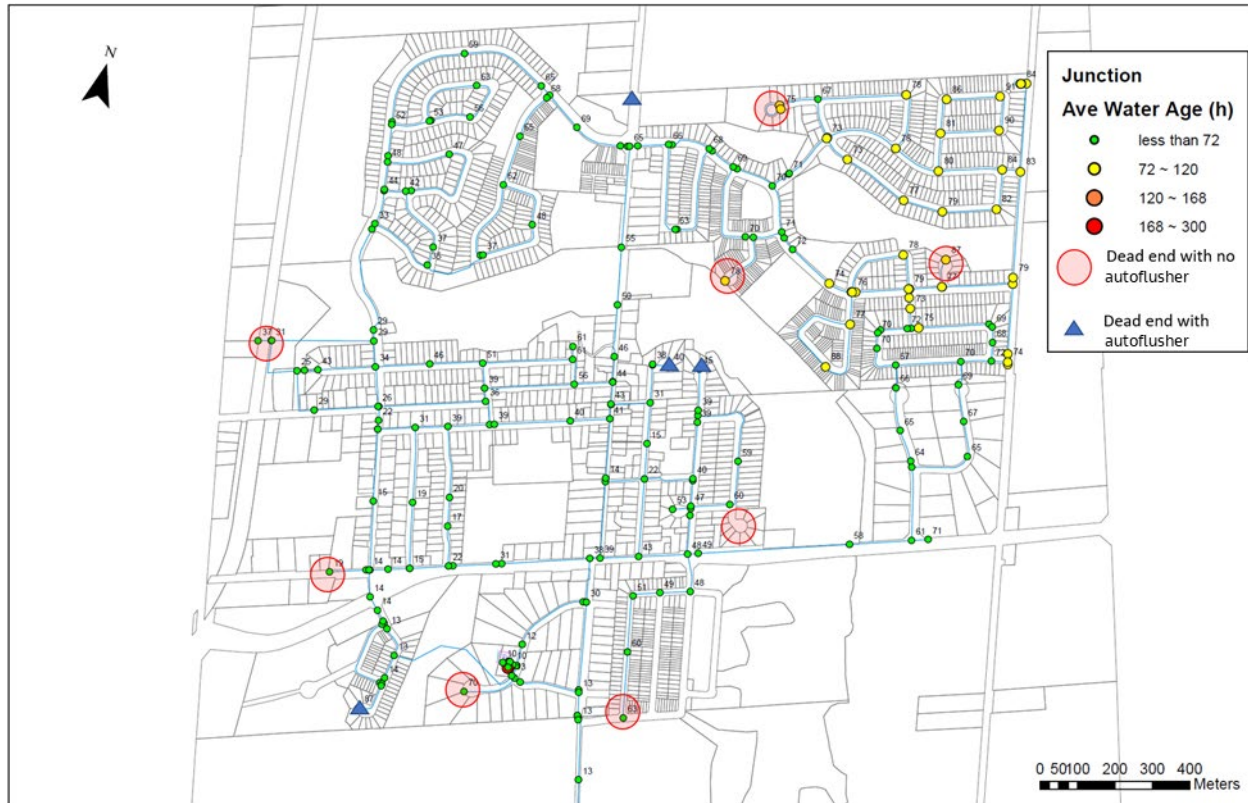
Figure 2-12. Average Water Age (hours) in Mount Albert Water Supply System Showing Location of Dead-Ends and Autoflushers

The model was used to predict water age across the system (Figure 2-11) under average day demand (ADD) and maximum day demand (MDD). The average water age was determined from the model from a full-length simulation of 600-hour of normal operation. Modelled water age near the North ET is predicted by the model to be the highest. Water age was found to be lowest near the well facilities. The ADD water age in the North ET stabilizes at an average of about 113 hours (4.7 days), with a maximum of 129 hours (5.4 days), which is in excess of the 72-hour target for sequestration effectiveness identified in the Region's ongoing GWTS. The MDD water age in the elevated tank stabilizes at an average of about 60 hours (2.5 days), with a maximum of 66 hours (2.75 days). The ADD water age in the distribution system ranges from 10 to 146 hours on average, with a maximum of 222 hours (9.2 days), which is in excess of the 72-hours target for sequestration effectiveness

identified in the Region's ongoing GWTS. Additionally, average water age at dead-end pipes is higher than within looped mains, as dead-ends have lower water demands and less flow.

Water age was found to be the lowest at the southwest end of the system, where water generally comes directly from the wells without mixing with older water from the elevated tank. The average water age in the south end of the distribution system is generally between 10 and 42 hours. High water age was determined to exist at the South ET and adjacent to the Wells 1&2 Treatment Facility in the southwest end of the distribution system, but these are an artifact of the South ET being out of service and are not representative of distribution conditions.

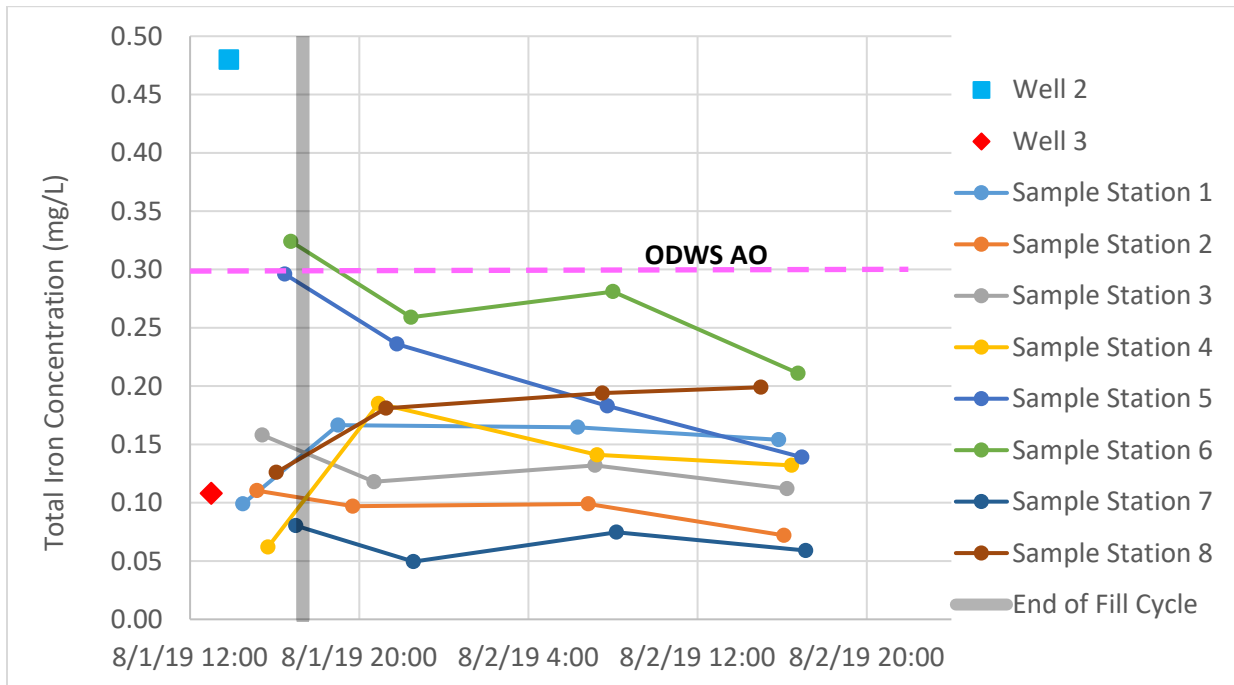
Figure 2-17. Total Iron Concentration from Mount Albert Wells and Sampling Stations

During sampling, distribution iron concentrations were consistently below the AO, with an overall average total iron concentration of 0.142 mg/L (Figure 2-17). Results of the sampling showed that overall total iron concentrations tended to decrease with time, indicating that deposition was occurring in the distribution system despite sodium silicate addition. Silicate addition was effective in maintaining more than 90% of the iron in dissolved form in areas of the distribution system that were not fed by the North ET (Sample Stations 1, 5, 6 and 7). However, when a sample station received water from the elevated tank the iron was mainly particulate (generally 75% to 95% particulate). While water from the elevated tank had a clear impact on the form of iron, there was no obvious impact on total iron concentrations. All sample locations appeared to have some decrease in iron concentrations regardless of the proportion of iron that was maintained in the dissolved form. Based on these results, the maintenance of iron in the dissolved form does not necessarily indicate the prevention of deposition.

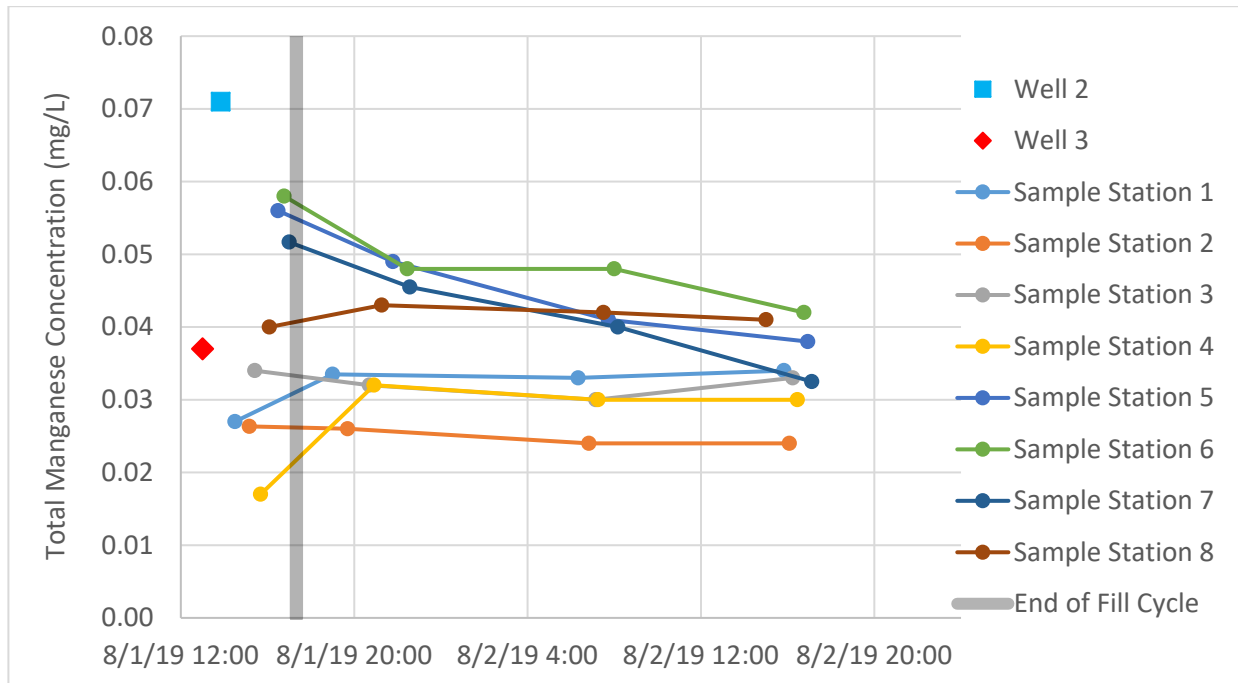
Figure 2-18. Total Manganese Concentration from Mount Albert Wells and Sampling Stations

The average total manganese concentration for the distribution system during the sampling period was 0.024 mg/L (Figure 2-18). Manganese concentrations were above the Health Canada treated water operational goal of 0.015 mg/L but below the Health Canada MAC of 0.120 mg/L. Total manganese concentrations followed a similar pattern to iron concentrations, with a general decrease in total manganese concentrations with time. Areas receiving water from the elevated tank had a much higher proportion of particulate manganese, but a lower total manganese concentration (Sample Stations 2, 3, 4). Areas that were not influenced by the elevated tank tended to maintain most of the manganese in the dissolved form, generally between 80% and 100%. However, toward the end of the drain cycle, the manganese concentrations were lower than expected in all sampling locations, indicating that manganese deposition occurred throughout the distribution system. In addition, measured manganese concentration at Station 7 was substantially higher (almost 1.5 times) the concentration of the supply from Well 3, suggesting a release of legacy manganese from the distribution system.

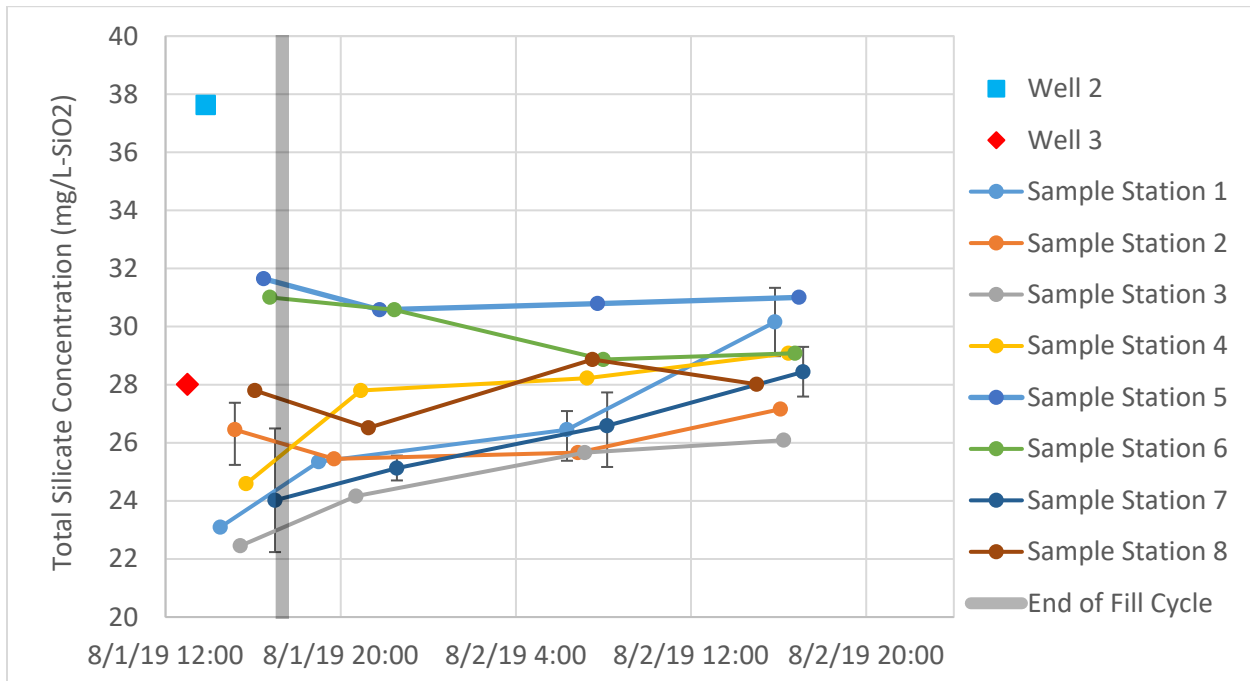
Figure 2-19. Silicate Sampling Results from Mount Albert Wells and Sampling Stations

The major finding of the sampling was that iron and manganese concentrations were generally lower in the distribution system than at the well facility outputs, regardless of whether iron and manganese were dissolved. Iron and manganese deposition was occurring regardless of water age, pipe material, pipe age or pipe diameter. More importantly, iron and manganese deposition was occurring regardless of the amount of iron and manganese in the dissolved form, suggesting that changes to the silicate dosing will not substantially improve sequestration in the drinking water system. Based on these results, silicate addition may be helpful in reducing discoloured water issues, but currently, the data suggests that silicate is not effective at preventing iron and manganese deposition in the Mount Albert distribution system. Silicate measurements collected during the sampling (Figure 2-19) showed concentrations at sampling stations less than initially measured at both wells (Sample locations 1,2,3, 7) which could reflect the impact of dosage variability during the sampling event, or that the silicate was depositing within the distribution system between Well 3 and the sampling stations. It was also noted that several sampling locations (1,3,4,7) showed an increase in silicate concentration over time, which could suggest remobilization of silicate previously deposited in the system.
