Appendix H.2 – Heritage Relocation Report – George Hunter House

*Kennedy Road Environmental Assessment between
Steeles Avenue and Major Mackenzie Drive*

Kennedy Road Widening
Heritage Relocation Study
George Hunter House – 9286 Kennedy Road
Prepared for York Region
Publication Date January 2020

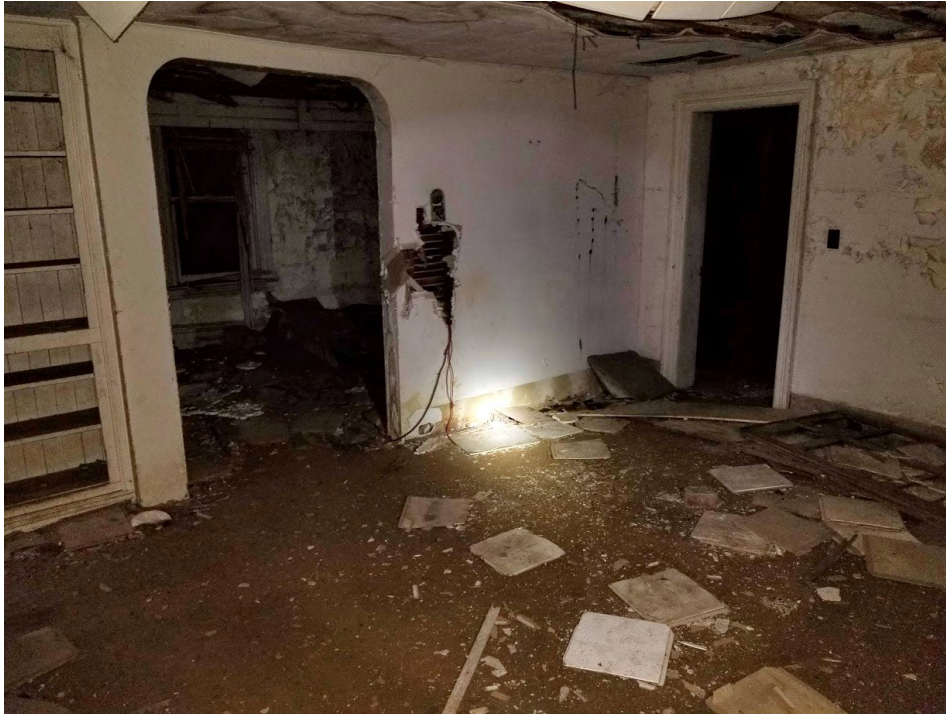
The floor assembly has been severely compromised and could need full removal and reinstatement prior to moving. However it is still a relocatable building.

Main floor showing floor upheaval and poor conditions

The building would need to be cleaned out with the removal of the garbage and mechanical items. Once that is complete inspection of the floor assembly can be made.

If it is as it seems and needs to be replaced, then it would be sequentially replaced by a qualified contractor to stabilize the structure prior to relocation.

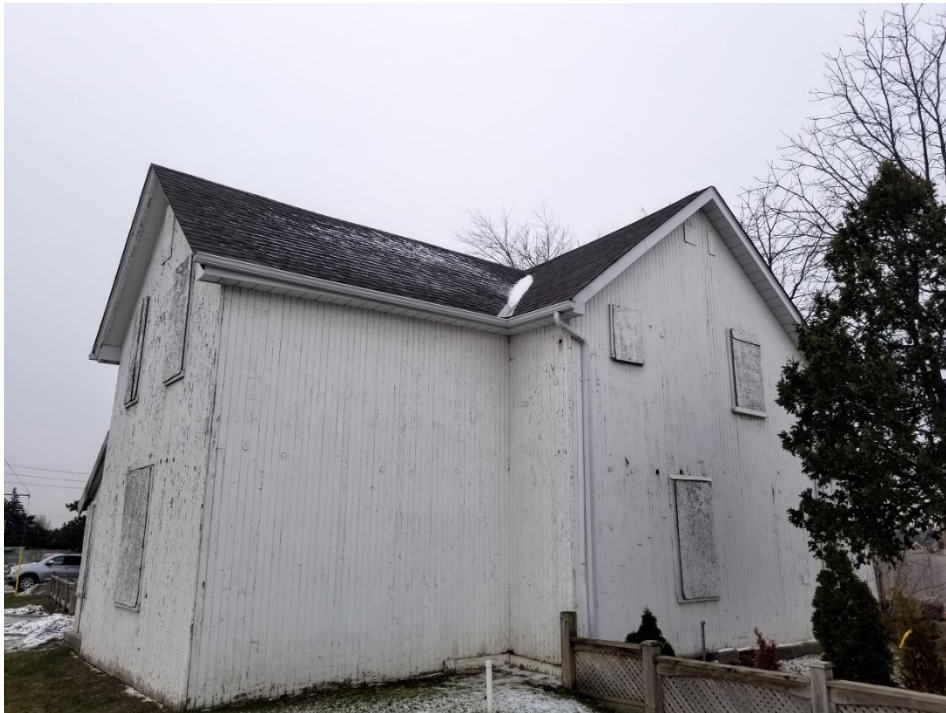
The exterior of the building has remained relatively intact and straight.

Exterior North Side

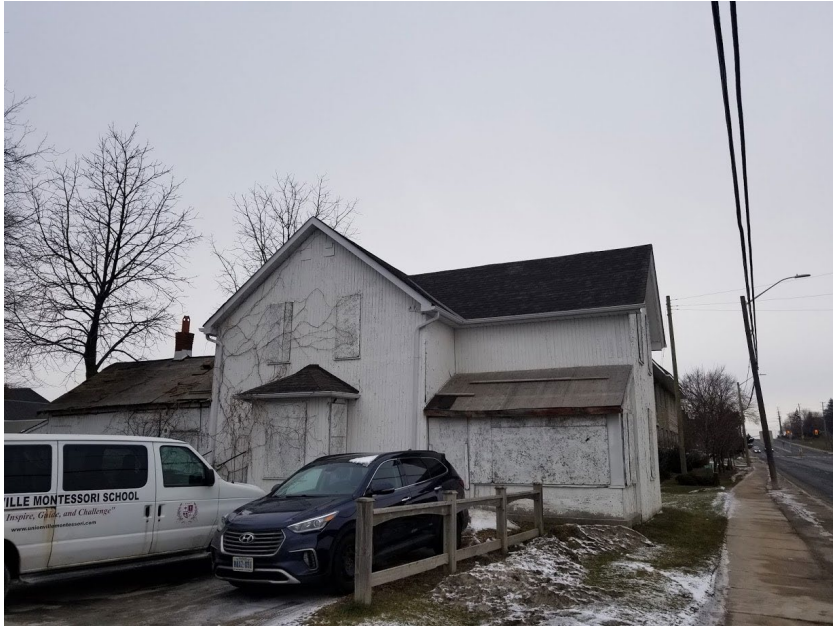
The west addition (kitchen) is in an unsafe condition and is not appropriate for relocation. Documentation and replication are recommended. The author believes permission to remove has already been granted by the City of Markham

Exterior south side with addition on left

Recommendation that west addition (kitchen) be demolished as it is in poor condition and could easily be rebuilt at new location.

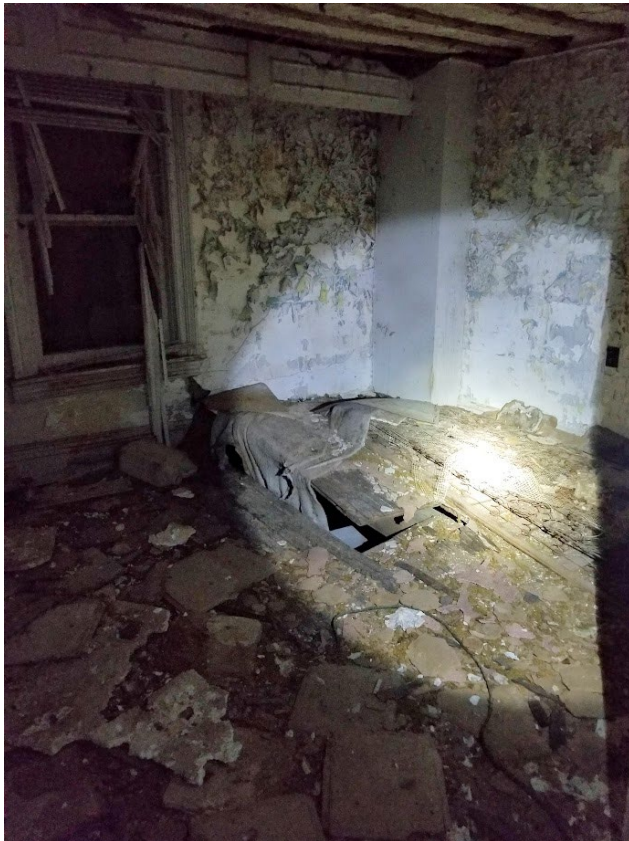
Deterioration of floor assembly
