# Appendix H.5 – Heritage Impact Assessment Report – George Hunter House

**George Hunter House, 9286 Kennedy Road,  
City of Markham, Ontario**  
*Heritage Impact Assessment*

1664178-13000-R02

August 9, 2019

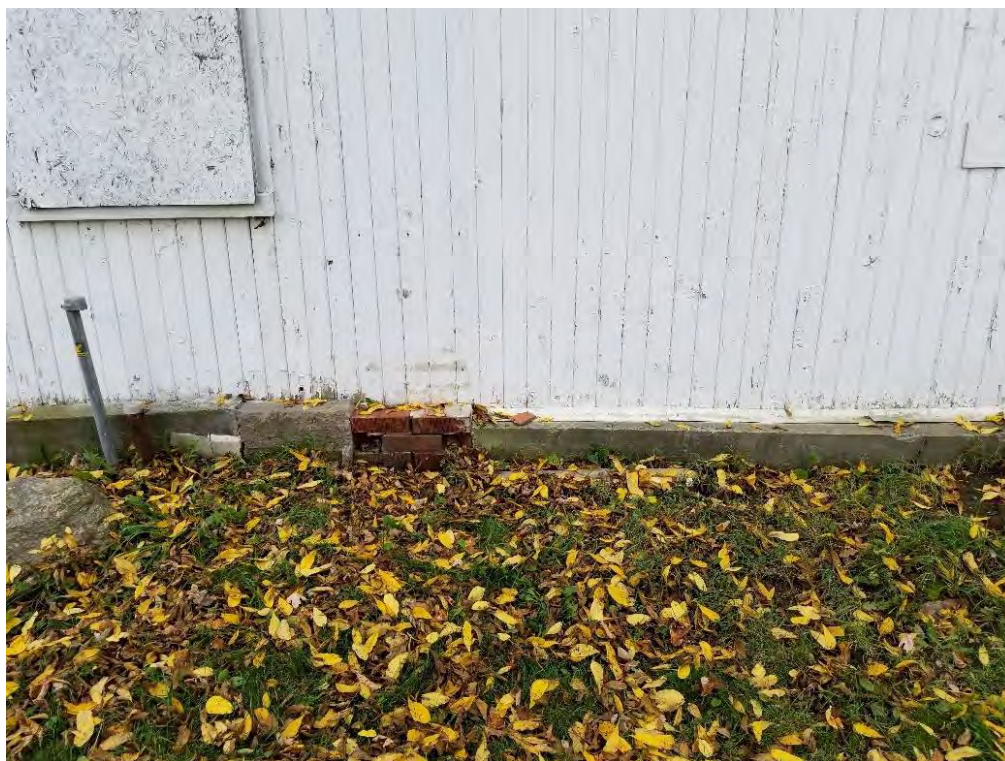
The West Wing stands on a concrete or concrete-parged stone foundation (Figure 17). It has a medium gable roof with asphalt shingles and projecting eaves and verges, as well as a small section at the southwest corner with a shed roof. A single-leaf, wood-plank door is on the south façade (Figure 18), but otherwise all openings have been blinded with plywood.

**Figure 17: Concrete foundation of the west extension.**

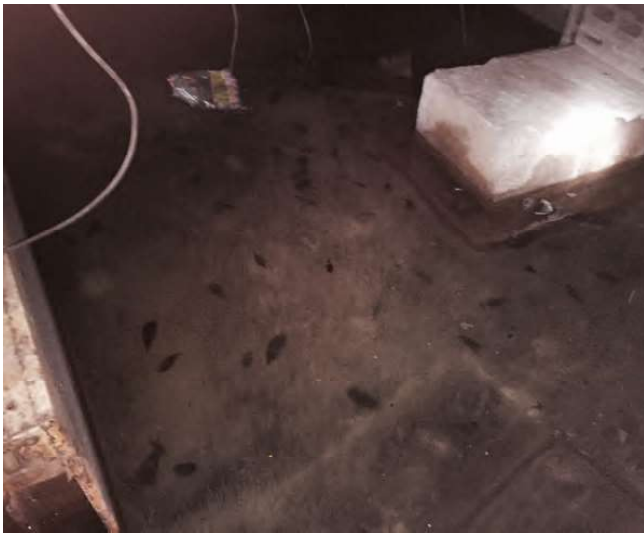
Ten centimeters of standing water is present in the basement. The furnace oil aboveground storage tank (AST) is located in the north-east corner of the basement. The AST is expected to be corroded since oil sheen was observed on the standing water in the basement.

Basement floor with 4" of water

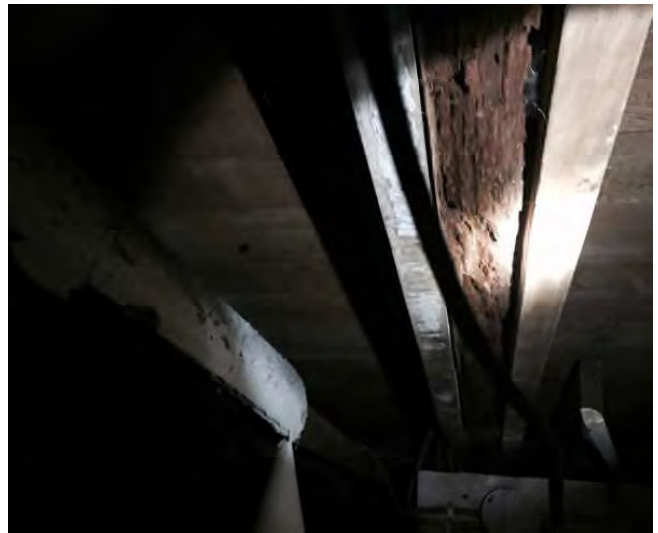
The main floor original studs are rotted to the point that sometime in the past, additional side beams have been added to support the building due to lack of support. Cracks of the supporting members are also showing deterioration as well as lacking anchoring with the foundation. Six supporting beams are cracked and no support is present.

Original beam supported by 2" beams on each side

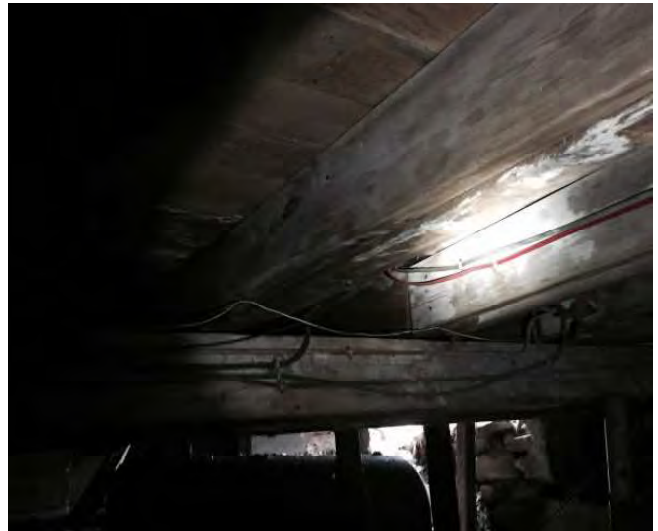
Original beam supported by 2" beams on each side

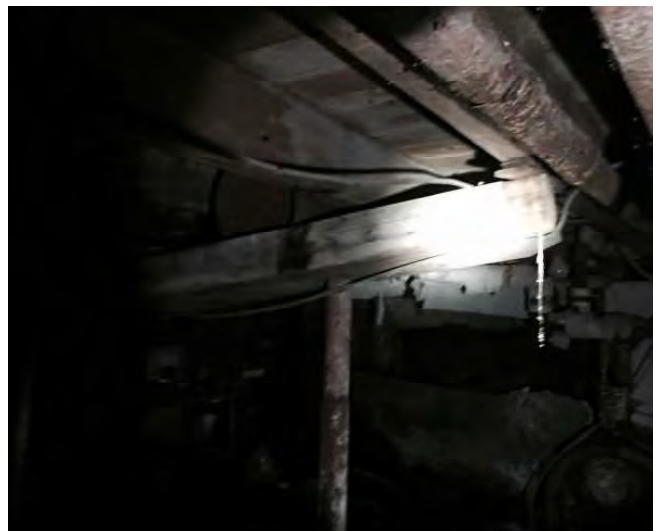
The basement is seven feet high with main floor supporting members showing rot, wood worm attack, cracks, and missing supporting members which were added with 1.5" pipes. These pipes are no longer supporting and the floor is ready to collapse.

Loose beam supported by 1.5" pipe

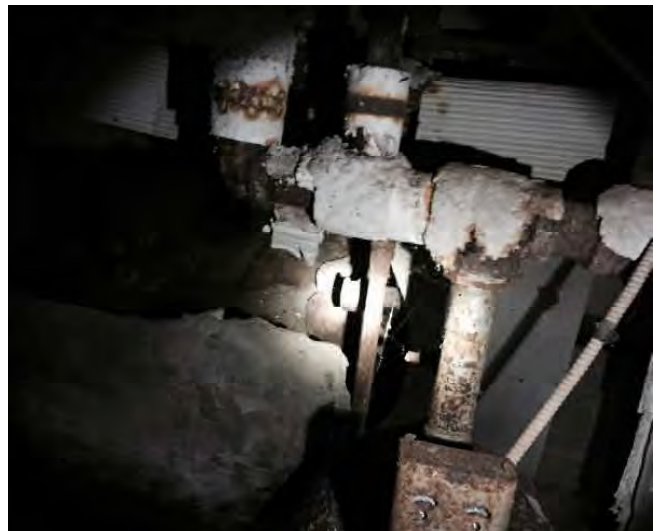
Furnace asbestos detail

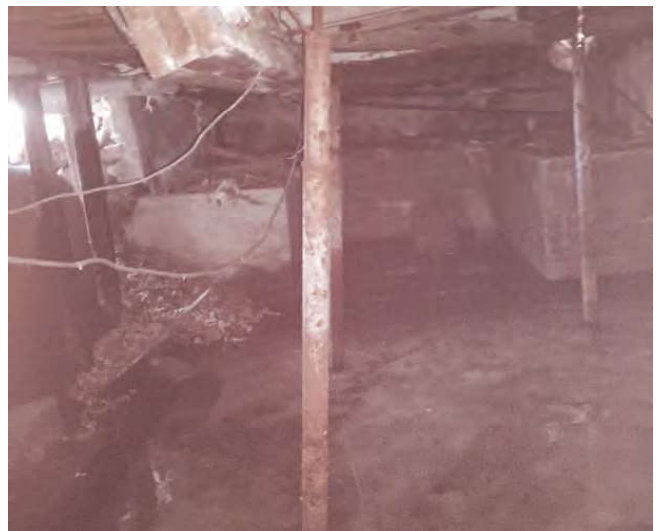
Basement pipe supports

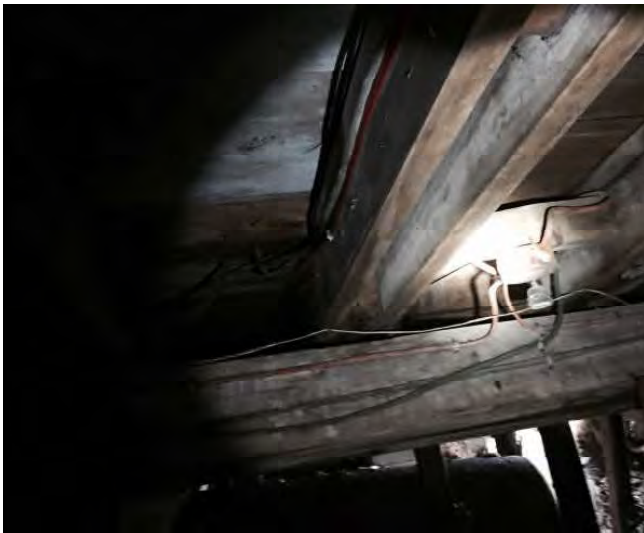
Beam lacking support

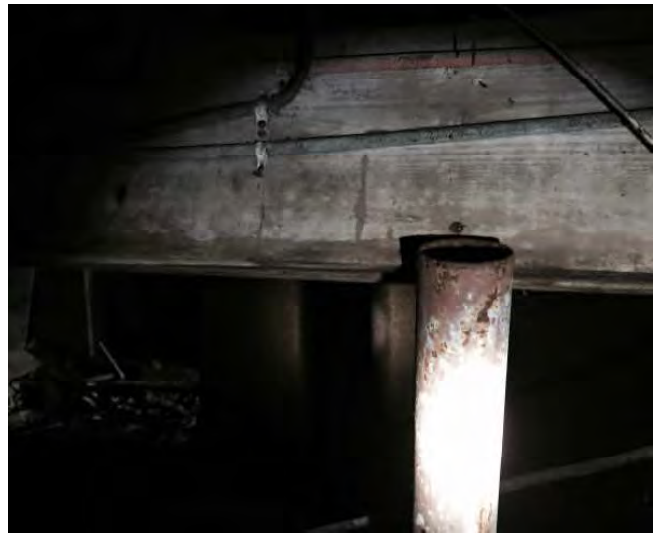
Pipe without support

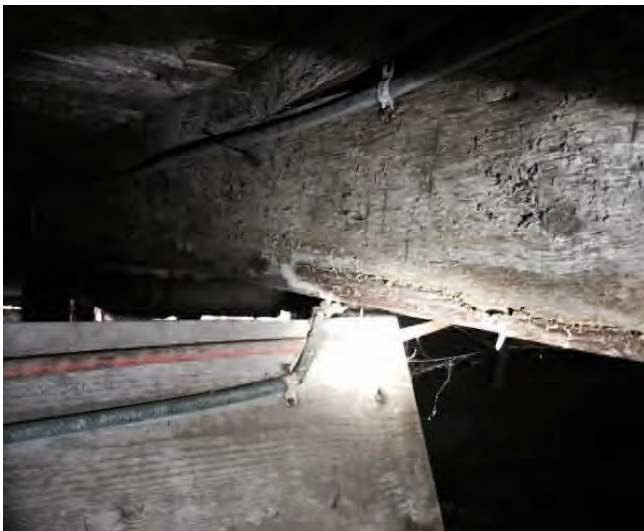
Cracked beam

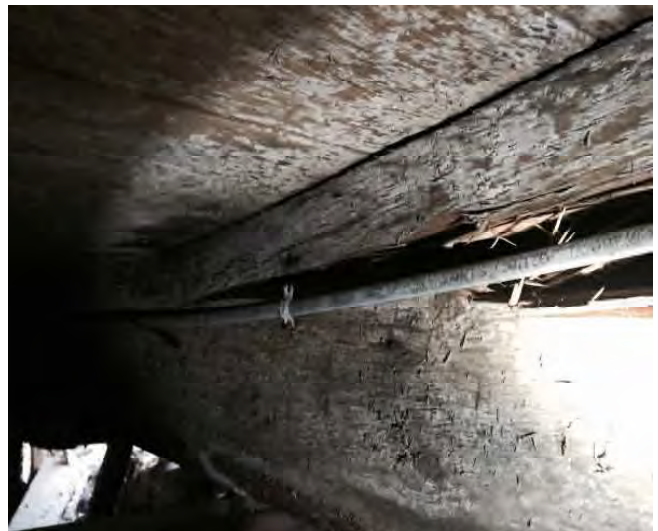
Cracked beam detail

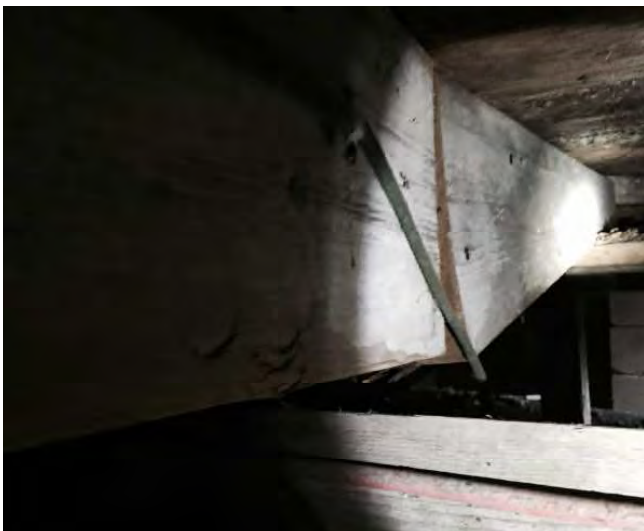
Cut beam, no support

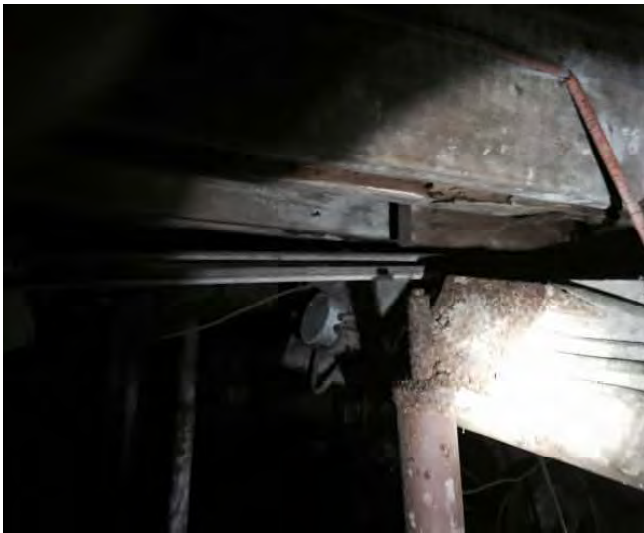
Pipe, no support

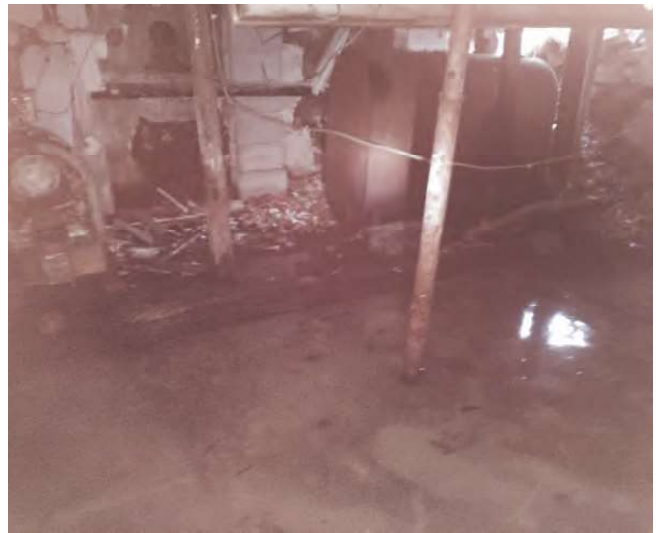
Furnace detail, crooked pipe support

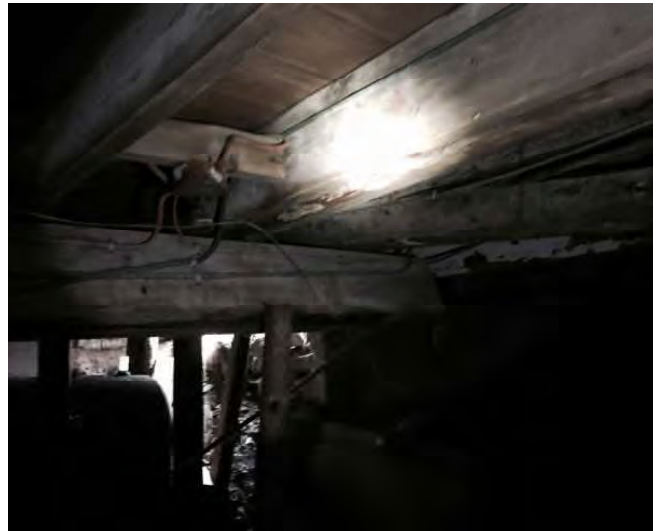
Beam lacking support

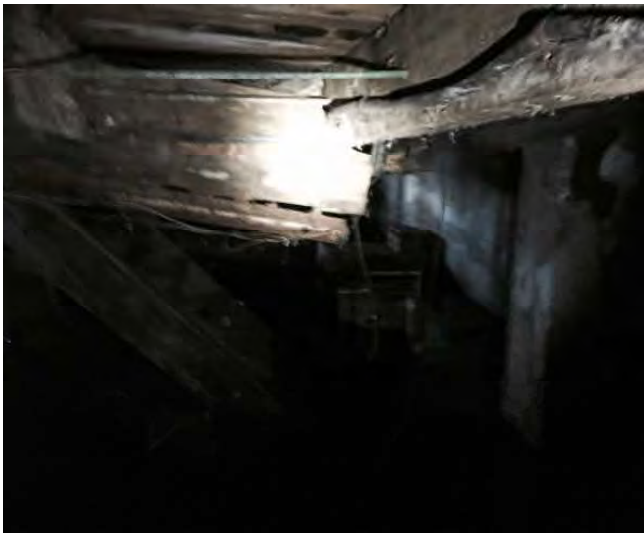
Unsupported beam detail

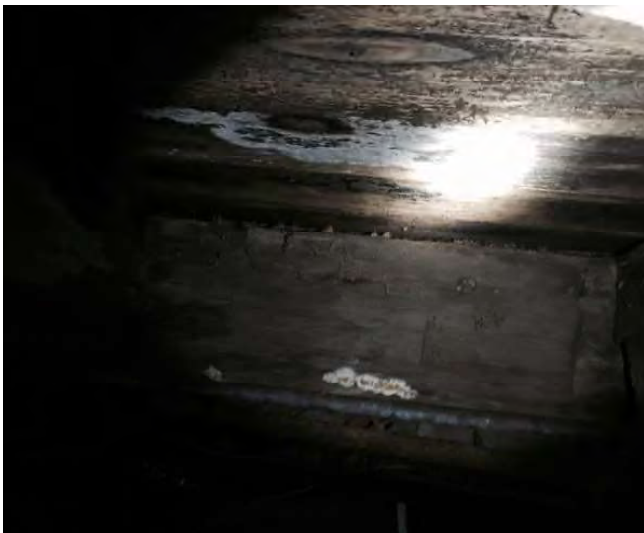
Rotten beam detail

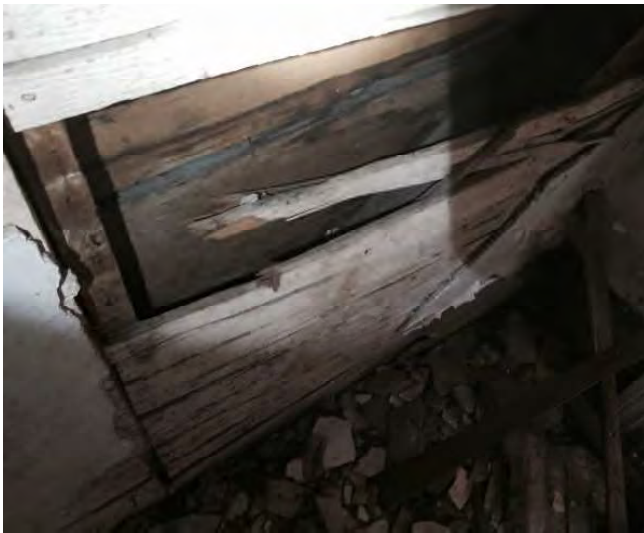
Main floor wall detail - mould

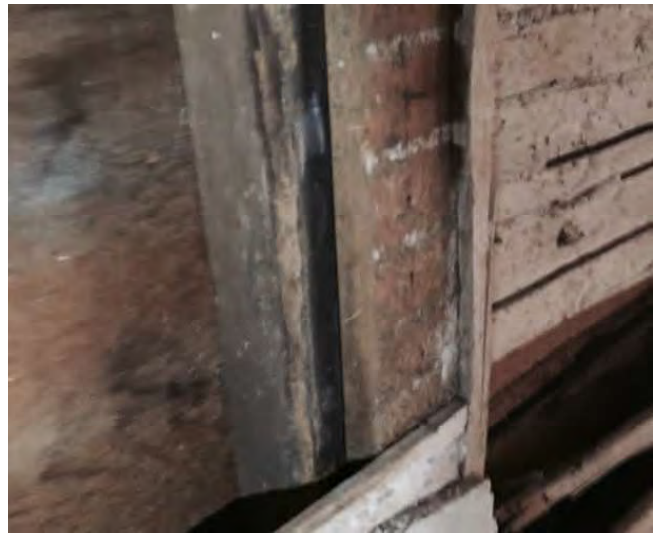
Main floor wall detail - mould

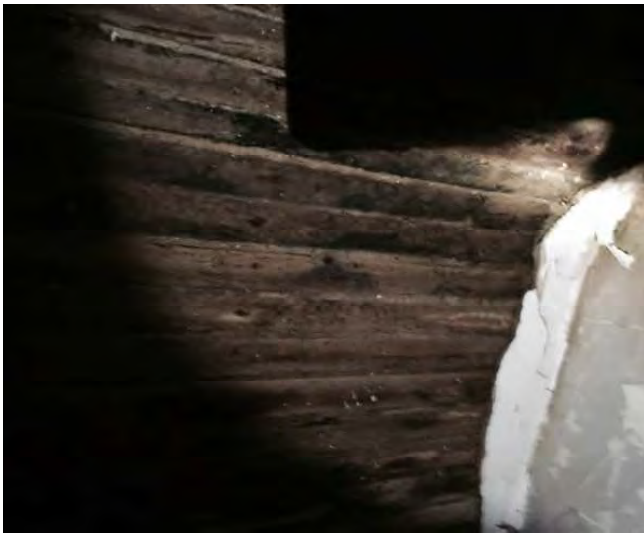
Second floor - mould detail

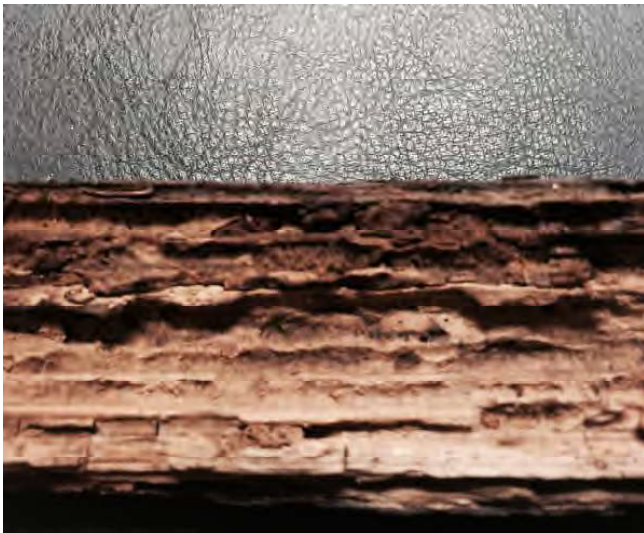
Wood worm attack of the beam

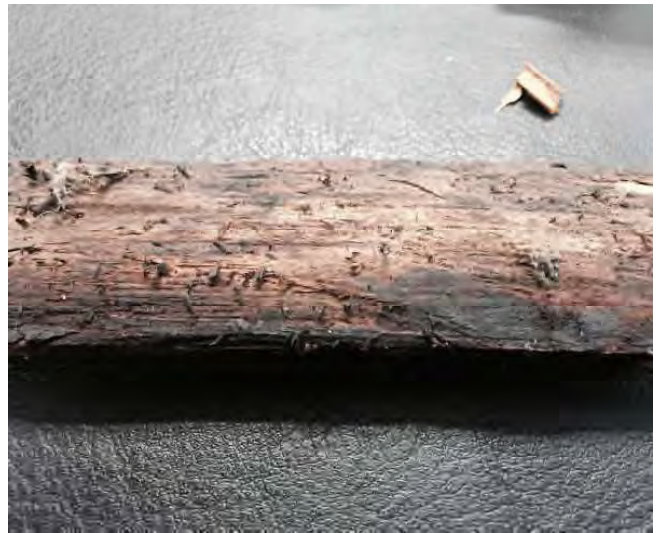
Mould and wood worm attack of the beam

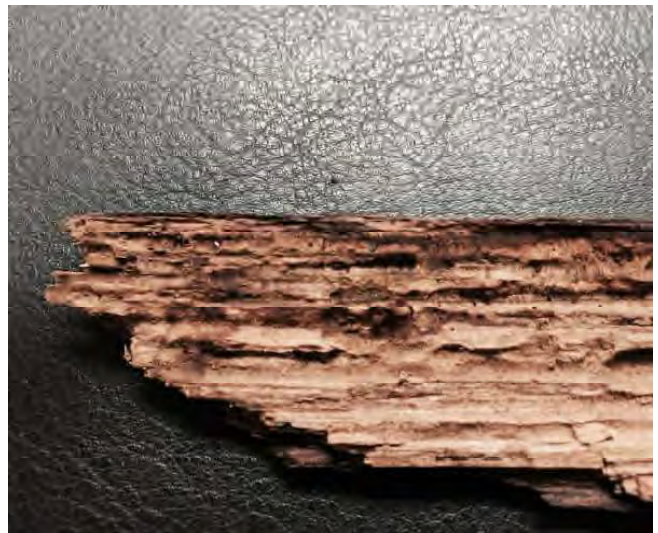
Wood worm attack of the beam detail

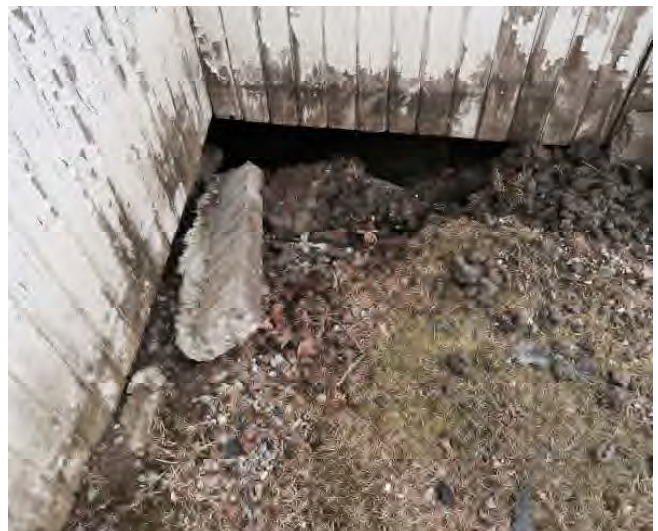
The foundation wall in north-east corner of the building has collapsed and exposes the basement. It is clear that the outside shell of the building is supported by main floor ceiling studs with little support extending to foundation. The brick chimney has a 2" gap from the wall.

Outside unsupported basement
