Appendix N.1 – Structural Inspection Report

*Kennedy Road Environmental Assessment between
Steeles Avenue and Major Mackenzie Drive*

Structural Inspection Report

Class Environmental Assessment for Kennedy
Road from Steeles Avenue to Major Mackenzie
Drive

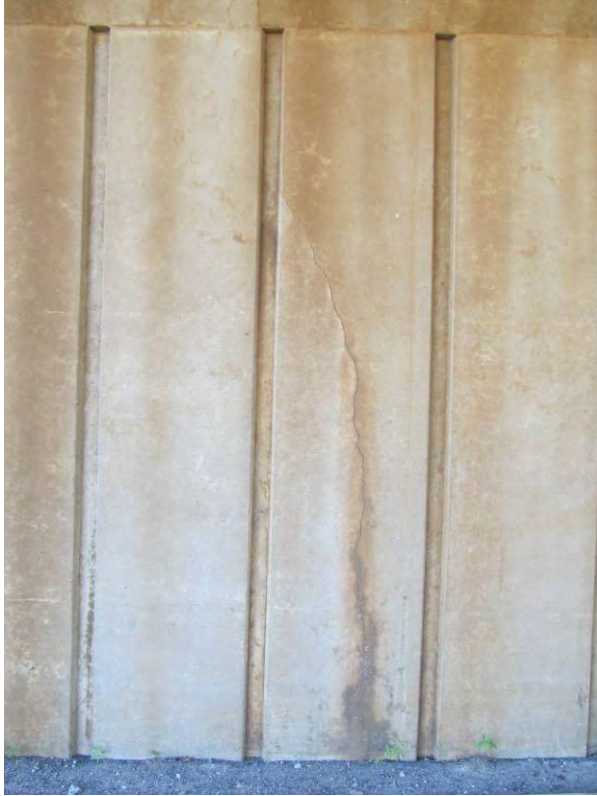
Exhibit 03 – Kennedy Rd – CN Rail Underpass
Wide Crack on East Abutment, Base of Middle Portion (view from West)

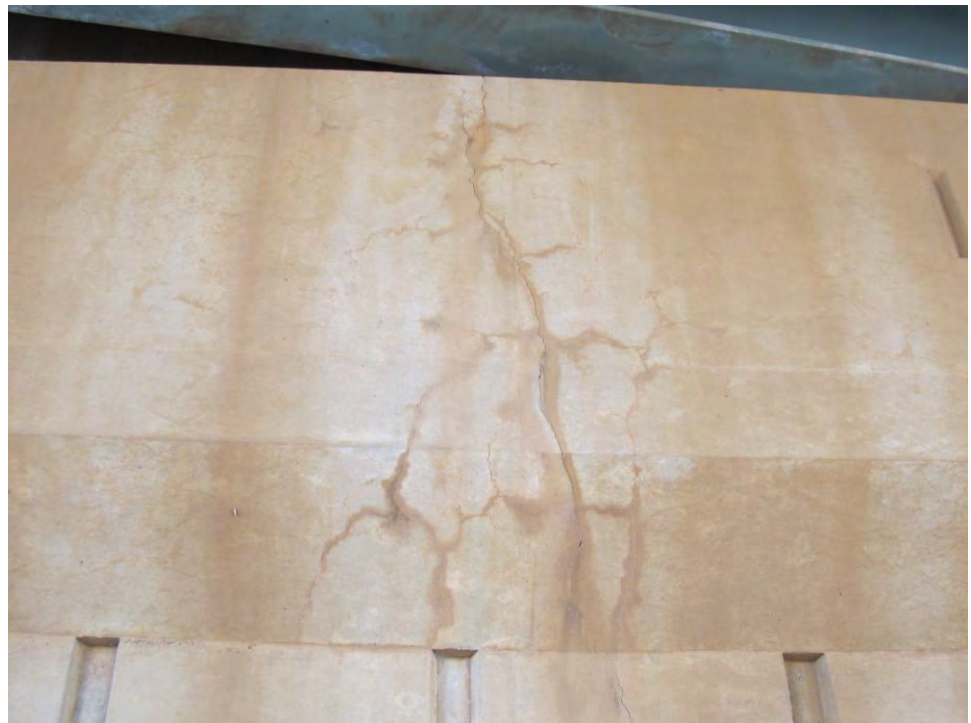
Exhibit 04 – Kennedy Rd – CN Rail Underpass
Wide & Map Cracking on East Abutment, Top of Middle Portion (view from West)

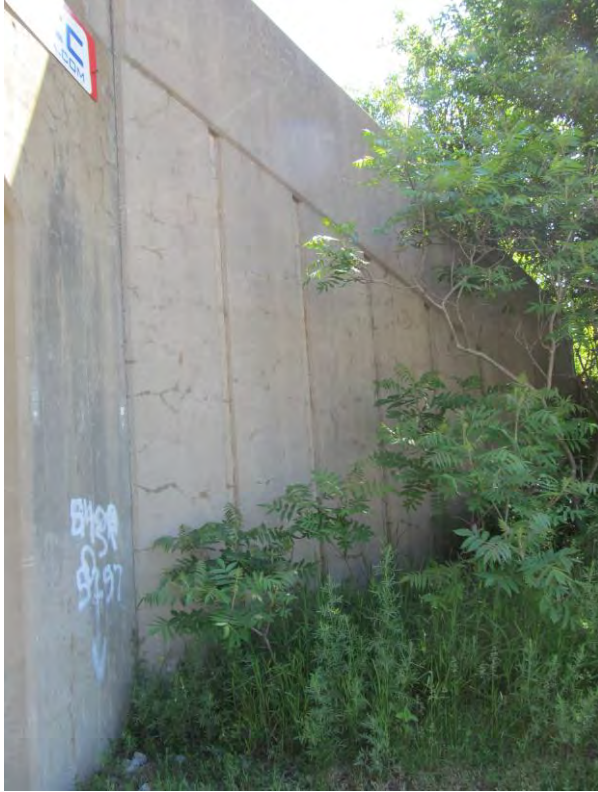
Exhibit 05 – Kennedy Rd – CN Rail Underpass
Stained Map Cracks on Southeast Wingwall (view from Southwest)

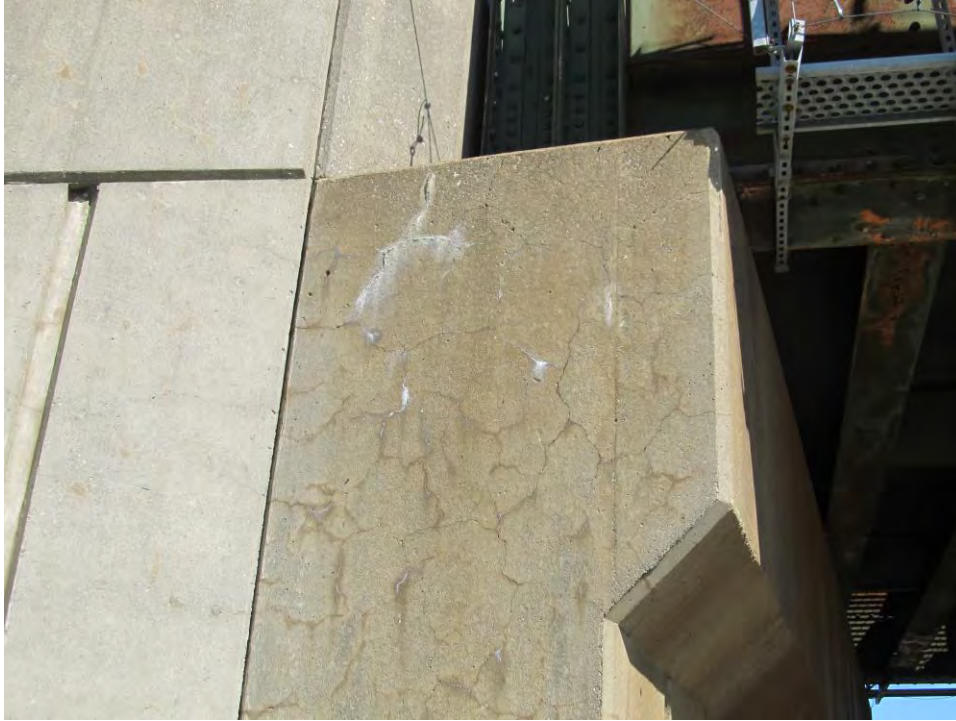
Exhibit 07 – Kennedy Rd – CN Rail Underpass
Map Cracks and Efflorescence on Southwest Bearing Seat (view from South)

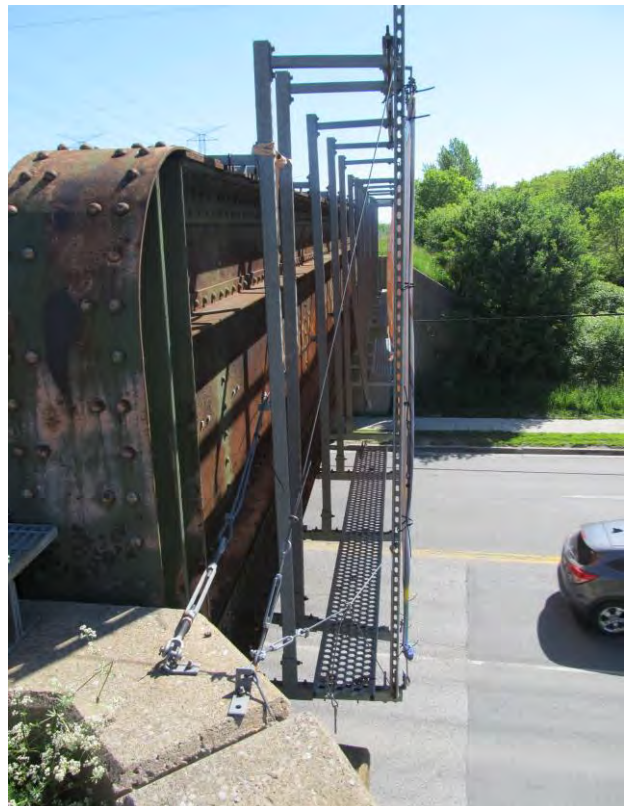
Exhibit 08 – Kennedy Rd – CN Rail Underpass
South Exterior Girder & Trainmen's Walk, Missing Sections (view from West)

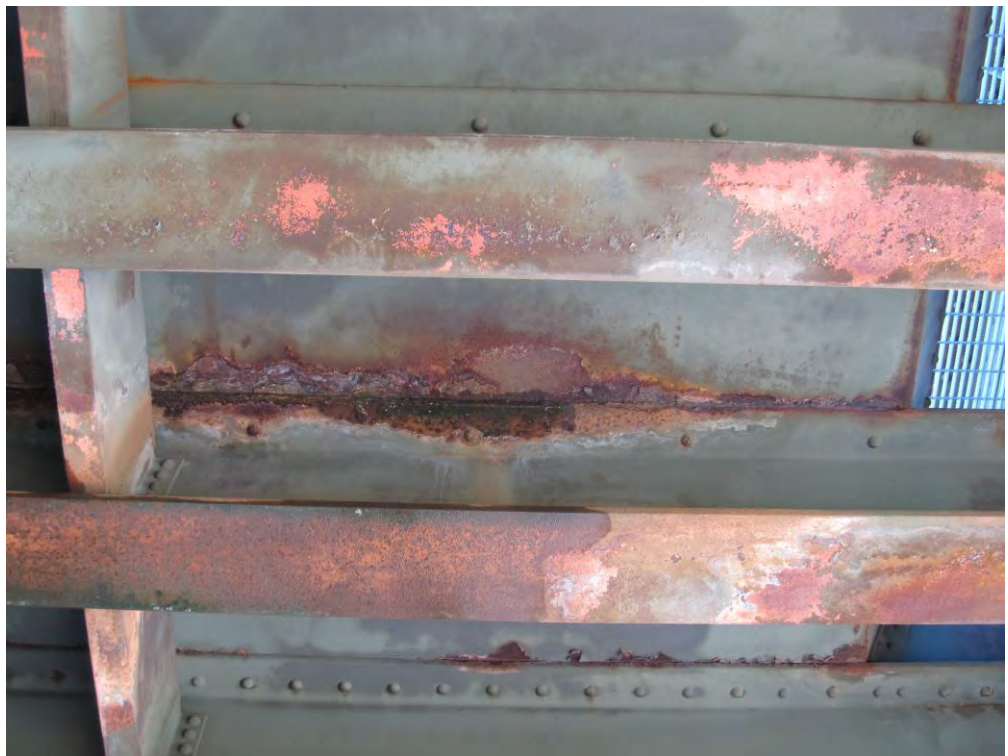
Exhibit 10 – Kennedy Rd – CN Rail Underpass
Corrosion & Wet Areas on Southwest Soffit (view from West)

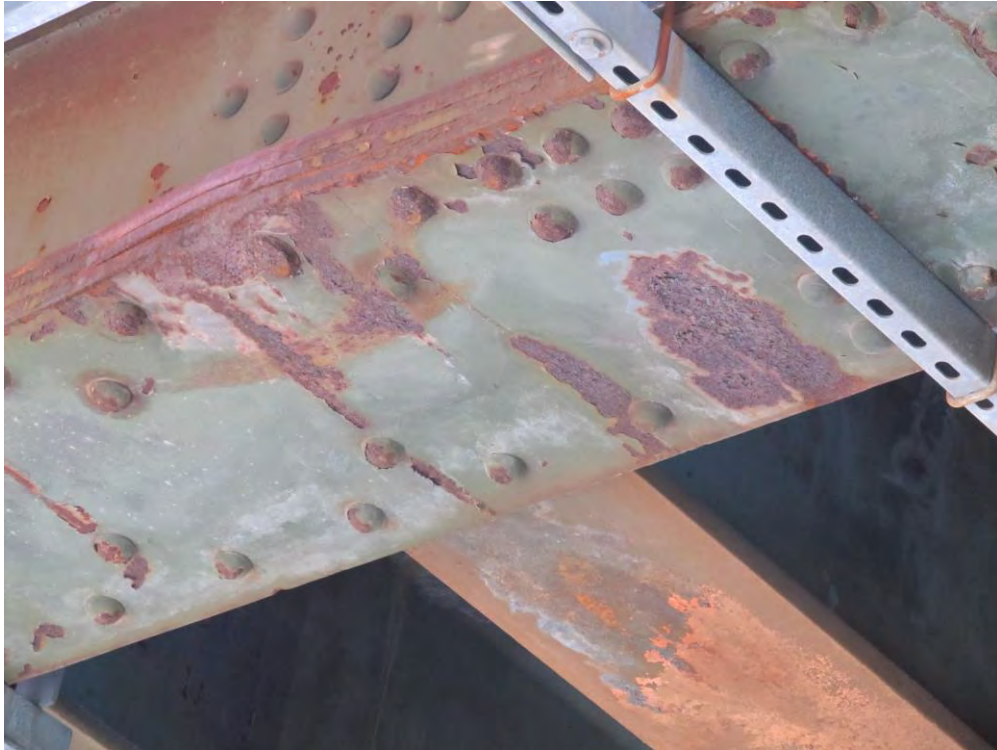
Exhibit 11 – Kennedy Rd – CN Rail Underpass
Impact Damage on Bottom Flange of Southeast Girder (view from Southeast)

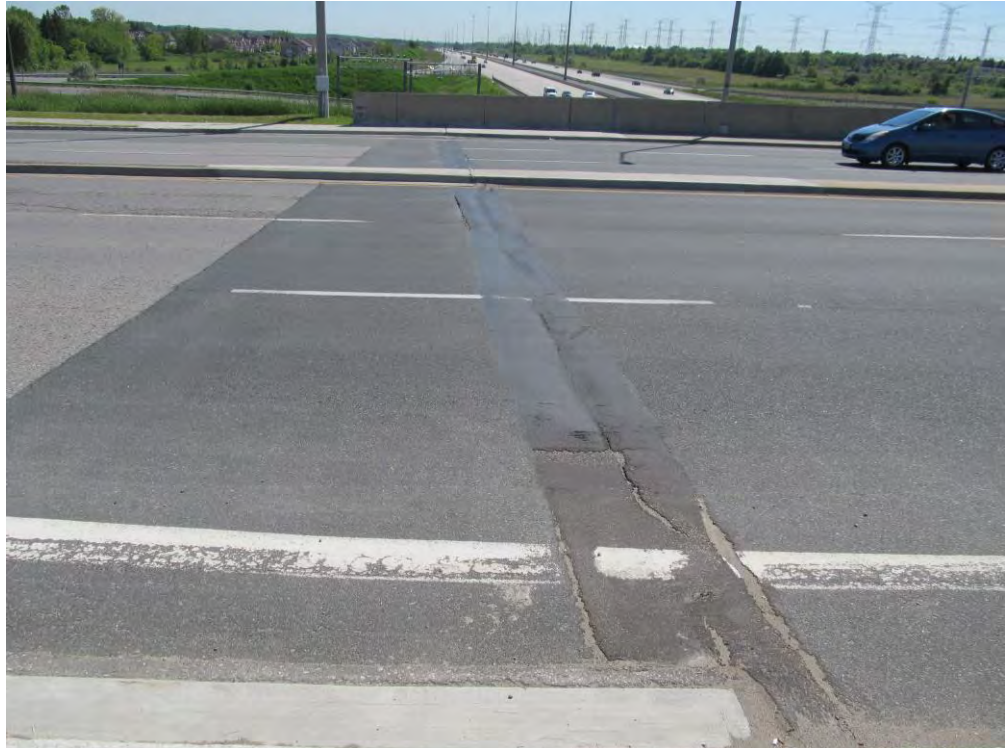
Exhibit 20 – Kennedy Rd – 407ETR Overpass
Cracks and Deterioration on North Approach (view from West)

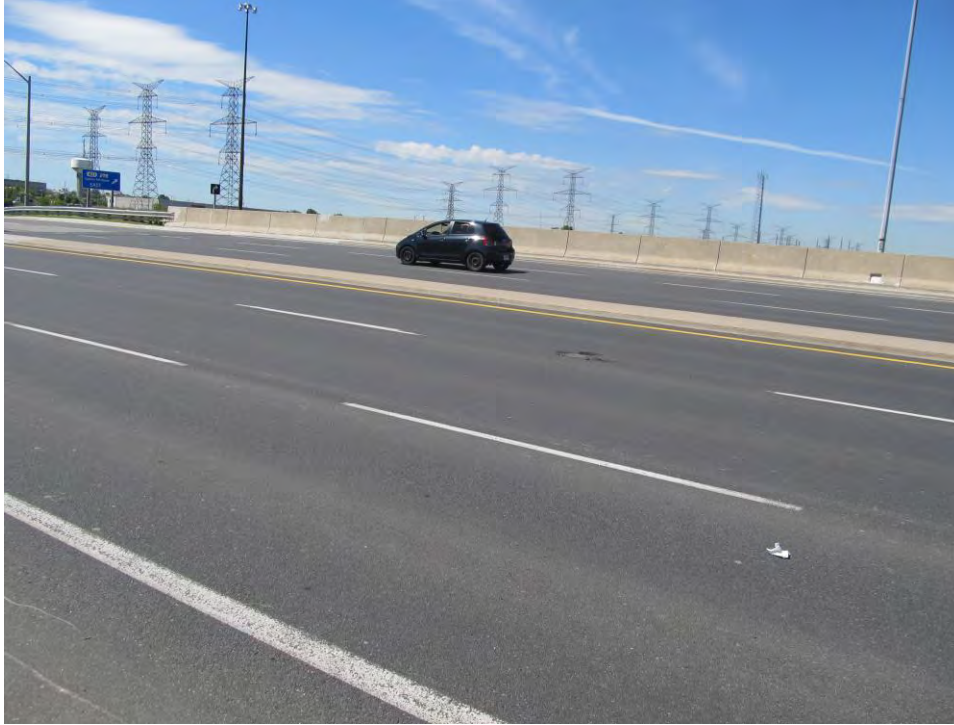
Exhibit 21 – Kennedy Rd – 407ETR Overpass
Pot Hole on Southeast Road Surface (view from East)

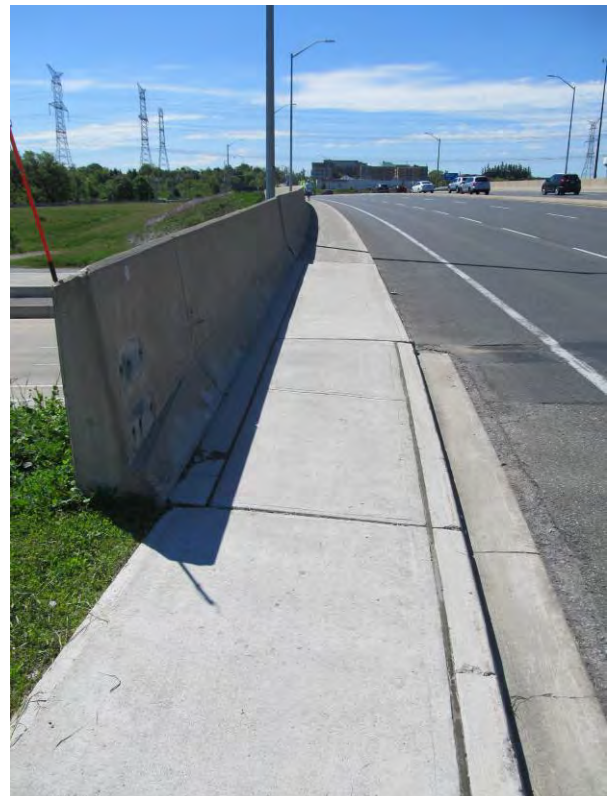
Exhibit 22 – Kennedy Rd – 407ETR Overpass
Missing Guiderail at Southeast Barrier Wall & Sidewalk (view from North)

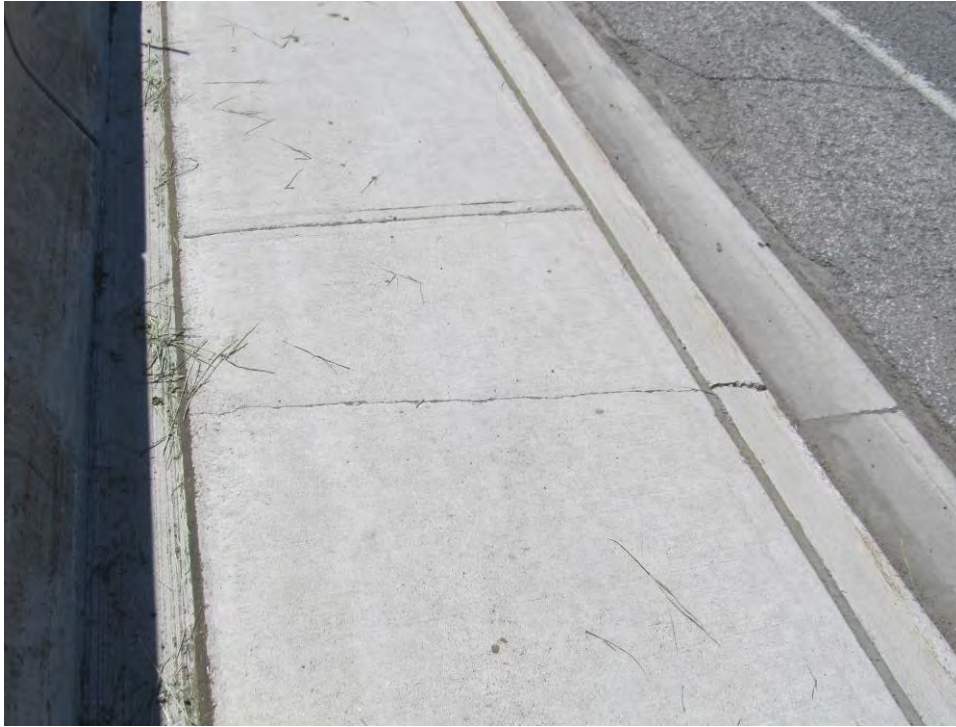
Exhibit 23 – Kennedy Rd – 407ETR Overpass
Wide Crack on Southeast Sidewalk (view from North)

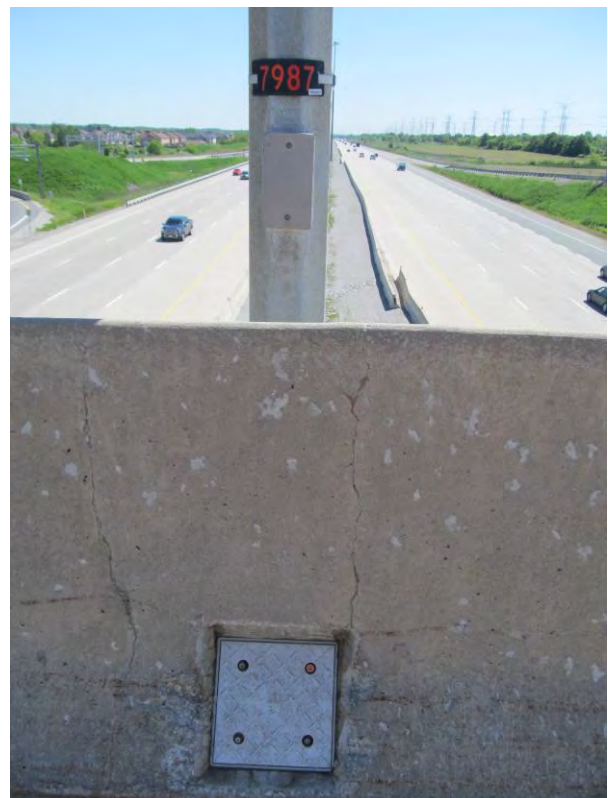
Exhibit 24 – Kennedy Rd – 407ETR Overpass
Cracks & Spalls on East Barrier Wall at Middle Light Pole (view from West)

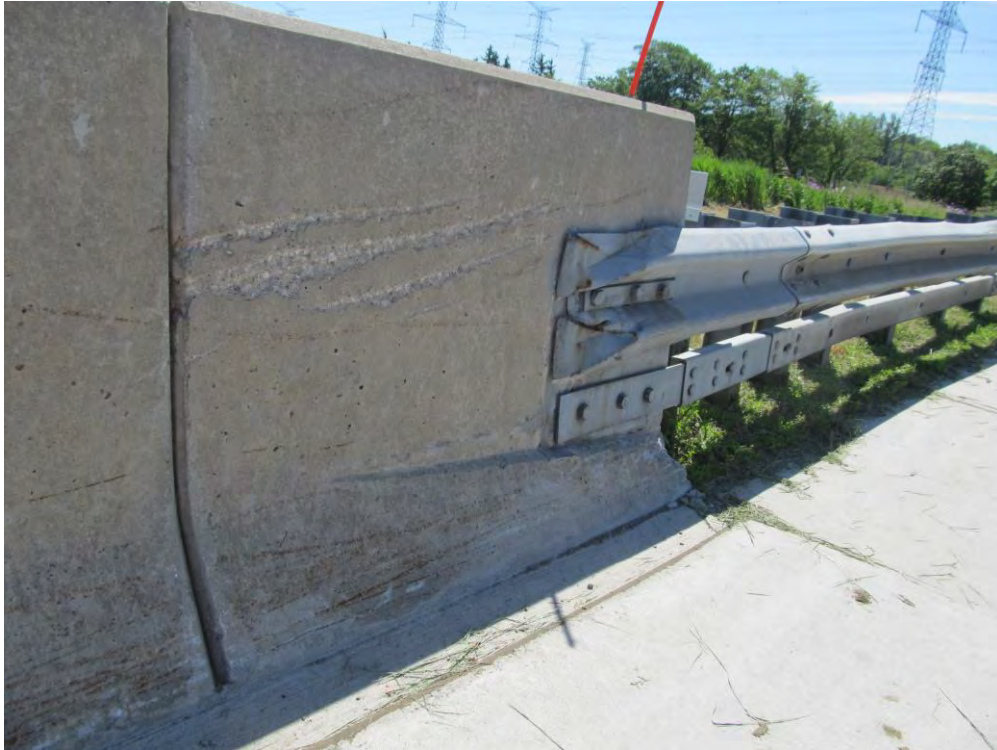
Exhibit 25 – Kennedy Rd – 407ETR Overpass
Impact Damage at Southeast Barrier Wall/Guiderail Connection (view from North)

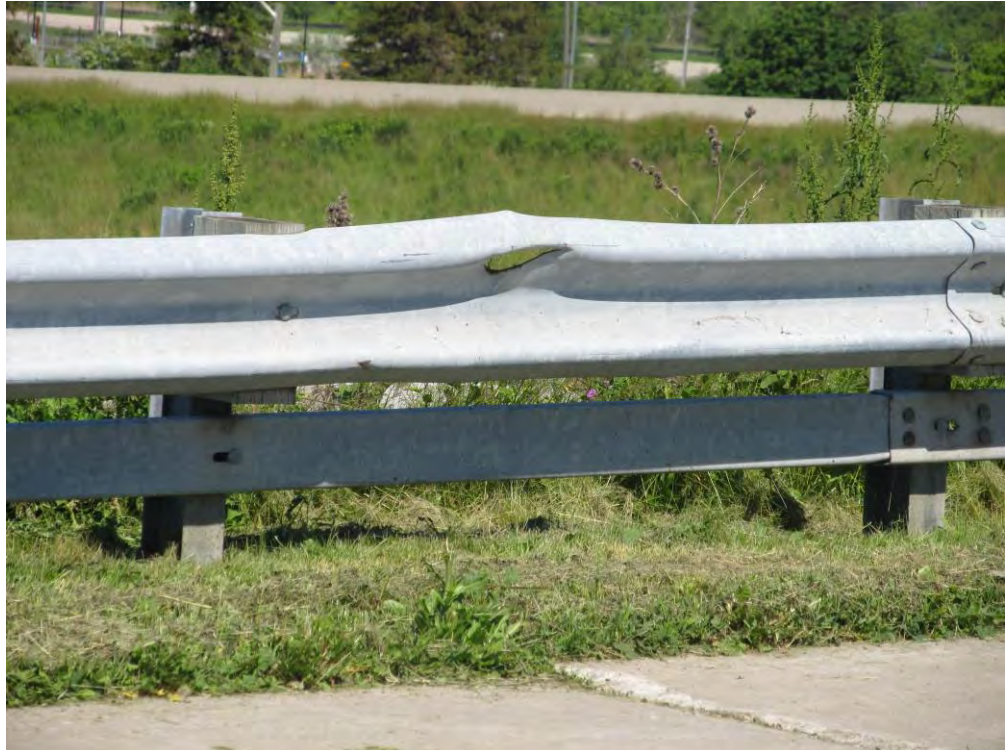
Exhibit 26 – Kennedy Rd – 407ETR Overpass
Damage on Southwest Guiderail (view from East)

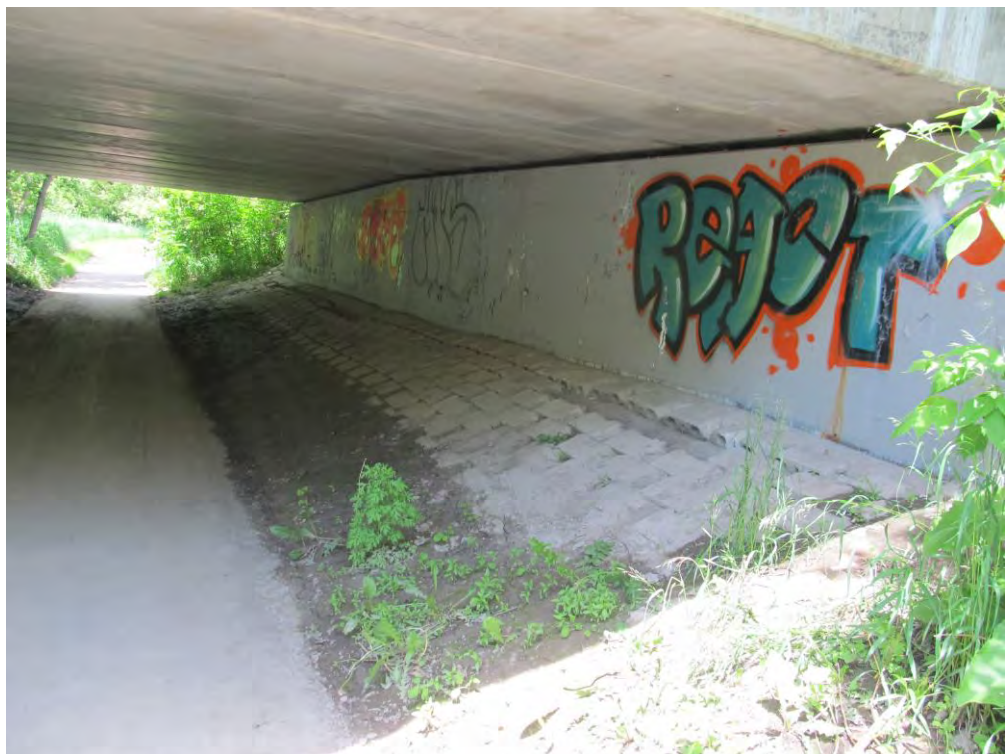
Exhibit 28 – Kennedy Rd – Rouge River Bridge
North Abutment, Graffiti & Missing Slope Protection Blocks (view from Southeast)

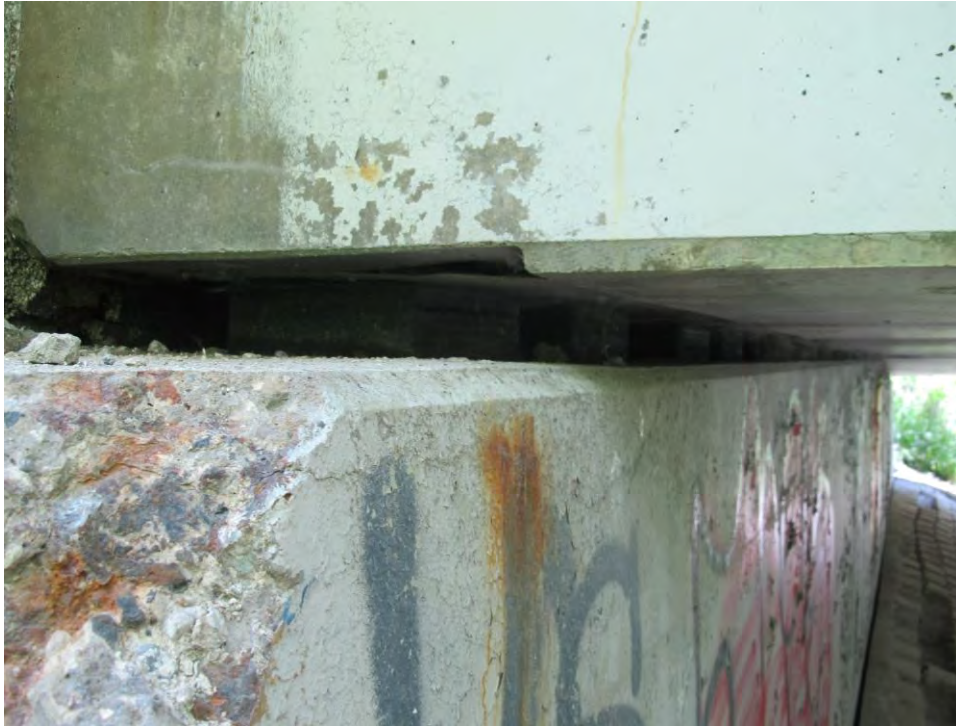
Exhibit 31 – Kennedy Rd – Rouge River Bridge
Spalling on Northwest Bearing Seat (view from West)

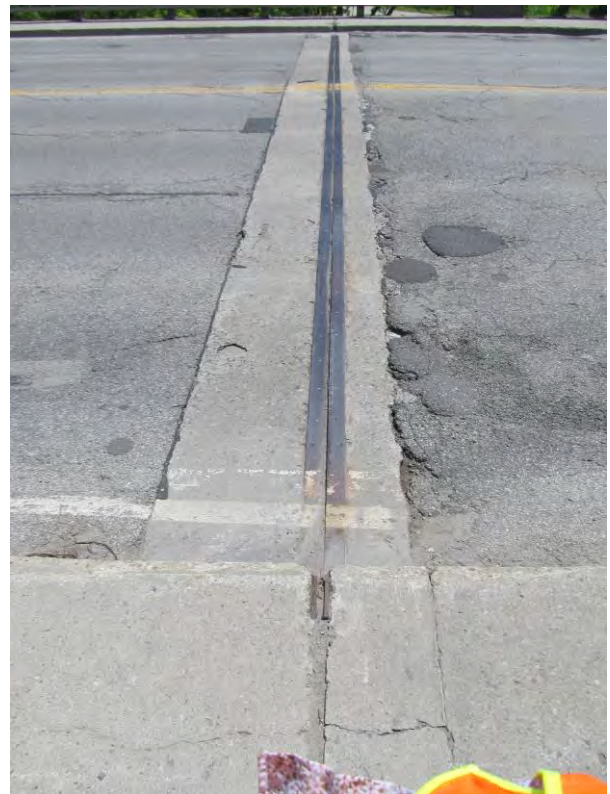
Exhibit 36 – Kennedy Rd – Rouge River Bridge
South Expansion Joint, Cracks/Deterioration/Patches (view from West)

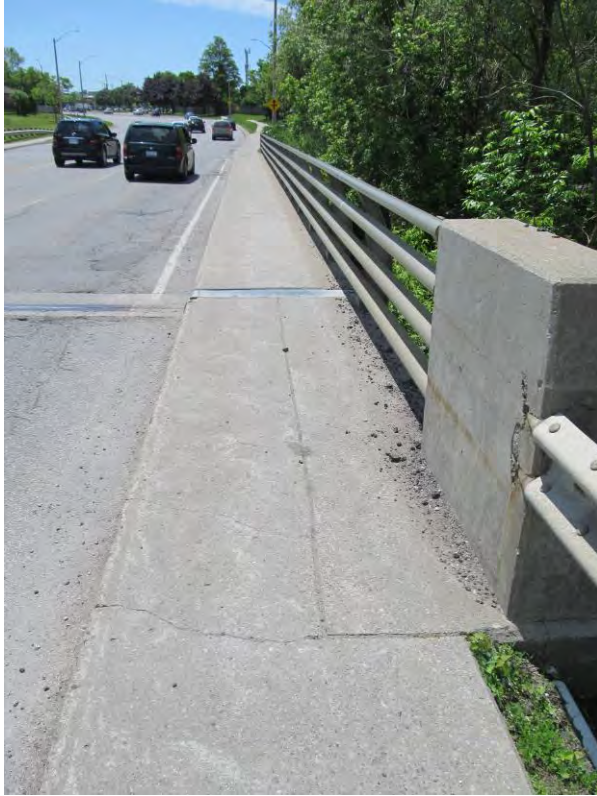
Exhibit 37 – Kennedy Rd – Rouge River Bridge
West Sidewalk & Railing, Cracks & Spalling (view from North)

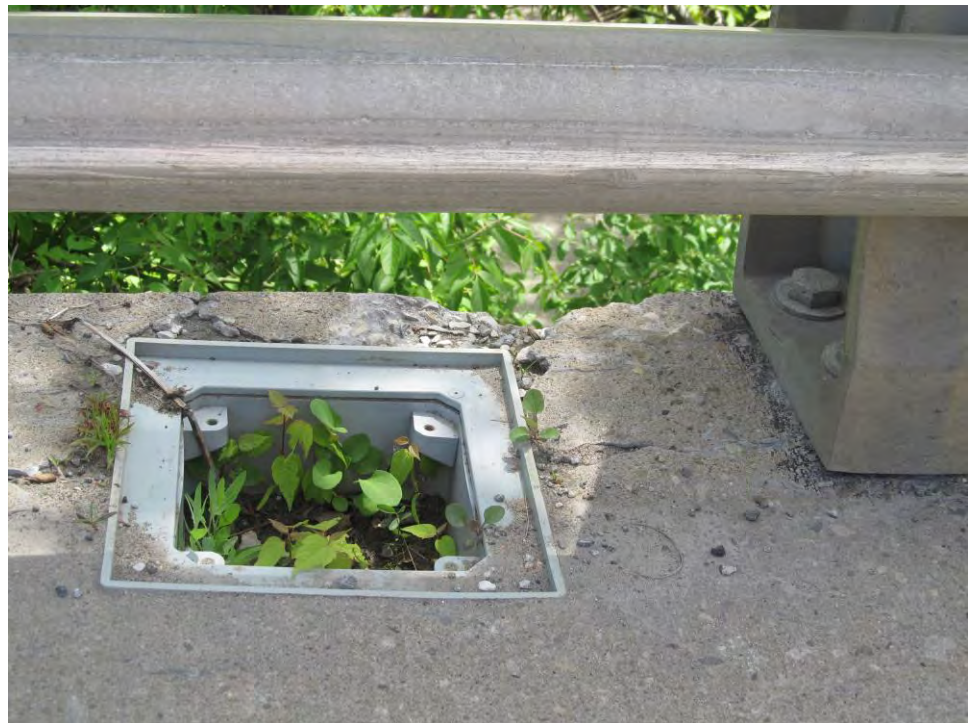
Exhibit 38 – Kennedy Rd – Rouge River Bridge
Spall & Missing Cover from Northeast Electrical Box (view from West)

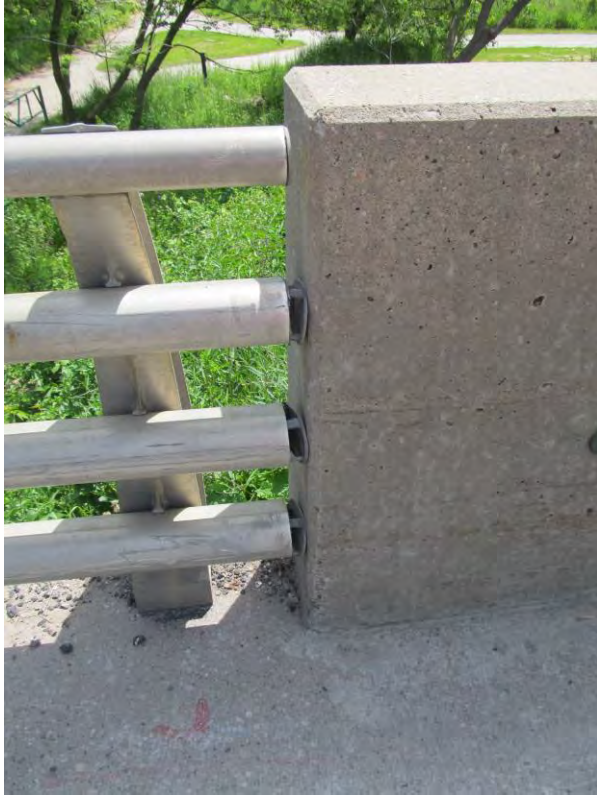
Exhibit 39 – Kennedy Rd – Rouge River Bridge
Spalling & Loose End Caps on Southeast Railing (view from West)

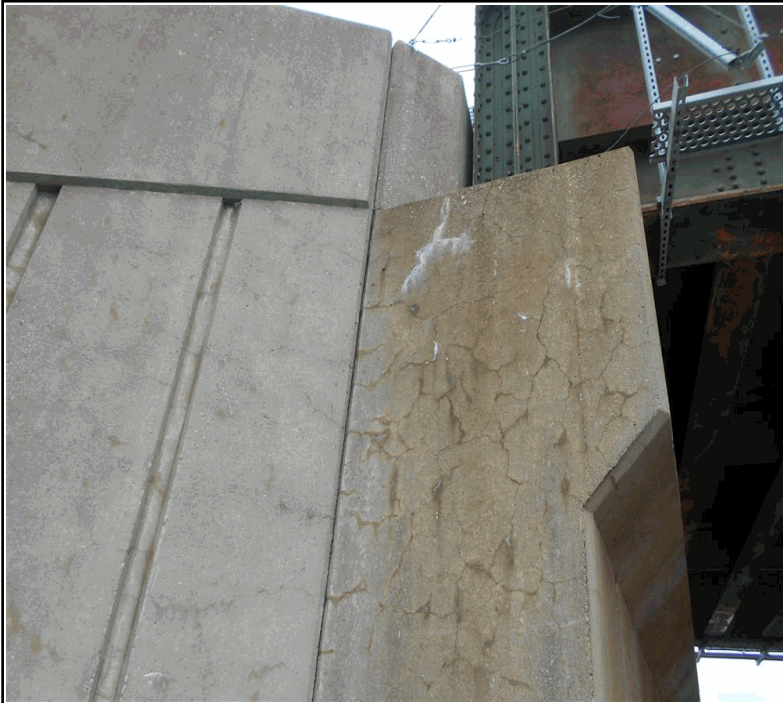
West abutment, narrow map crack/stained crack

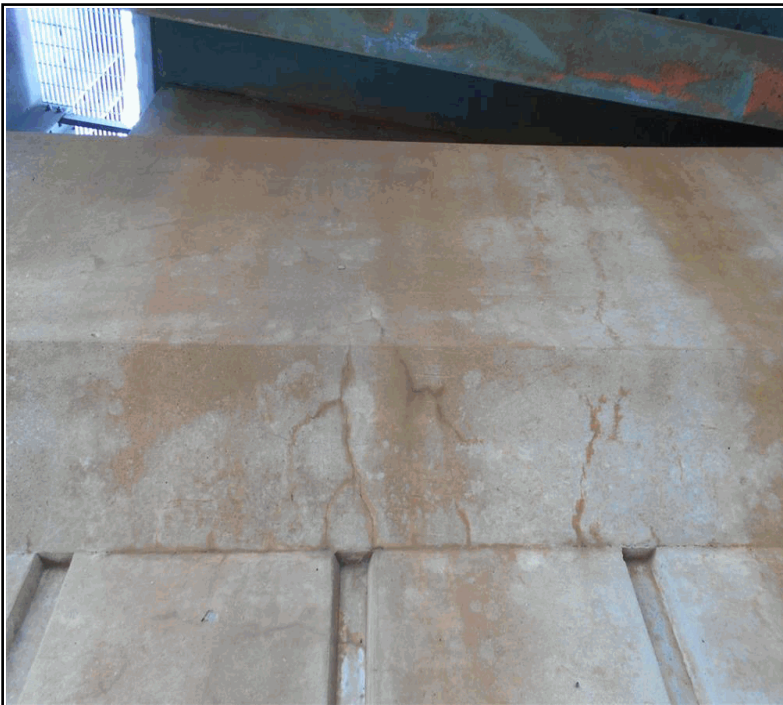
West abutment, narrow crack

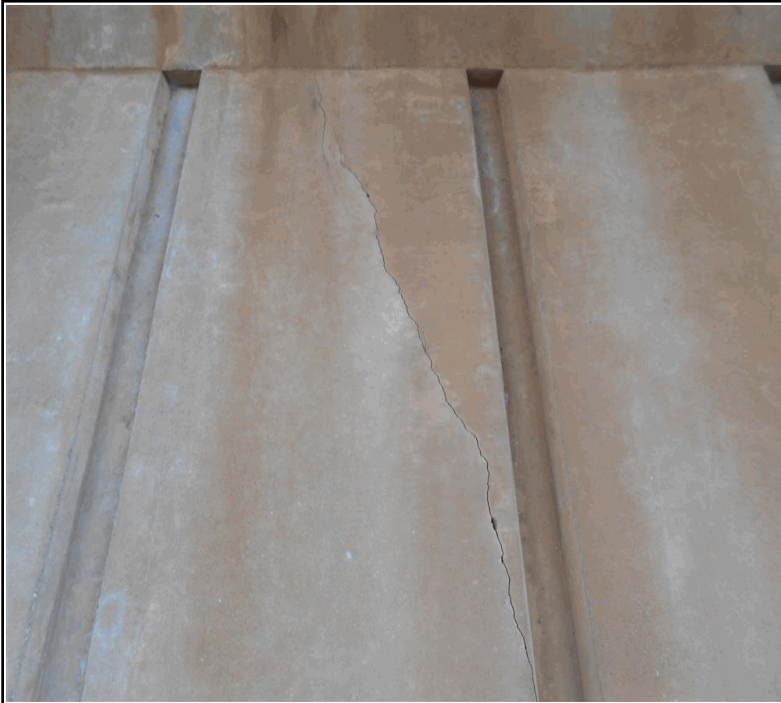
East abutment, wide crack

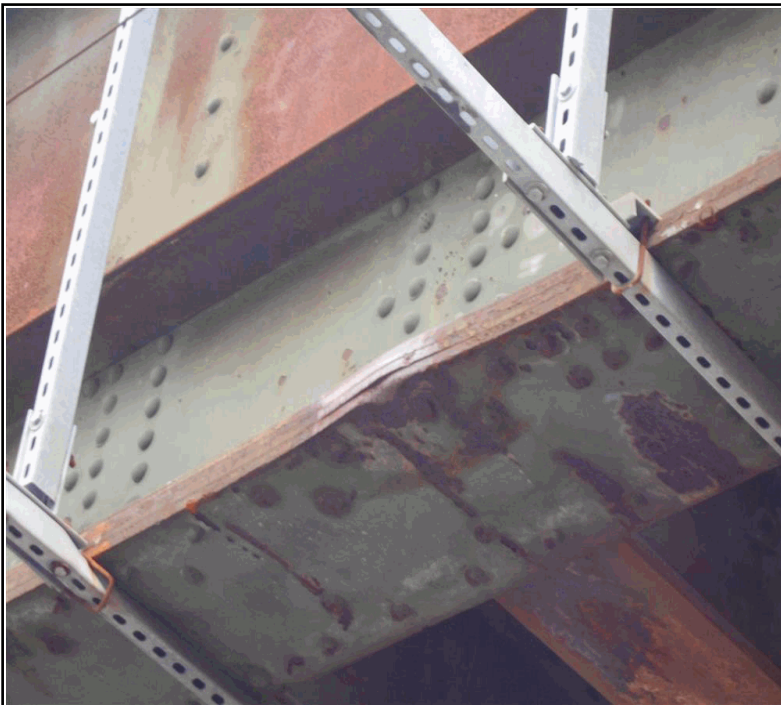
South girder impact damage, northbound lane

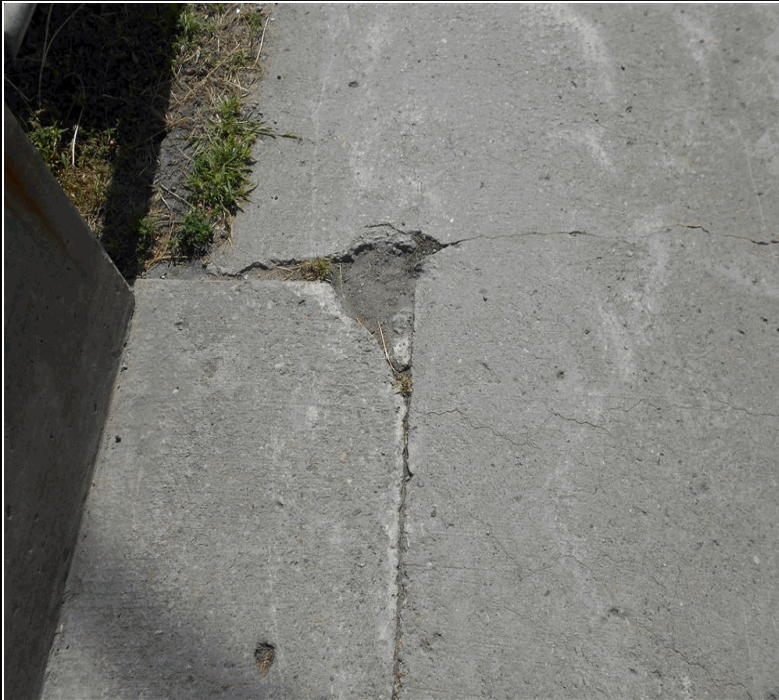
East sidewalk, spall

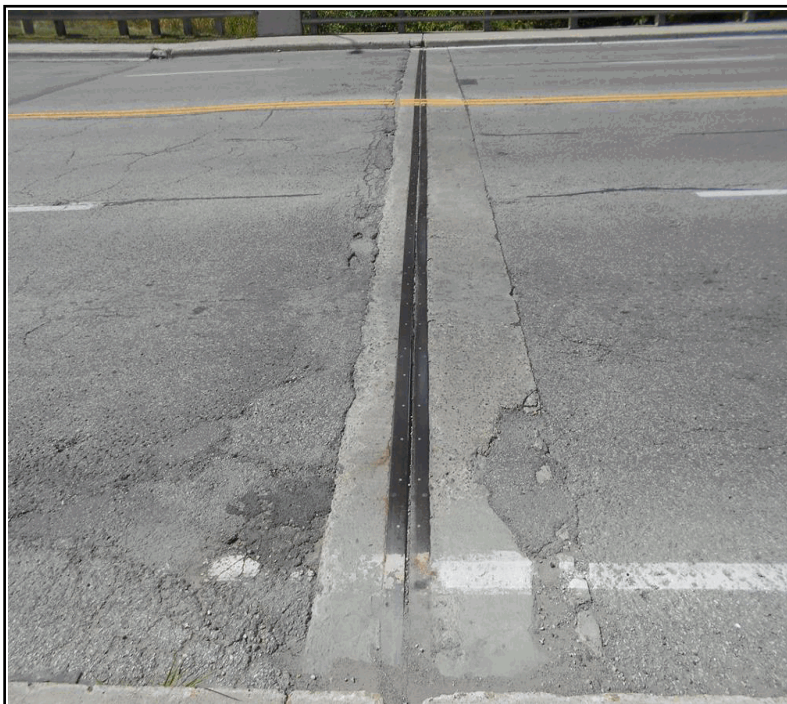
South expansion joint, spalls, asphalt patch, cracking

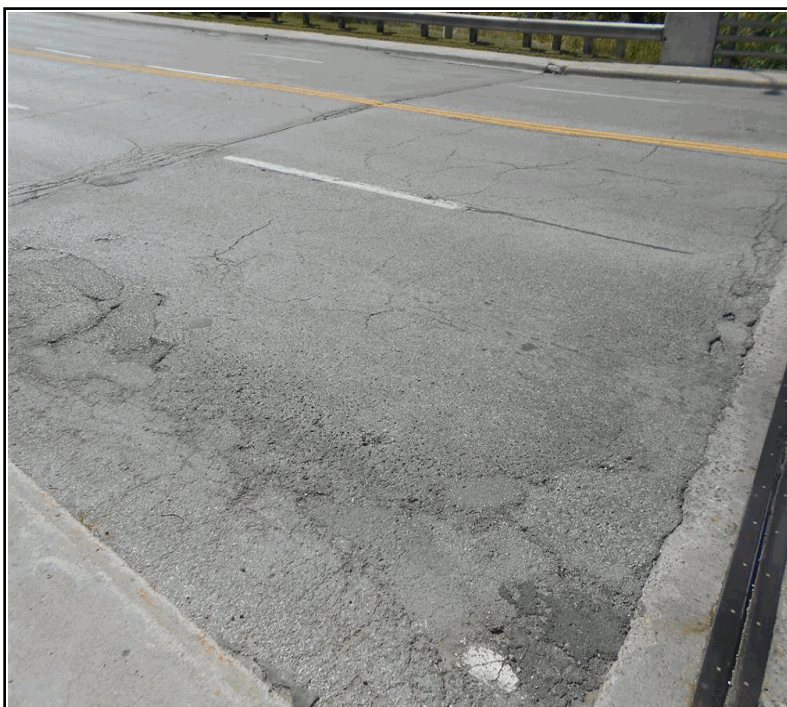
South approach, pot holes, map cracking

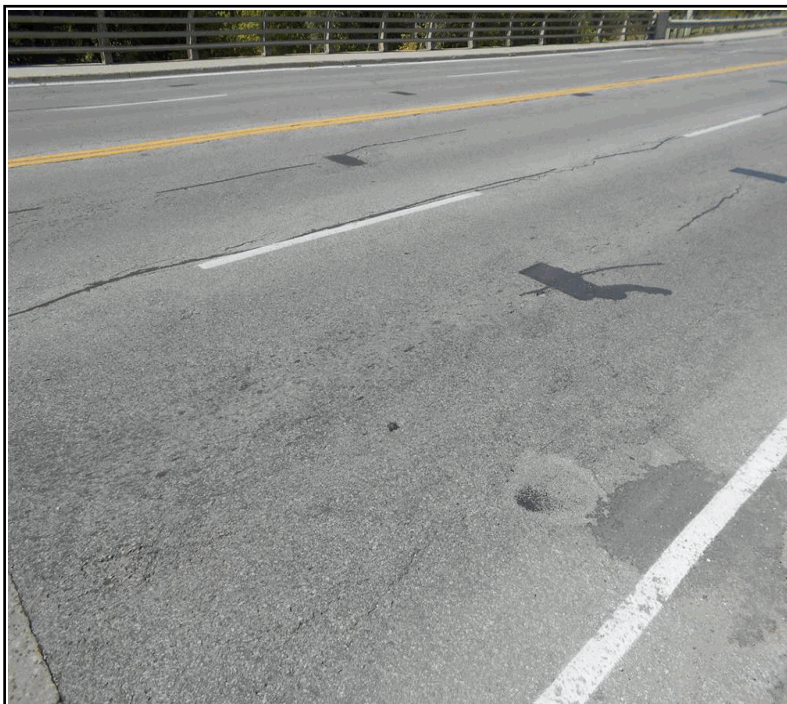
Pot holes filled, sealed cracks

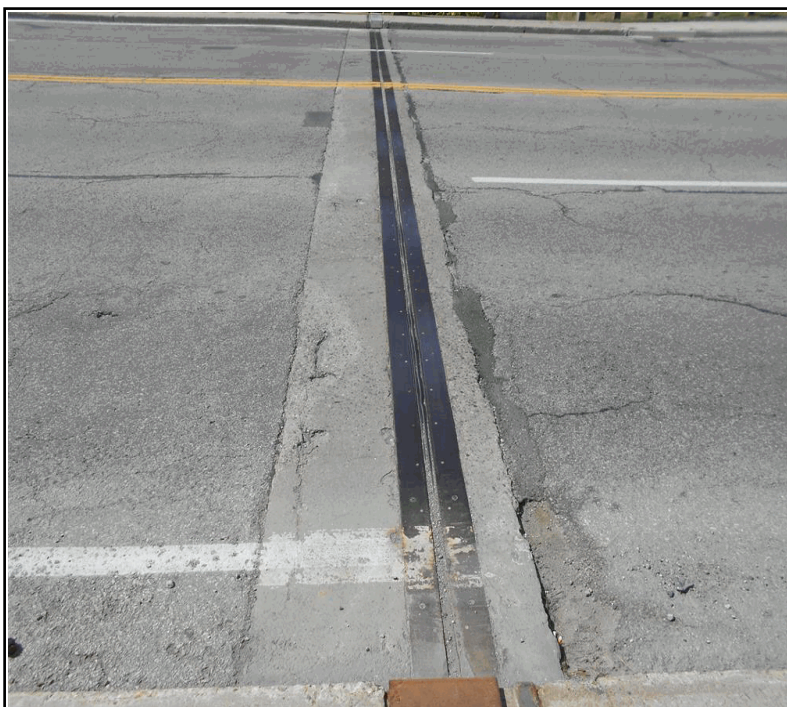
North expansion joint, spall
