Bridge Inspection Form

Struct. ID 03-06 B0400

York Region

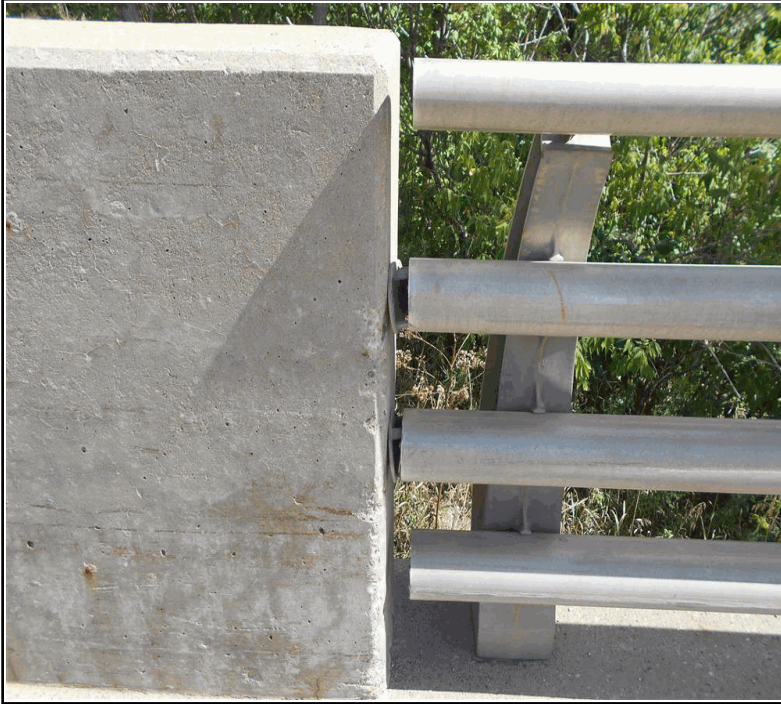
File Name DSCN4167.JPG

East railing, loose end cap

Elem Grp/Class	Barriers/Railing Systems
Elem Type	4 Rail Metal Railing - Aluminum
Sub Element	
Material Type	Aluminium
Locator	East
Defect Descript1	Fair condition
Defect Descript2	
Defect	
Other

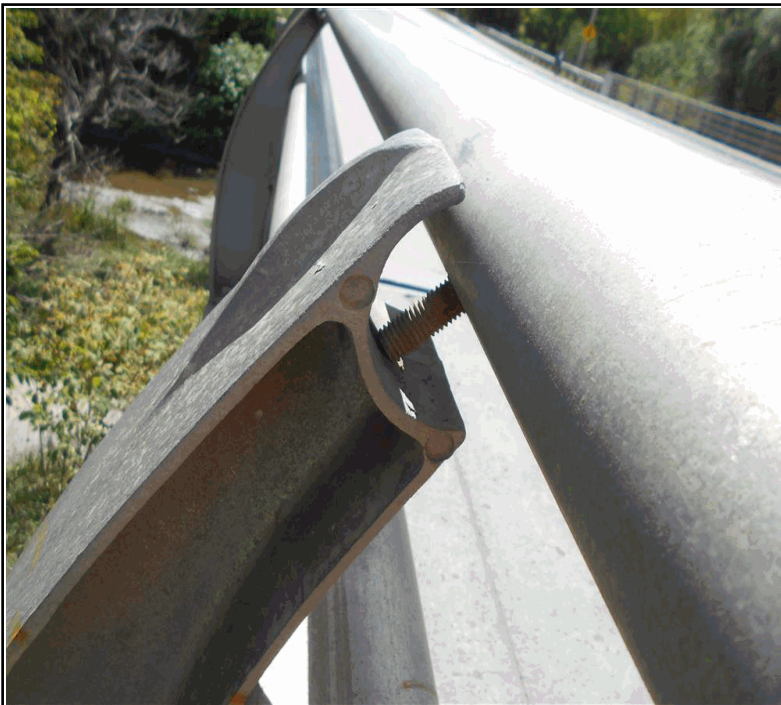
File Name DSCN4168.JPG

East railing, top rail separated

Elem Grp/Class	Barriers/Railing Systems
Elem Type	4 Rail Metal Railing - Aluminum
Sub Element	
Material Type	Aluminium
Locator	East
Defect Descript1	Fair condition
Defect Descript2	
Defect	
Other

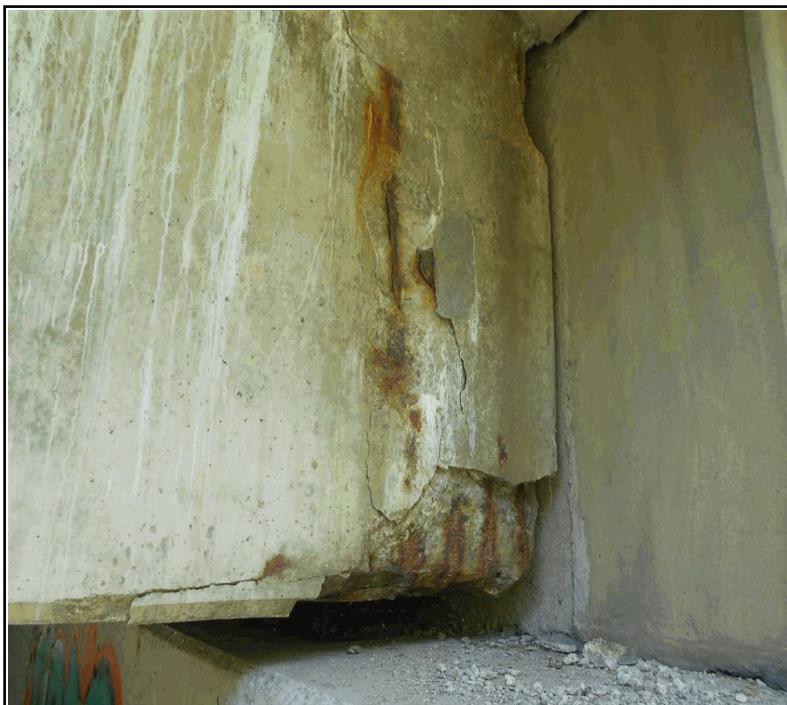
File Name DSCN4175.JPG

Spall, exposed rebar

Beams/MLE's/Girders

Box/trapezoidal

End

Precast concrete

North

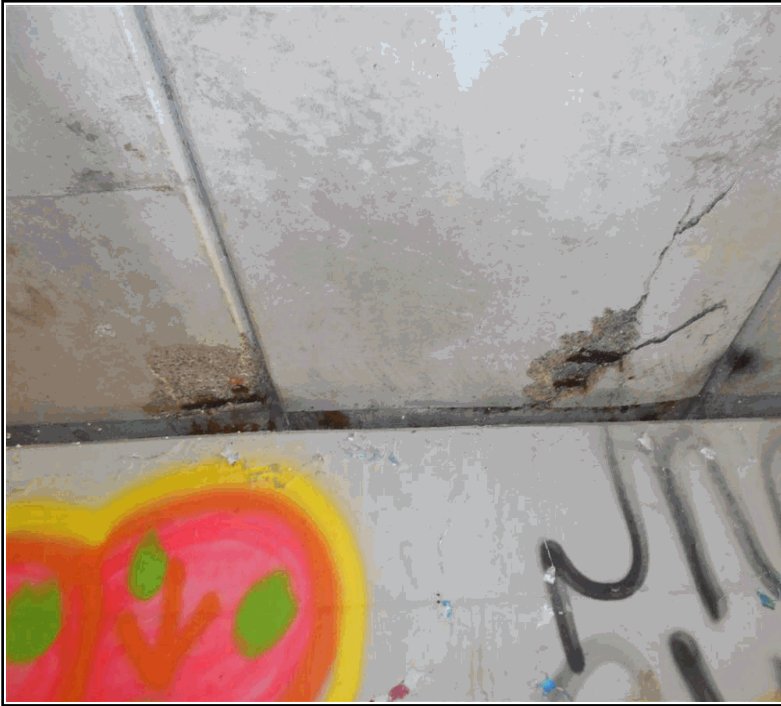
File Name DSCN4179.JPG

Delamination on box girder

Elem Grp/Class	Beams/ML'E's/Girders
Elem Type	Box/trapezoidal
Sub Element	End
Material Type	Precast concrete
Locator	
Defect Descript1	Poor condition
Defect Descript2	
Defect	Delamination
Other

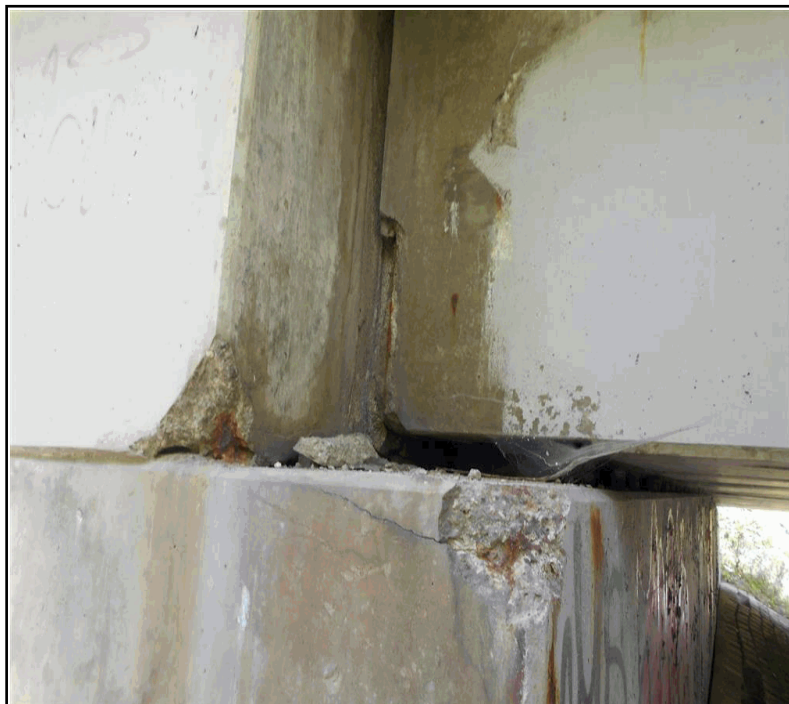
File Name DSCN4186.JPG

Spalls with exposed rebar

Elem Grp/Class	Abutments/Ballast walls
Elem Type	
Sub Element	
Material Type	Cast-in-place concrete
Locator	North
Defect Descript1	Poor condition
Defect Descript2	
Defect	Spalling
Other	reinforcement

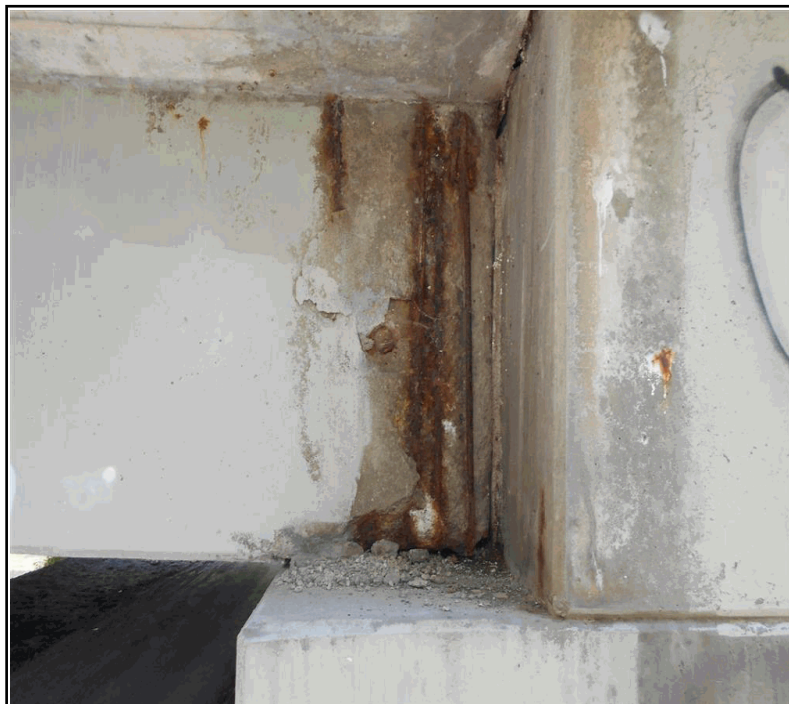
File Name DSCN4197.JPG

West girder, spalls with exposed rebar

Elem Grp/Class	Beams/ML's/Girders
Elem Type	Box/trapezoidal
Sub Element	End
Material Type	Precast concrete
Locator	West
Defect Descript1	
Defect Descript2	
Defect	
Other

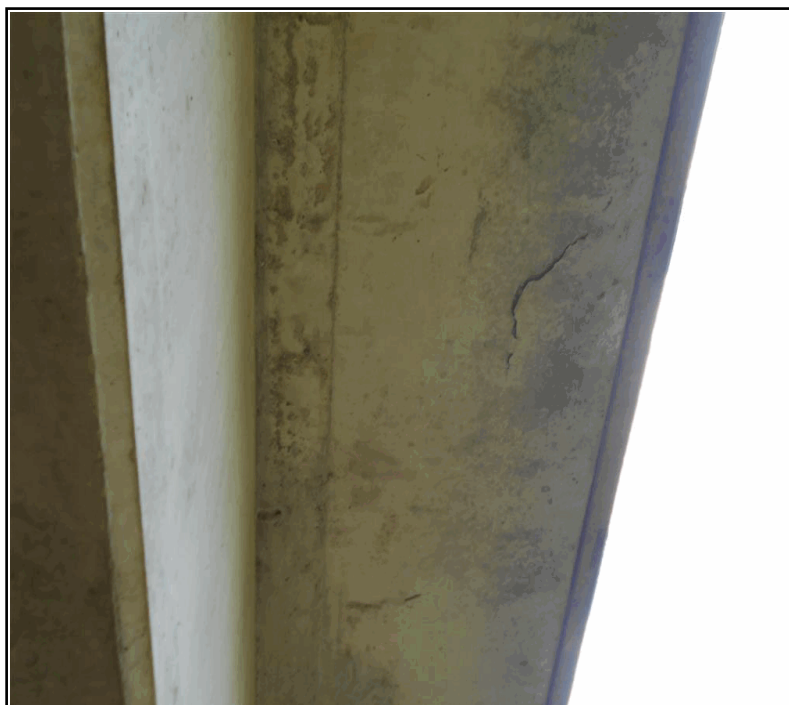
File Name DSCN4199.JPG

Soffit exterior, delamination

Elem Grp/Class	Barriers/Barrier/Parapet Walls
Elem Type	Other
Sub Element	Exterior
Material Type	Cast-in-place concrete
Locator	East
Defect Descript1	
Defect Descript2	
Defect	
Other

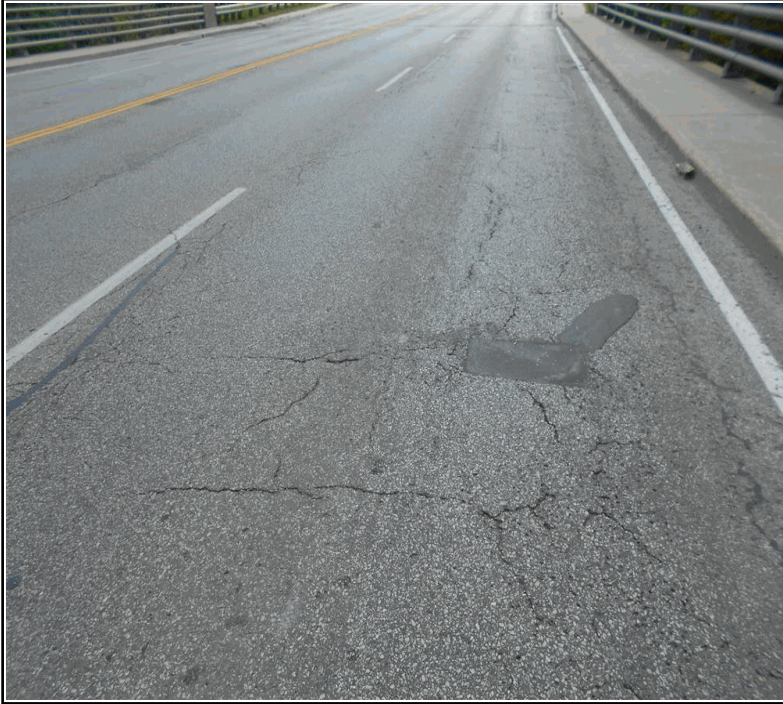
File Name DSCN4205.JPG

Southbound lane, cracking, filled pot holes

Elem Grp/Class	Decks/Wearing surface
Elem Type	
Sub Element	
Material Type	Asphalt
Locator	Middle
Defect Descript1	
Defect Descript2	
Defect	Cracking
Other
