# 2025 Annual Performance Report

## York Region Roads Stormwater Management System

Consolidated Linear Infrastructure Environmental  
Compliance Approval (CLI ECA): 013-S701  
for York Region Roads Stormwater Management System

<b>Issue Number: 1</b>
<b>System Owner:</b> The Regional Municipality of York	
<b>System Name:</b> York Region Roads Stormwater Management System	
<b>Reporting Period:</b> January 1, 2025 to December 31, 2025	
<b>Submitted to:</b> Director, Ministry of the Environment, Conservation and Parks (MECP)	<b>Report Date:</b> April 28, 2026

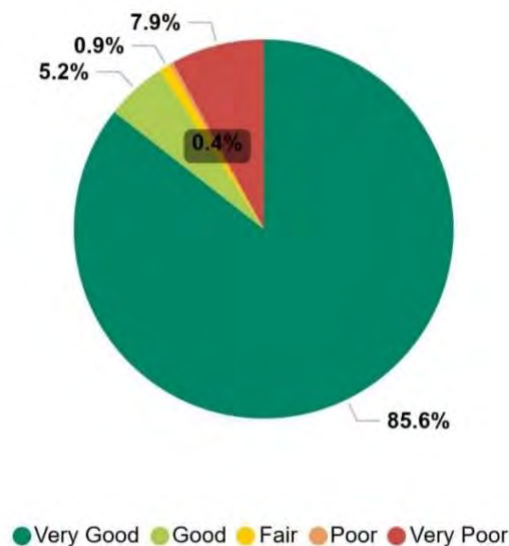
**Figure 1: Roads Stormwater Assets Overall Condition Summary**

**Figure 1** presents the condition distribution of the Region’s stormwater assets based on the age-based analysis. The results indicate that the majority of roads stormwater assets are in Very Good condition (85.6%), suggesting that most of the stormwater system is relatively new or has significant Remaining Service Life. An additional 5.2% of roads stormwater assets are in Good condition, while 0.9% are assessed as Fair. A small portion of the roads stormwater assets are in Poor condition (0.3%), while a more notable share, 8.0%, are in Very Poor condition, representing assets at or near the end of their expected service life.

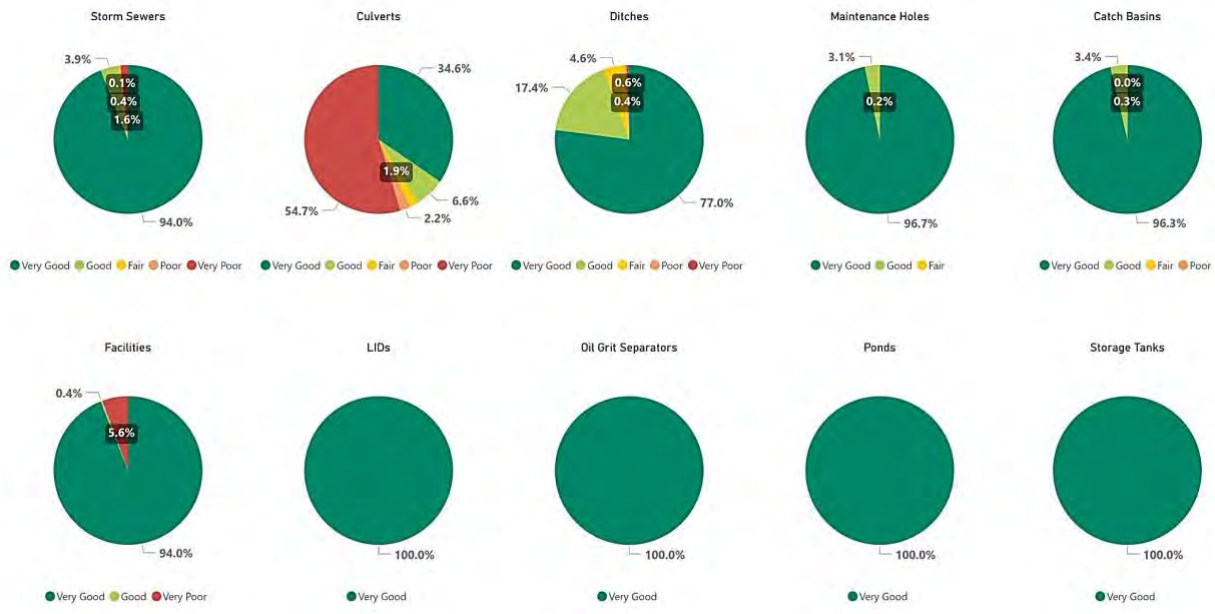
**Figure 2: Roads Stormwater Assets Condition Detail**

**Figure 2** below shows the condition profile of the Region’s stormwater assets by asset category, expressed as a percentage of total replacement value.

Overall, Region roads stormwater system performs well with over 90% of assets in Good or Very Good condition. Corrugated steel pipe (CSP) culverts and storm sewers have high share of Very Poor condition. They will require focused renewal and reinvestment in the near term to mitigate risks associated with asset failure.
