Appendix L – Fluvial Geomorphic Assessment

*Kennedy Road Environmental Assessment between
Steeles Avenue and Major Mackenzie Drive*

DATE January 23, 2019**PROJECT No.** 1664178**TO** HDR Inc.**CC** Steven Jagdat**FROM** Andrew Forbes and Nick Peppiatt**EMAIL** Andrew_Forbes@golder.com
Nick_Peppiatt@golder.com**FLUVIAL GEOMORPHIC ASSESSMENT IN SUPPORT OF THE KENNEDY ROAD MUNICIPAL CLASS ENVIRONMENTAL ASSESSMENT, YORK REGION**

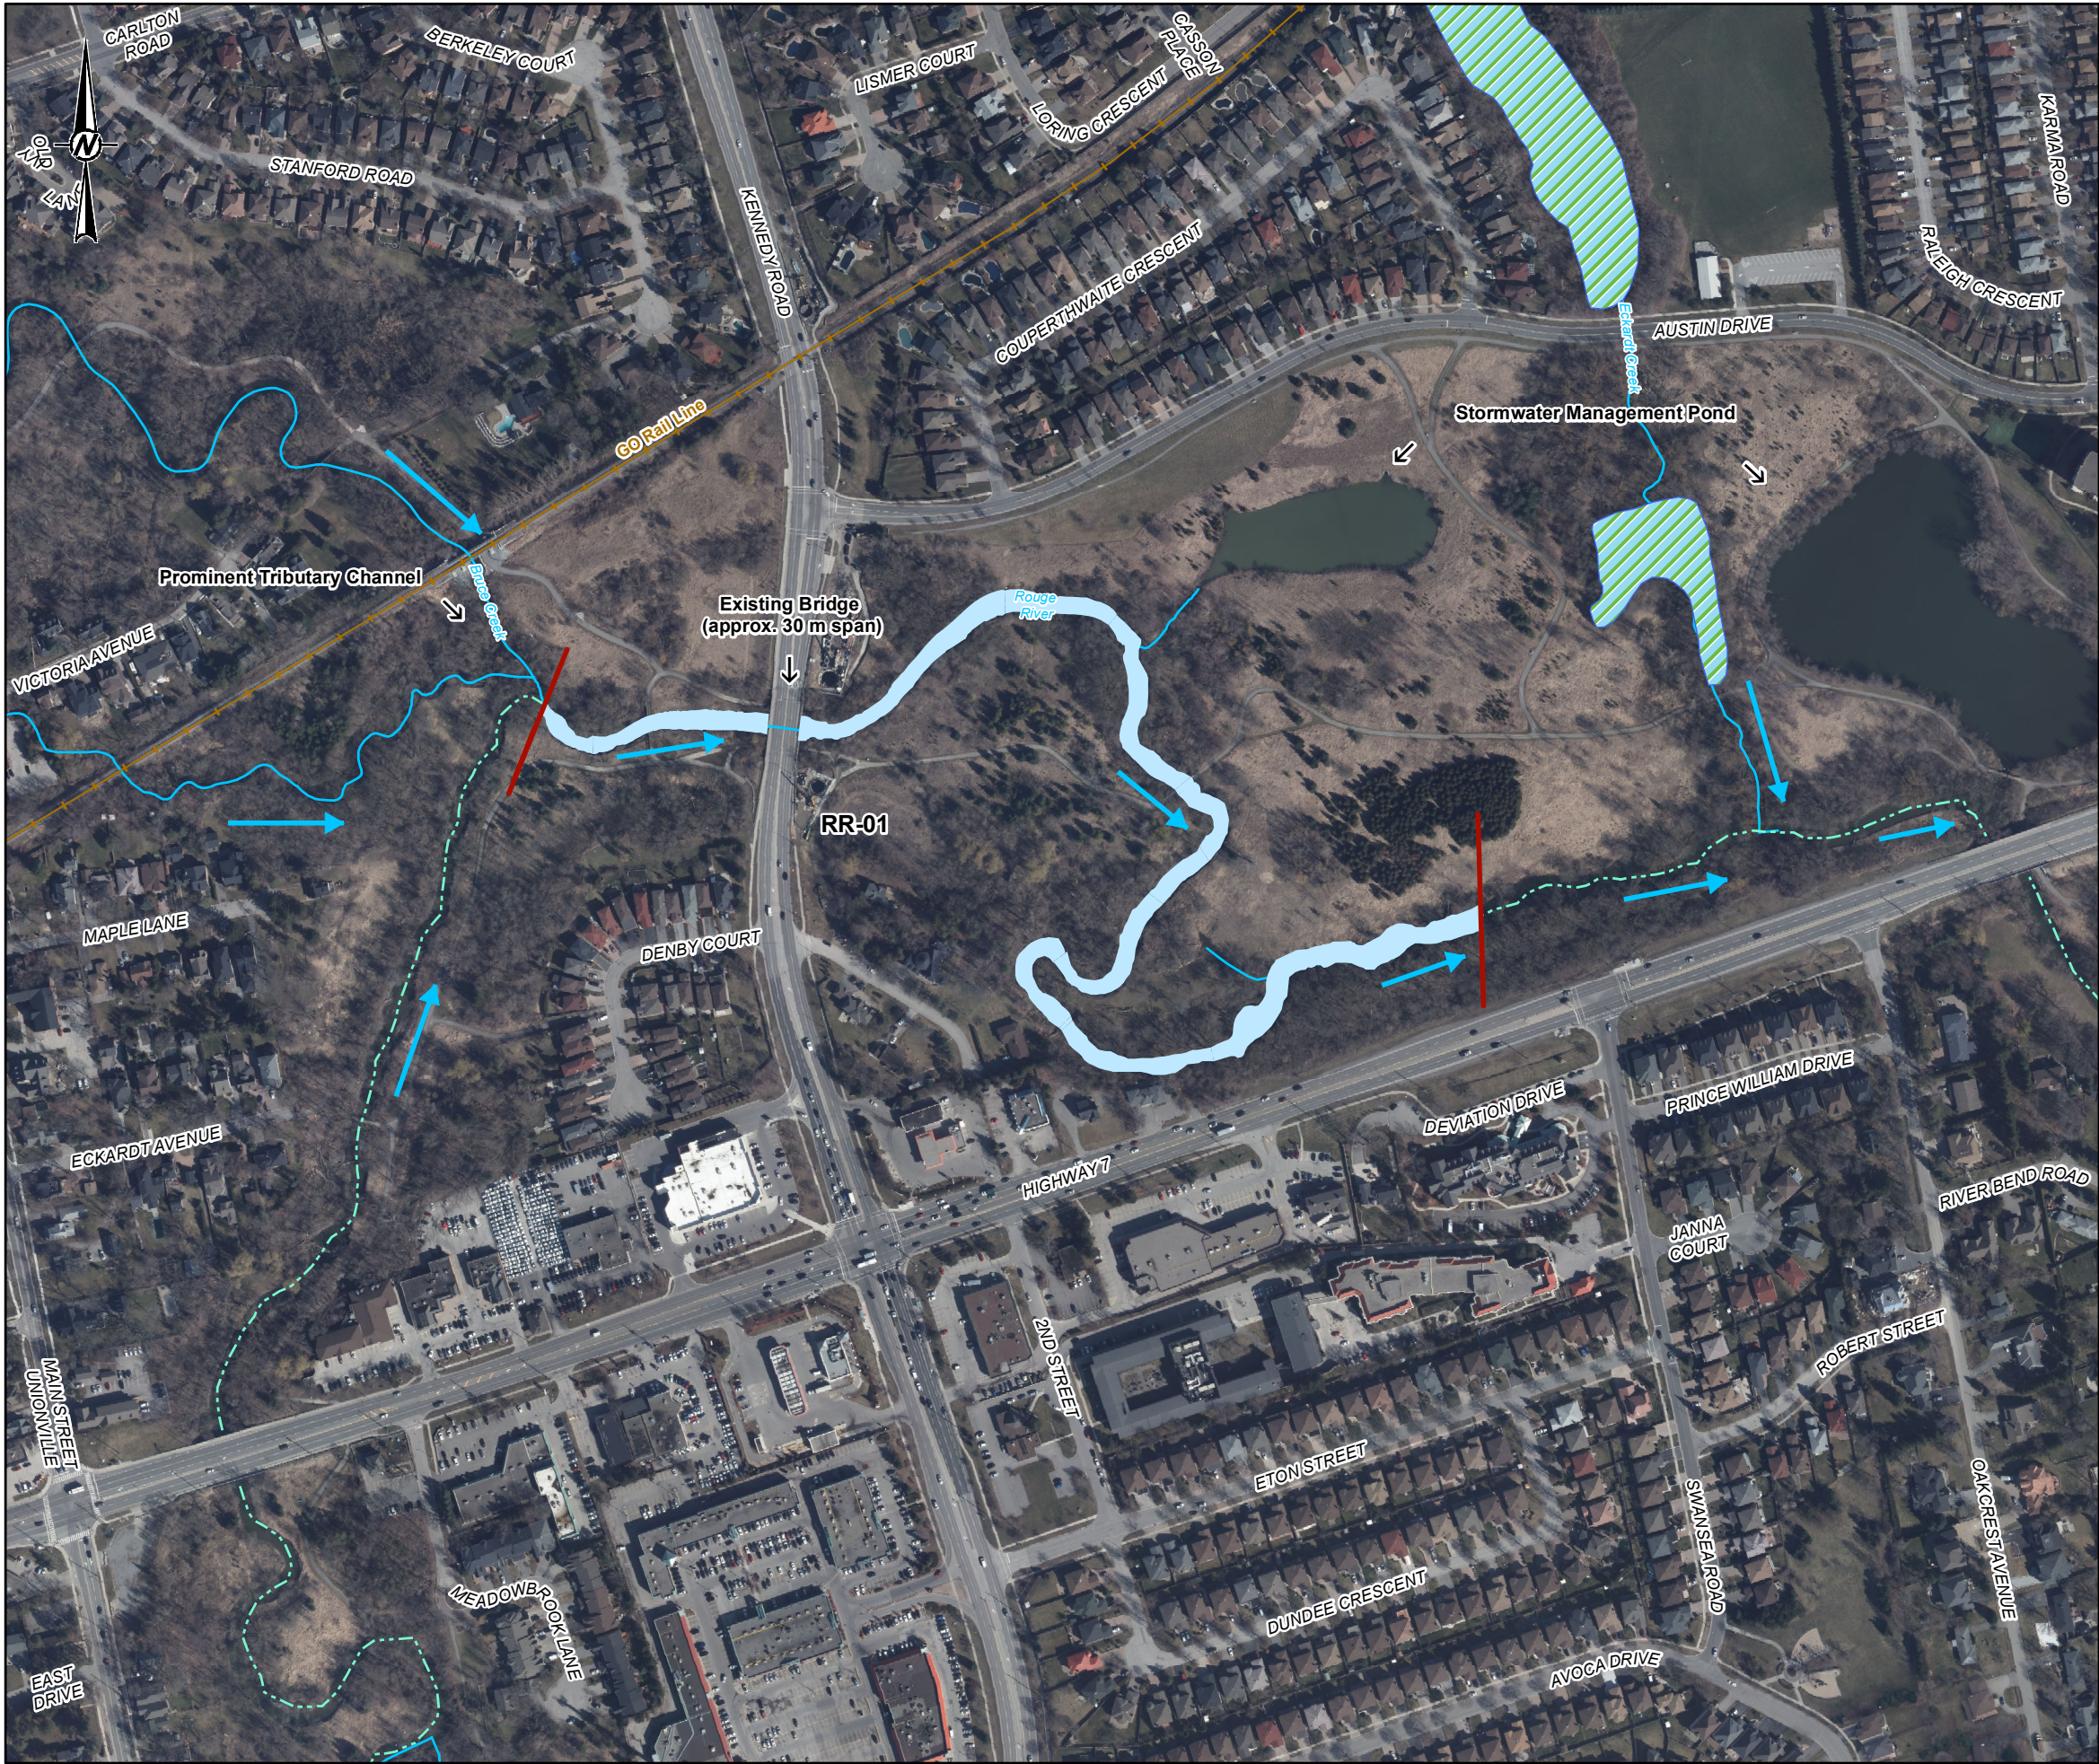
TITLE
REACH LENGTH FOR ROUGE RIVER CROSSING AT KENNEDY ROAD (RR-01)

To account for changes in fluvial geomorphologic characteristics along a channel, watercourses are typically separated into reaches that display similar physical characteristics and controls on channel morphology. With reference to Figures 1 and 2, field observations in combination with a review of available base mapping and air photographs identified one reach length at the Rouge River (described herein as RR-01) and two reach lengths at the unnamed tributary (UT-01 and UT-02). Of note, the delineation of the reach breaks for RR-01 (i.e., upstream and downstream boundaries of the reach length) were based on observed changes in hydrology and valley confinement at the channel, recognizing that the upstream reach break is located immediately downstream of the confluence between the main stem of the Rouge River and a prominent tributary, while the downstream reach break is located in an area where the meander pattern of the channel transitions from confined to unconfined conditions (with consideration of the unaltered channel configuration from the historical air photo record – refer to Section 3.2.2).

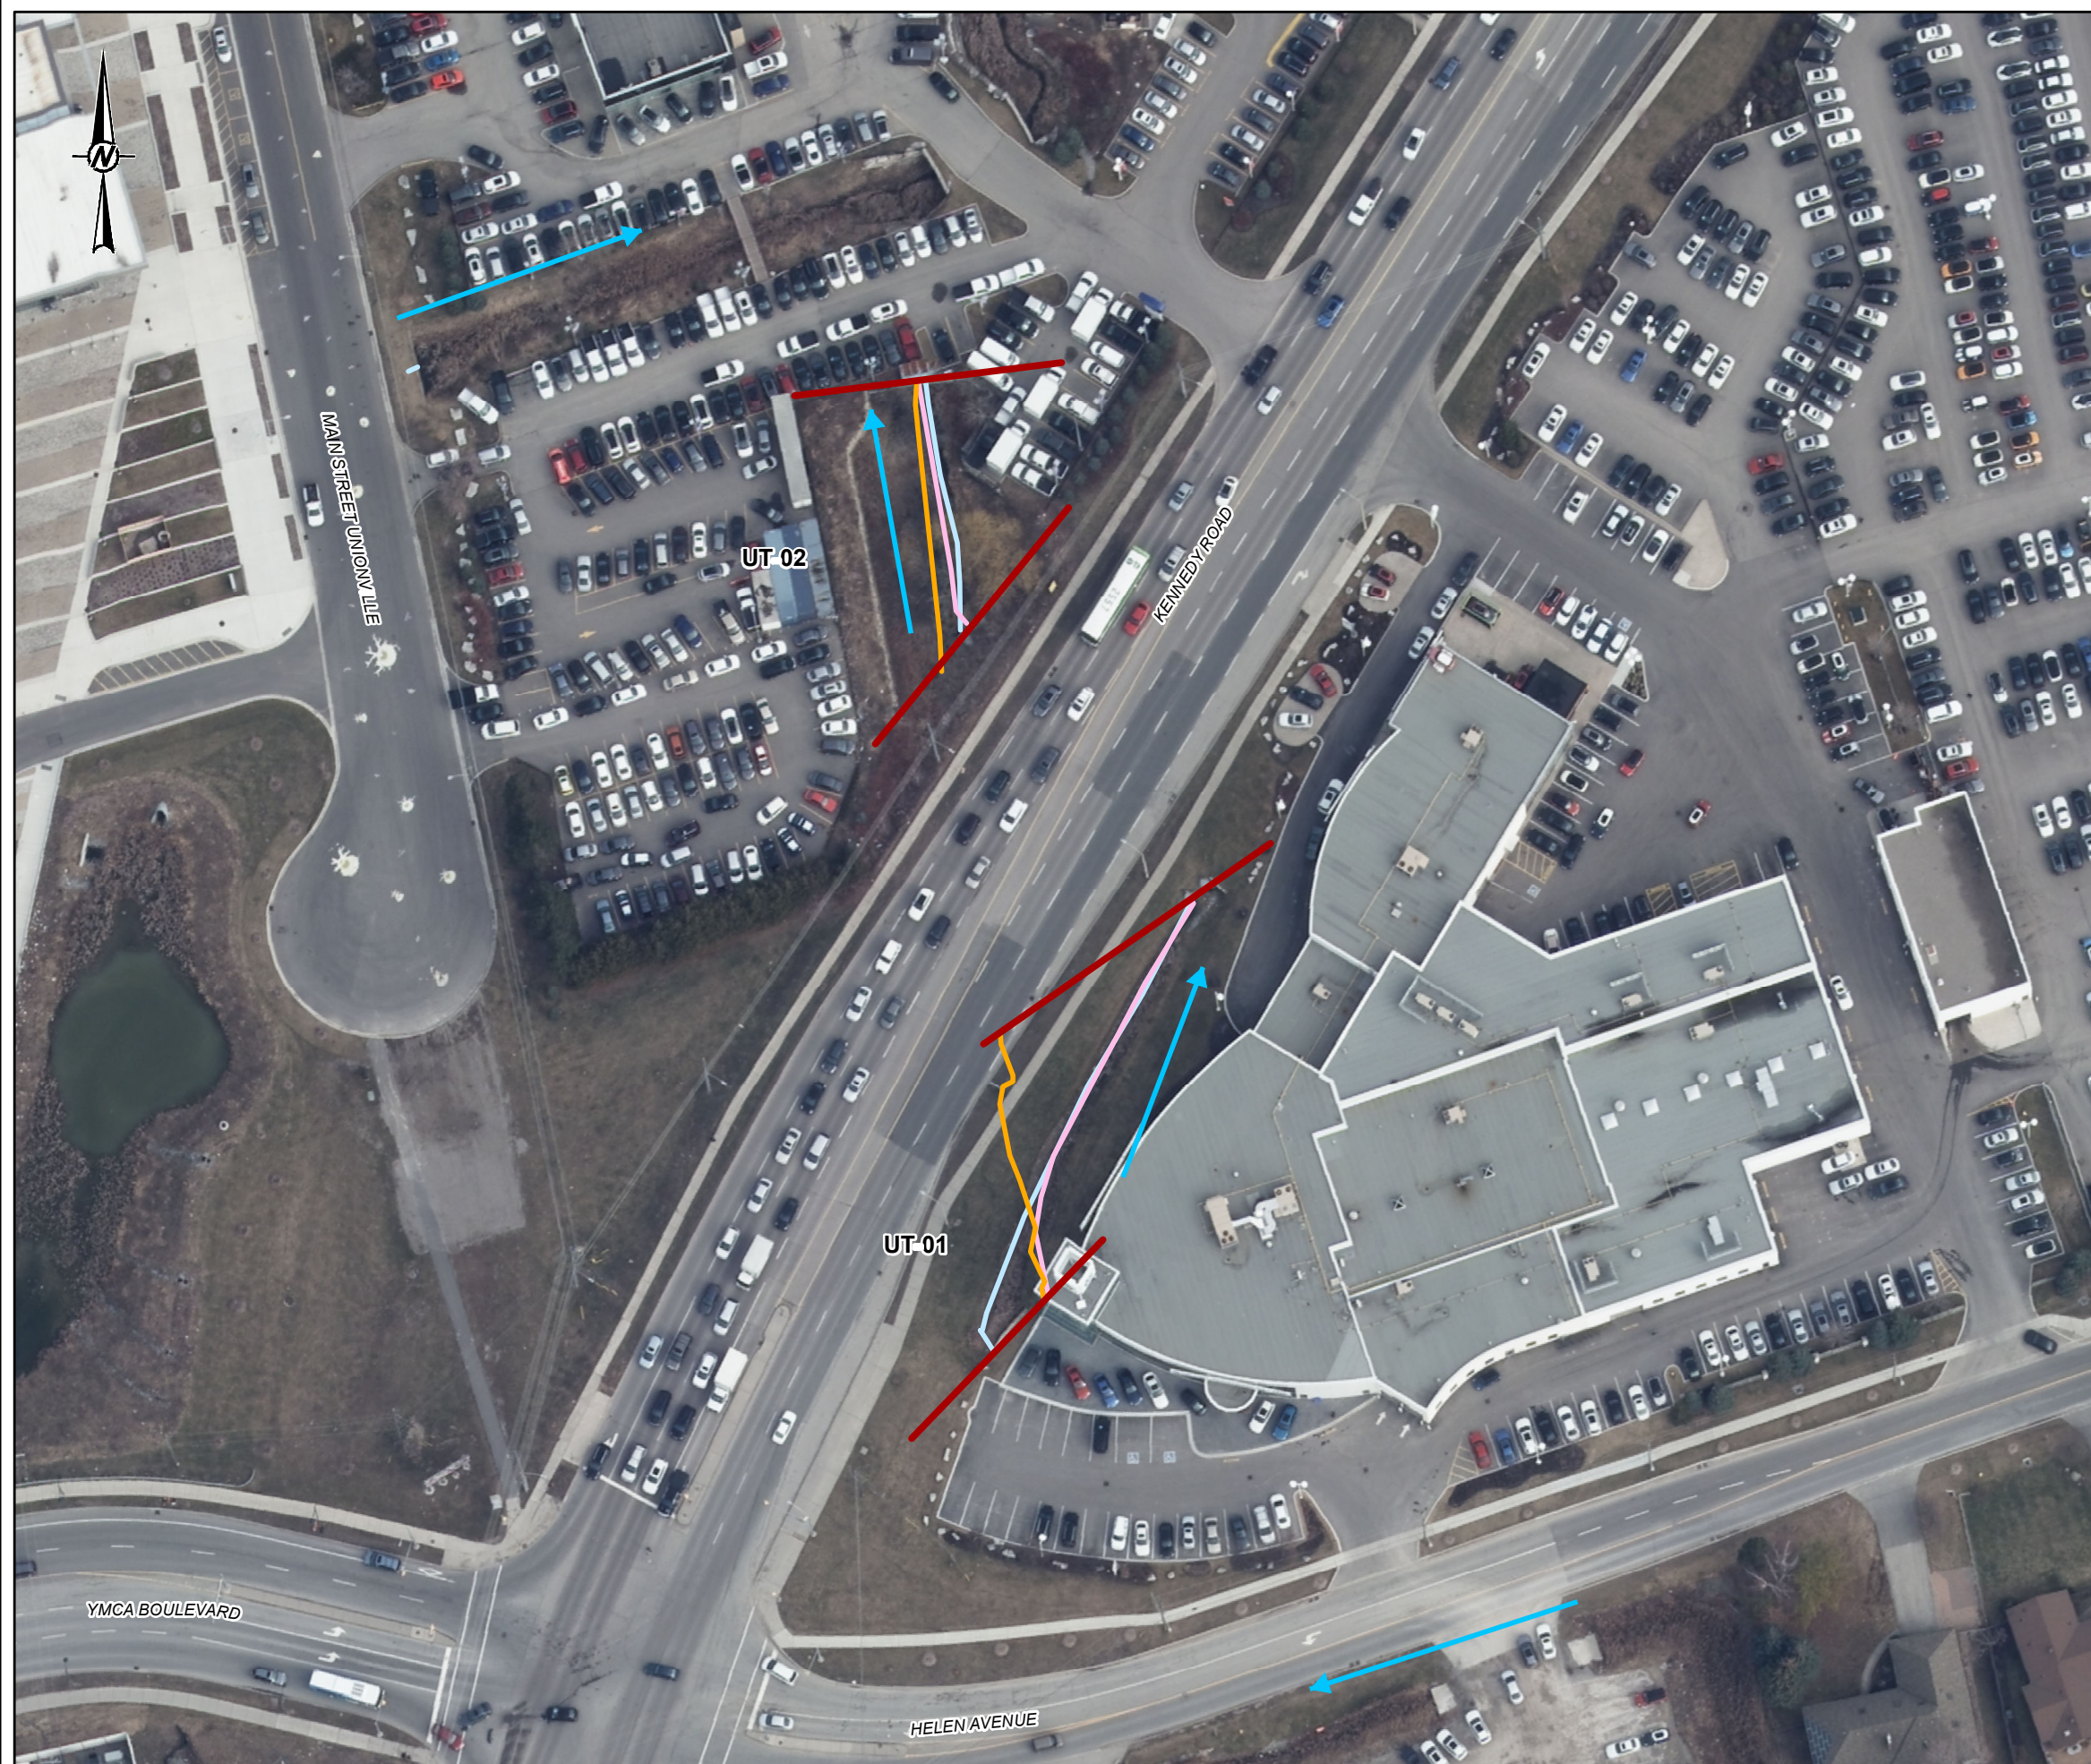
Based on the above and with reference to Figure 5, the meander belt width at the Rouge River (RR-01) was estimated to range from approximately 120 m at the Kennedy Road crossing (i.e., the narrowest portion of the valley along the reach length) to approximately 270 m at a location 320 m downstream of the Kennedy Road crossing (i.e., the widest portion of the valley along the reach length).

The 100-year erosion limit at RR-01 was assessed based on the average rate of channel migration at the following meander bends as shown on Figure 5:

- Meander Bend #1 (located 65 m upstream from Kennedy Road) – average migration rate of 50 cm/yr.
- Meander Bend #2 (located 220 m downstream from Kennedy Road) – average migration rate of 21 cm/yr.
- Meander Bend #3 (located approximately 500 m downstream of Kennedy Road) – average migration rate of 12 cm/yr.
- Meander Bend #4 (located approximately 760 m downstream of Kennedy Road) – average migration rate of 28 cm/yr.

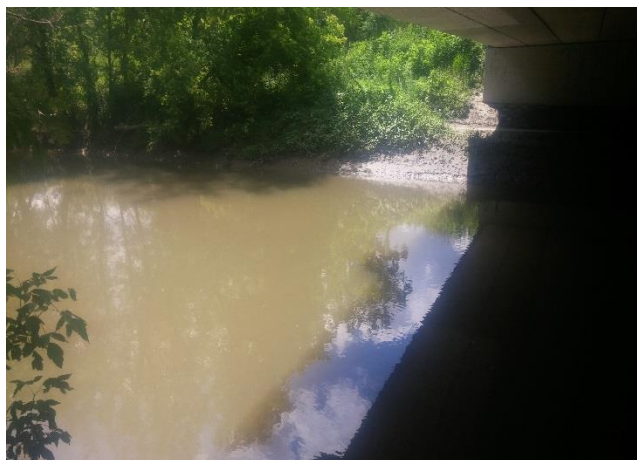
Photograph 1: Rouge River; view looking cross channel at existing bridge crossing.

For the reasons identified above and from the perspective of fluvial geomorphology, it is suggested, from a preliminary recommendations standpoint, that any upgrade or replacement of the existing bridge at the Rouge River crossing include a width of approximately 30 m, if feasible. This suggested crossing dimension represents two (2) times the average bankfull width of the channel. The suggested span for the proposed bridge is expected to provide sufficient opportunities to maintain channel form and function (e.g., sediment transport and fish passage).

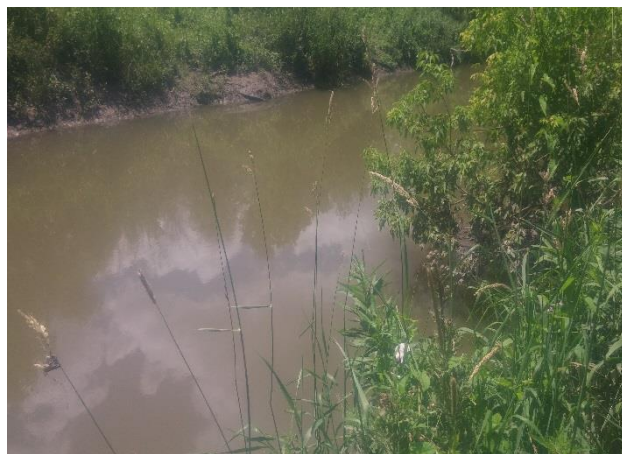
Photograph 2: Rouge River; view looking upstream from a location approximately 25 m upstream of the crossing.

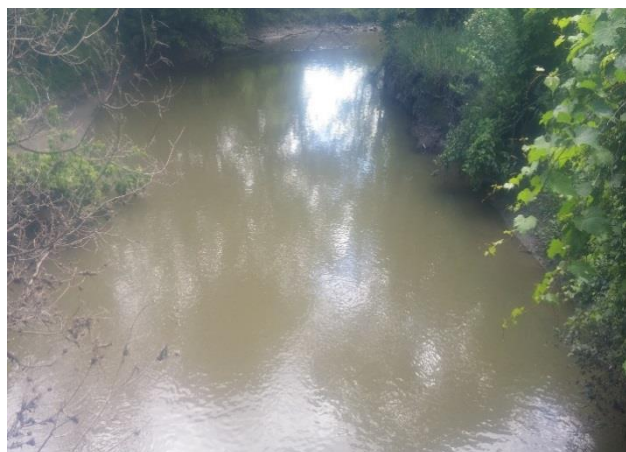
Photograph 3: Rouge River; view looking downstream from a location approximately 75 m downstream of the crossing.

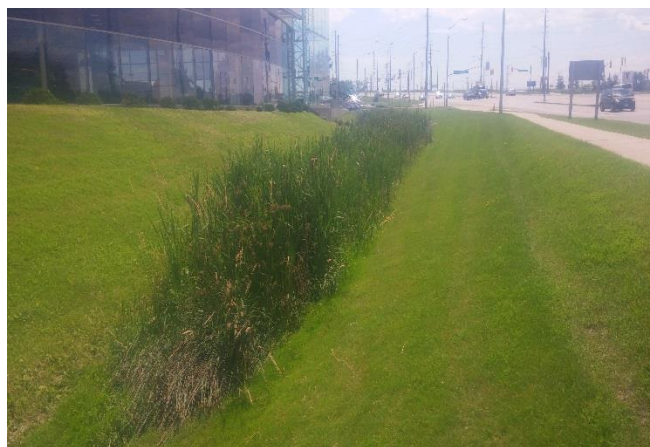
Photograph 4: Unnamed Tributary; view looking upstream at a location approximately 25 m upstream of the crossing.

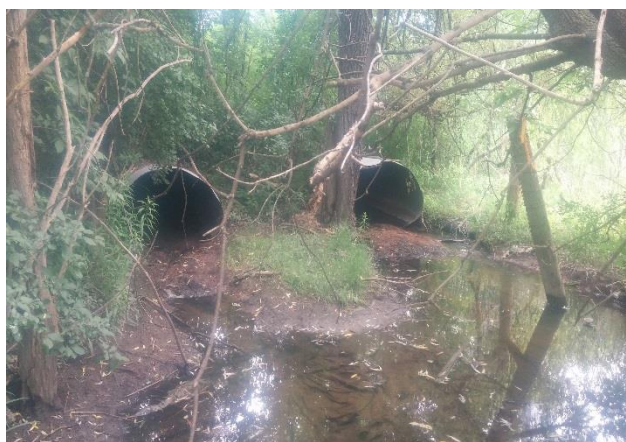
Photograph 5: Unnamed Tributary; view looking upstream at a location approximately 10 m downstream of the crossing.
