STAGE 1 AA FOR THE MOUNT ALBERT WATER SUPPLY SYSTEM UPGRADES MUNICIPAL CLASS EA
TOWN OF EAST GWILLIMBURY, R.M. OF YORK, ONTARIO

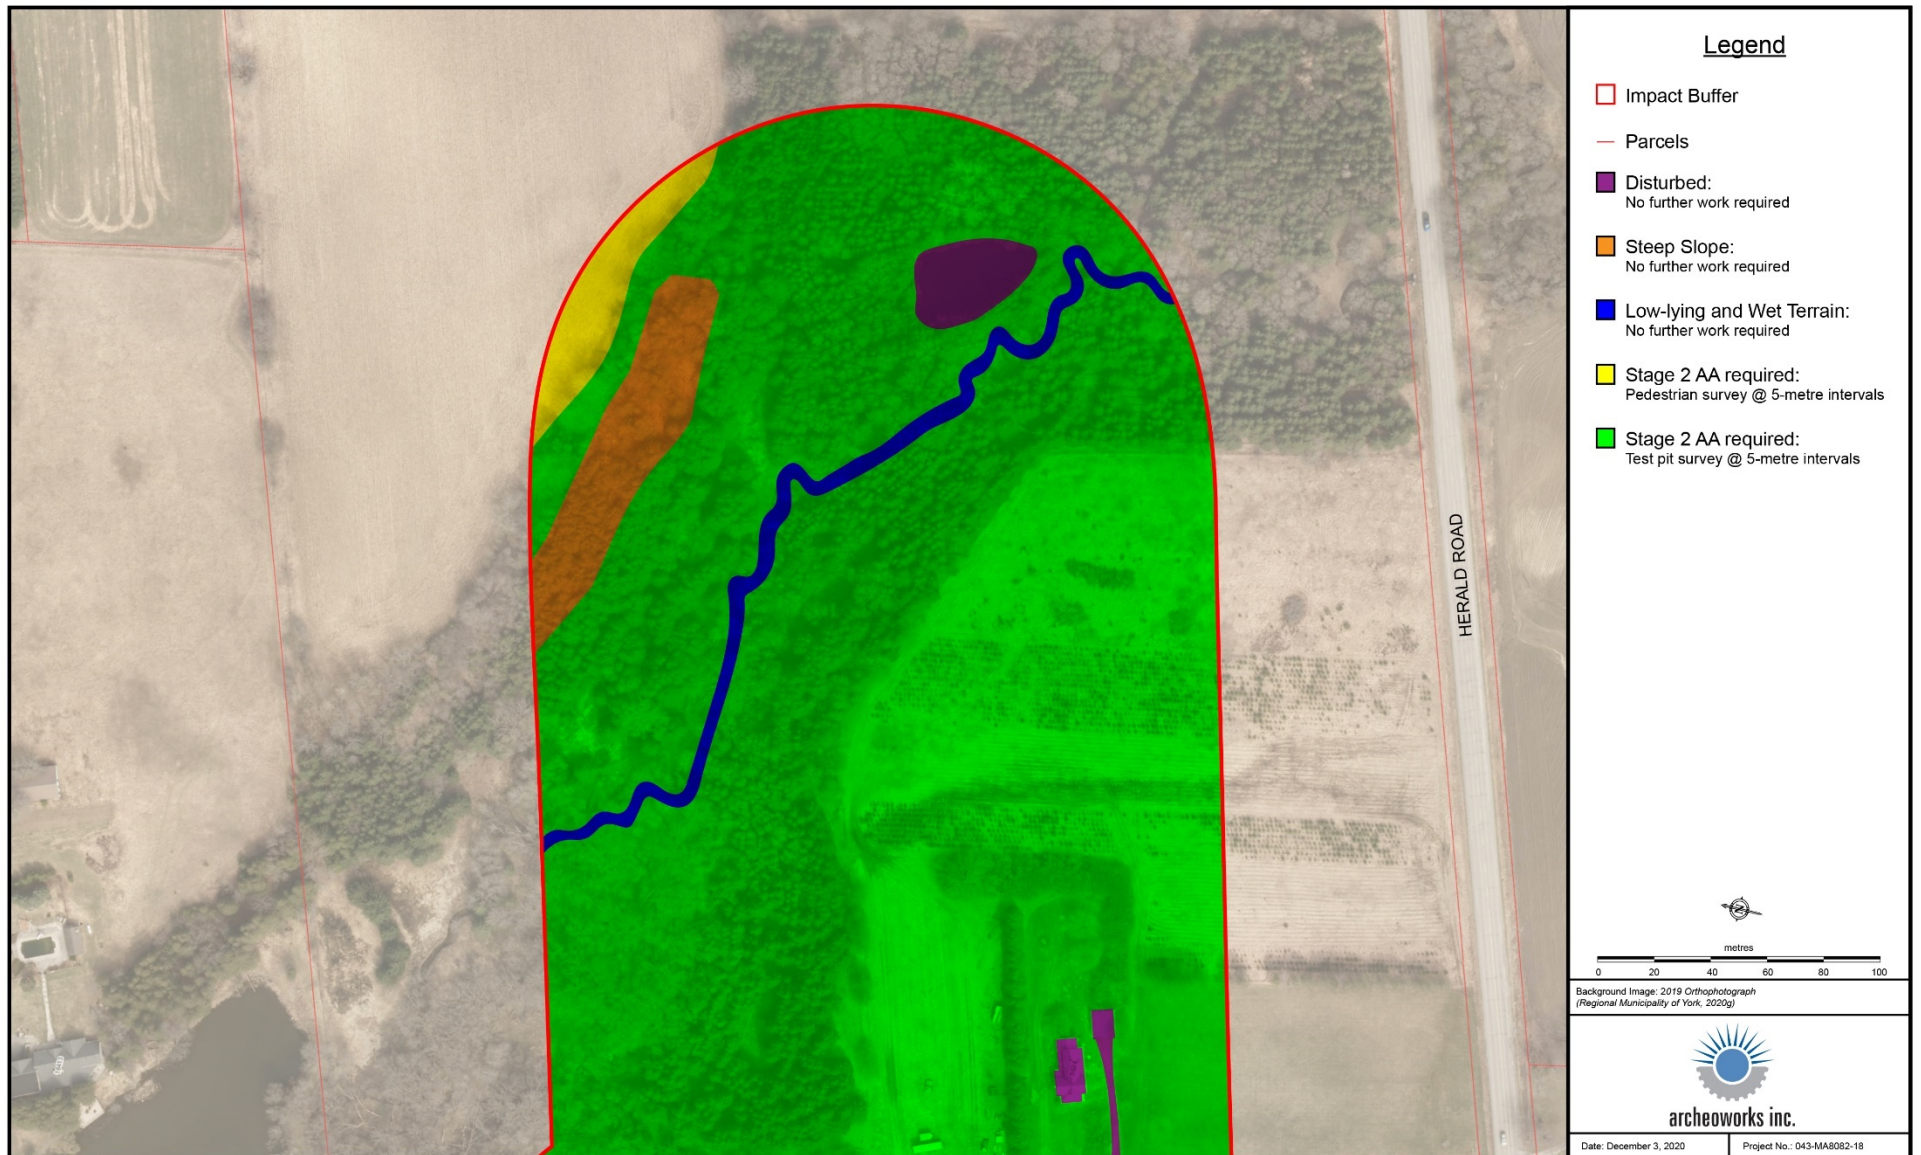
Map 17: Stage 1 AA results – Impact Buffer.

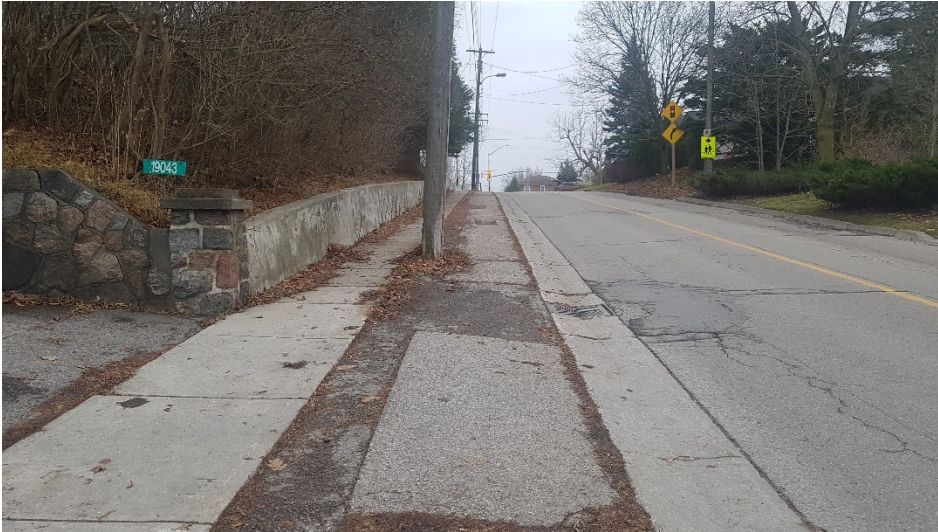
Image 1: View of disturbances associated with the asphalt roadway, concrete shoulder, curbs and sidewalk, and cut slope with concrete barrier.

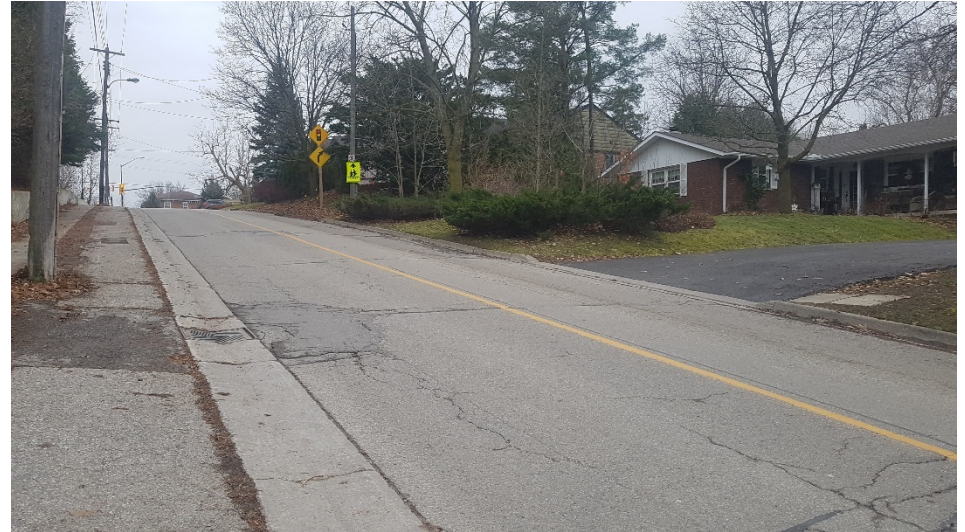
Image 2: View of disturbances associated with the asphalt roadway, concrete shoulder and curbs, intersecting driveways and residential structures.

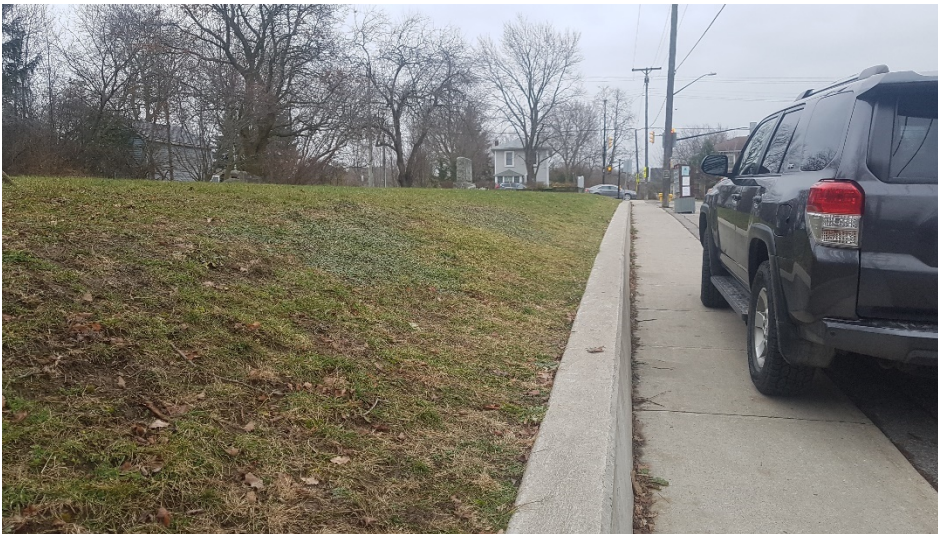
Image 3: View of disturbances associated with a cut slope, concrete sidewalk and barrier adjacent to the Mount Albert Wesleyan Methodist Pioneer Cemetery property limits.

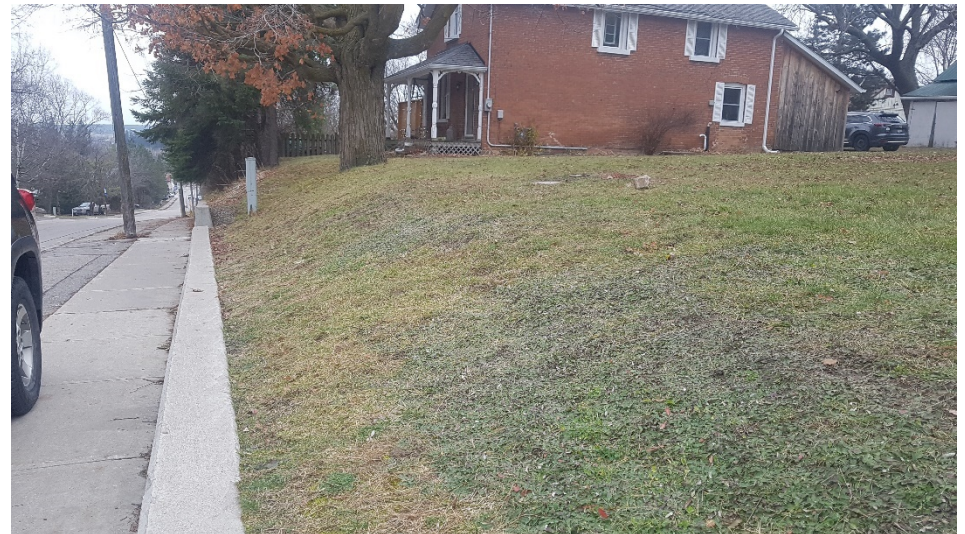
Image 4: View of disturbances associated with a cut slope, concrete sidewalk and barrier, and existing structures adjacent to the Mount Albert Wesleyan Methodist Pioneer Cemetery property limits.

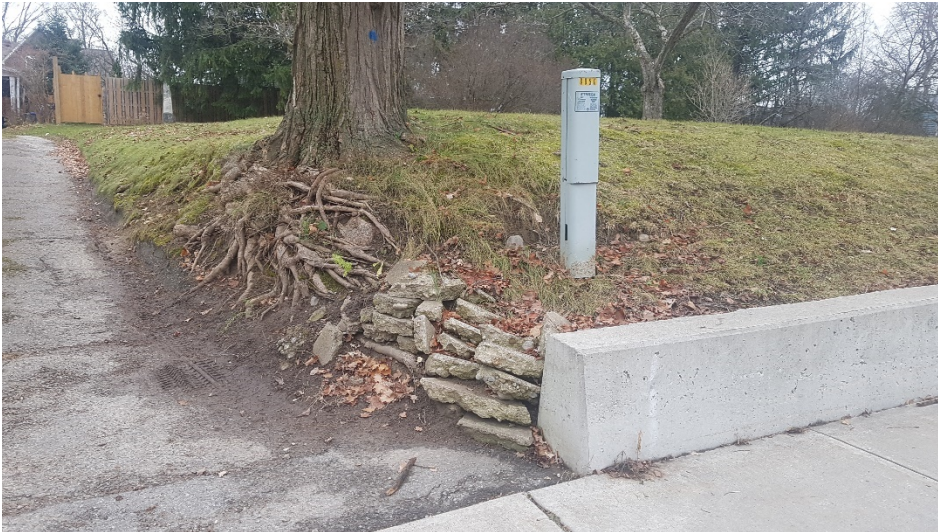
Image 5: View of disturbances associated with a cut slope, concrete barrier, sidewalk, driveway and utilities adjacent to the Mount Albert Wesleyan Methodist Pioneer Cemetery limits.

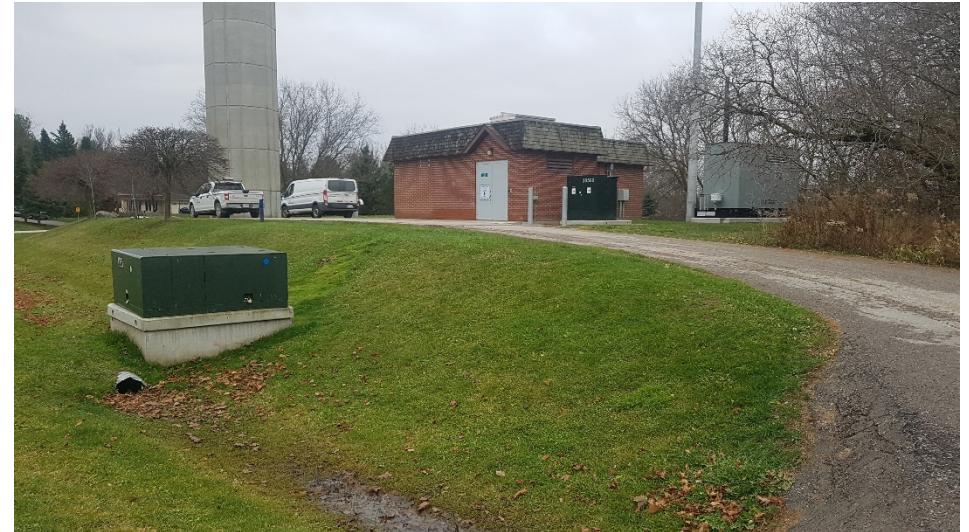
Image 6: View of disturbances associated with deep drainage ditching, an asphalt driveway and regional infrastructure (Mount Albert wells 1 and 2 and elevated tank).

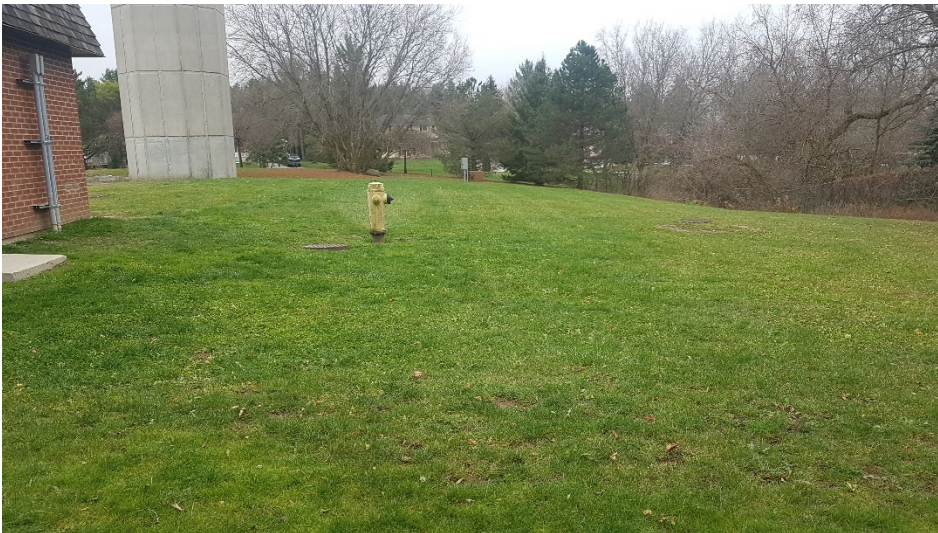
Image 7: View of area subjected to previous grading and construction activities associated with the installation of various buried utilities.

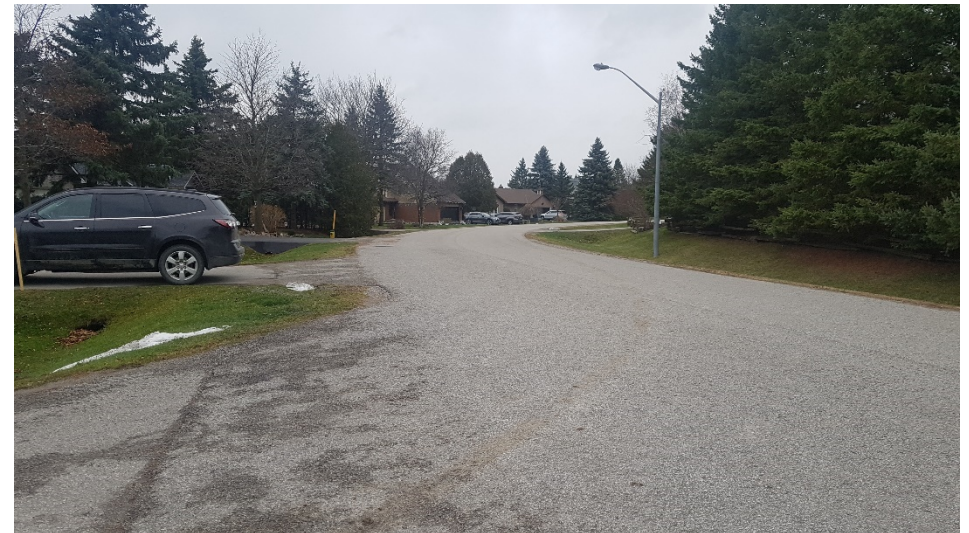
Image 8: View of disturbances associated with an asphalt roadway, intersecting driveways, deep drainage ditching, culverts, and residential structures.

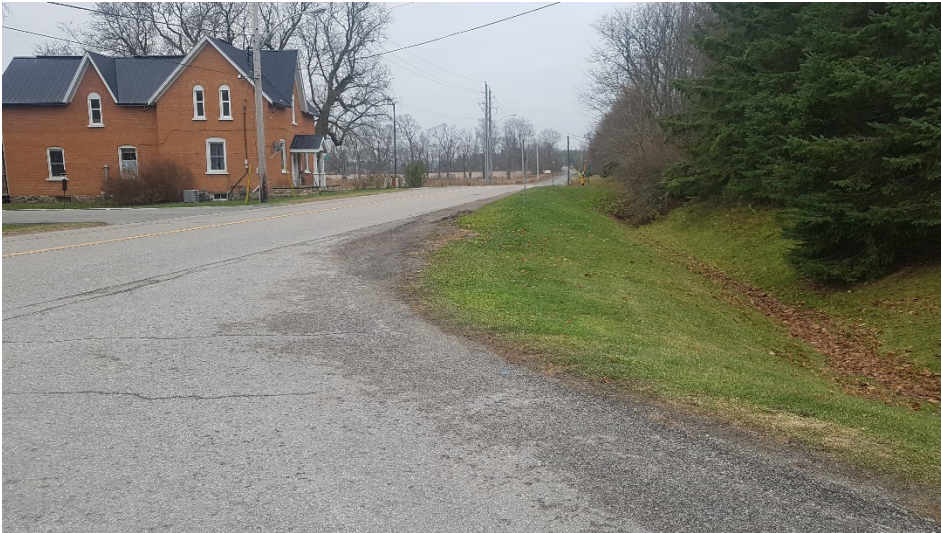
Image 9: View of disturbances associated with the asphalt roadways, gravel shoulders, deep drainage ditching, culverts and a residential structure.

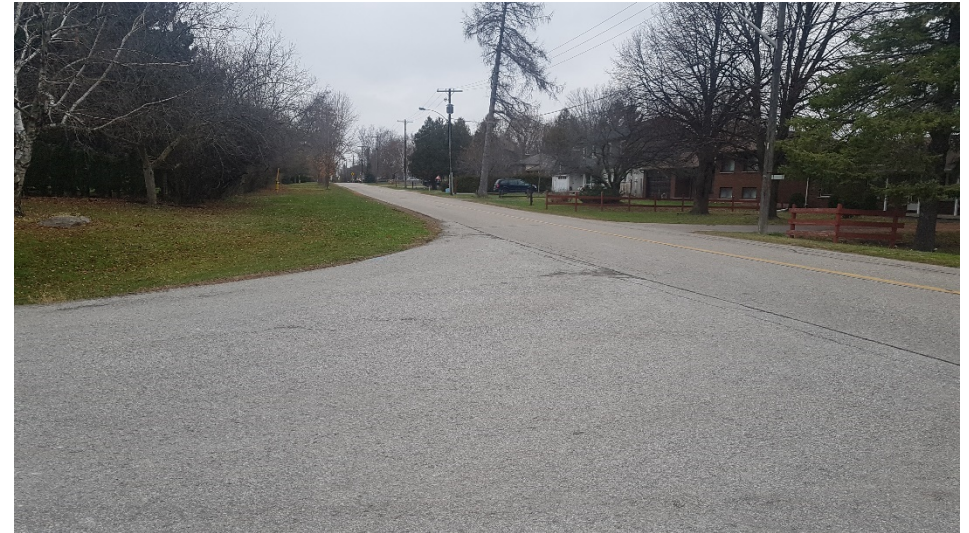
Image 10: View of disturbances associated with asphalt roadways, intersecting driveways and residential structures. Manicured lawns retain archaeological potential.

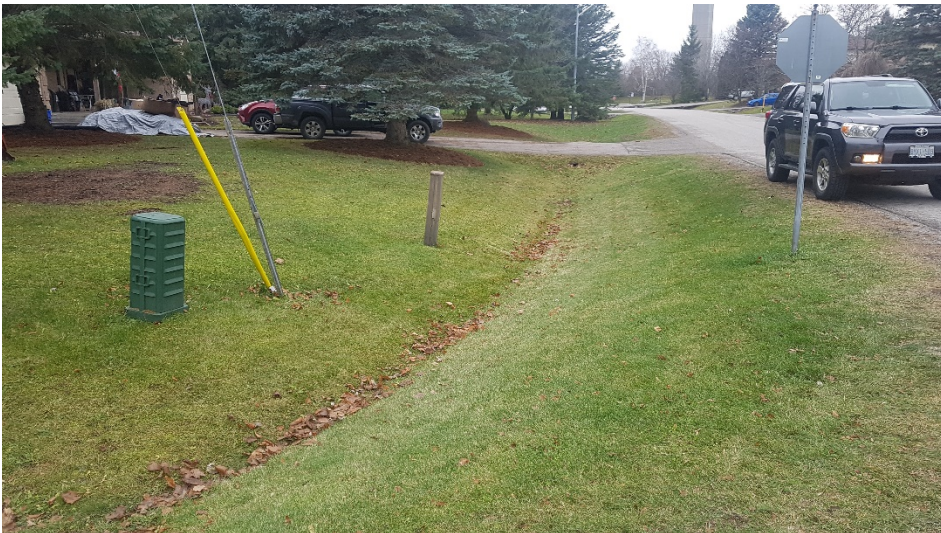
Image 11: View of disturbances associated with an asphalt roadway, intersecting driveways, various buried utilities and deep drainage ditching. Lands beyond the disturbed road ROW retain archaeological potential.

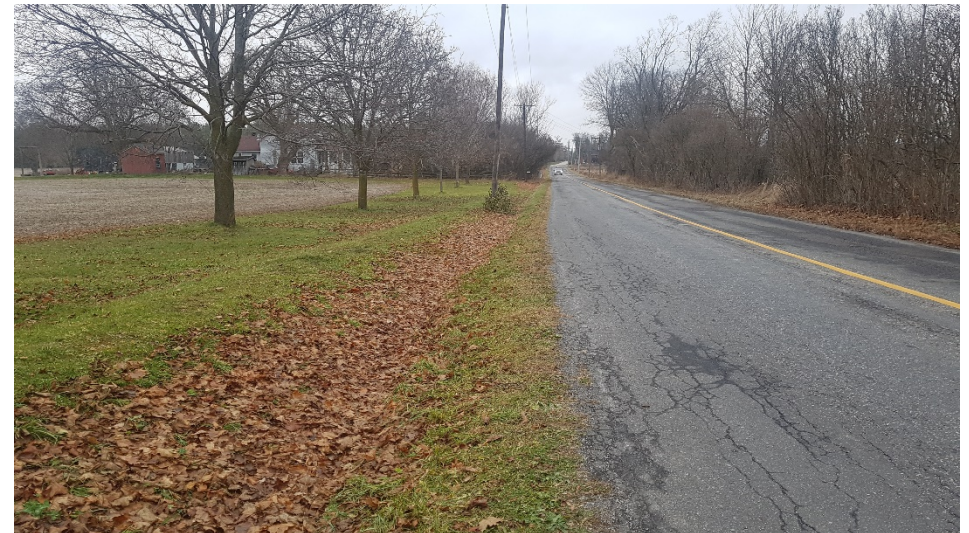
Image 12: View of disturbances associated with the asphalt roadway and roadside ditching. Manicured lawn and agricultural field on the left retain archaeological potential.

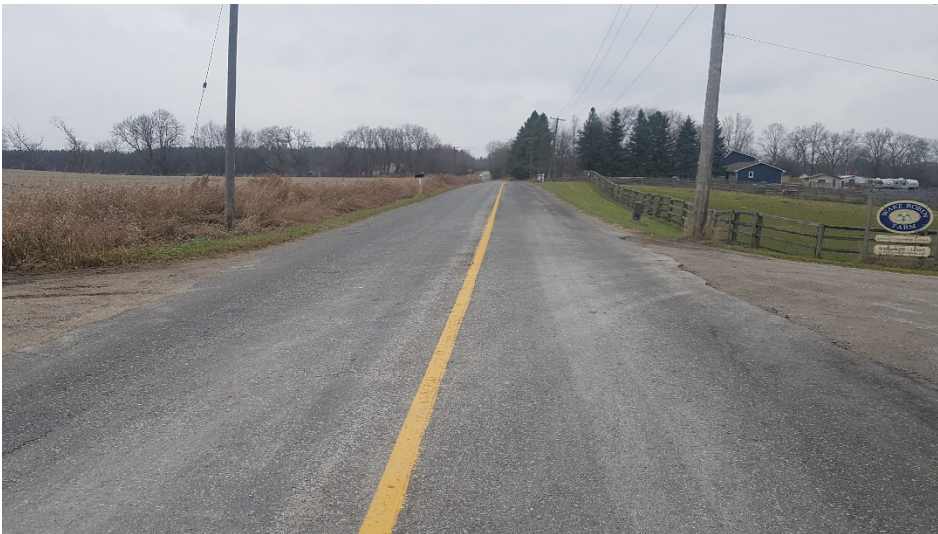
Image 13: View of disturbances associated with the asphalt roadway, intersecting gravel driveways and extant structures. Lands beyond the disturbed road ROW retain archaeological potential.

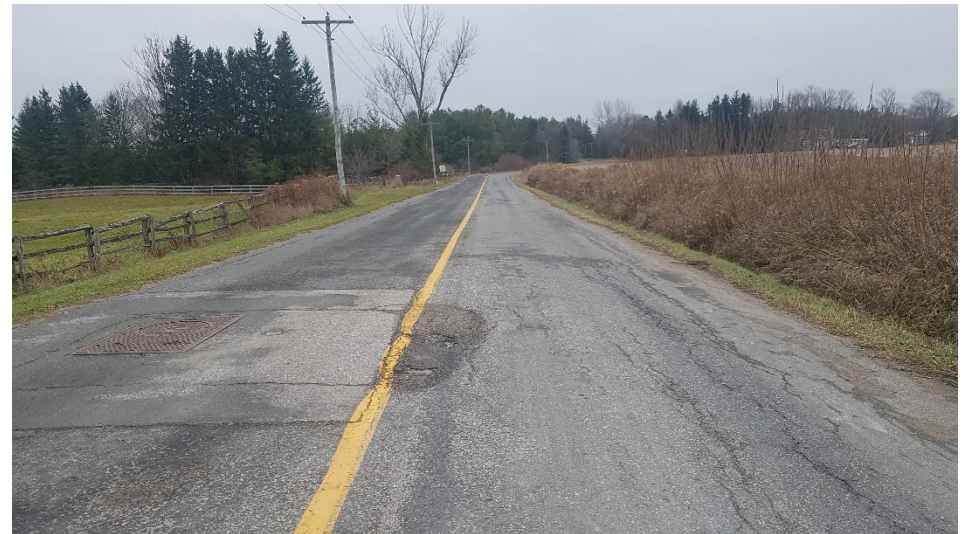
Image 14: View of disturbances associated with the asphalt roadway. Note the cut and embankment of the road bed within the surrounding slightly sloping terrain. Lands beyond the disturbed road ROW retain archaeological potential.

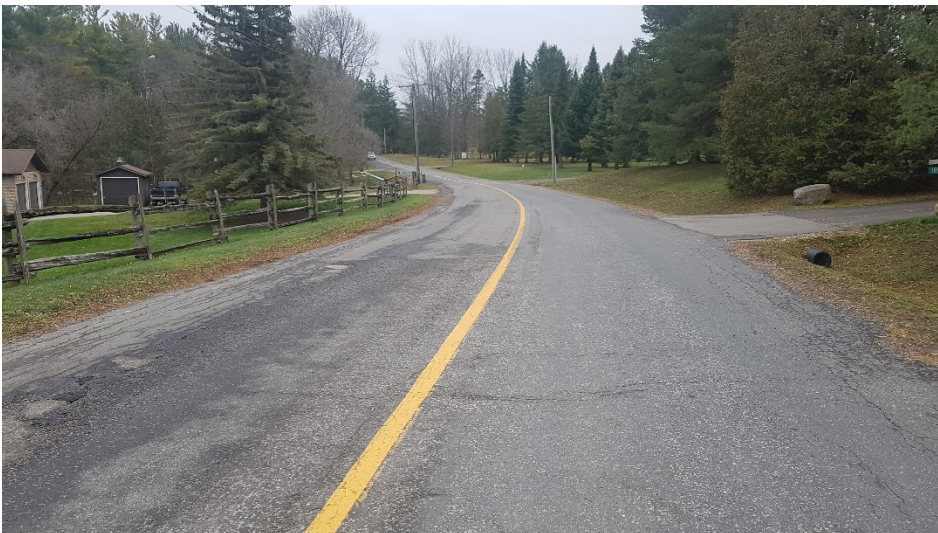
Image 15: View of disturbances associated with the asphalt roadway, intersecting driveways, existing structures, roadside ditching and culverts. Lands beyond the disturbed road ROW retain archaeological potential.

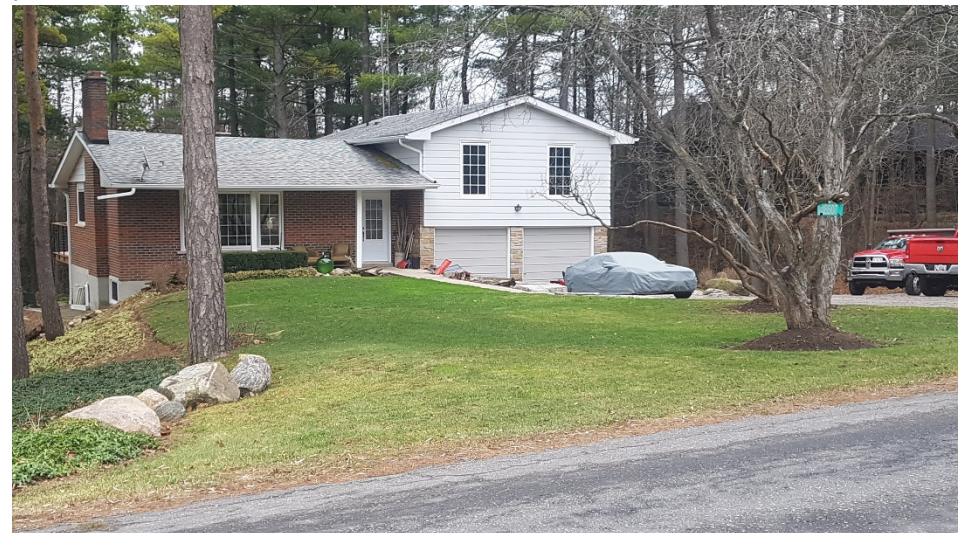
Image 16: View of disturbances associated with a residential structure. Manicured lawn retains archaeological potential.

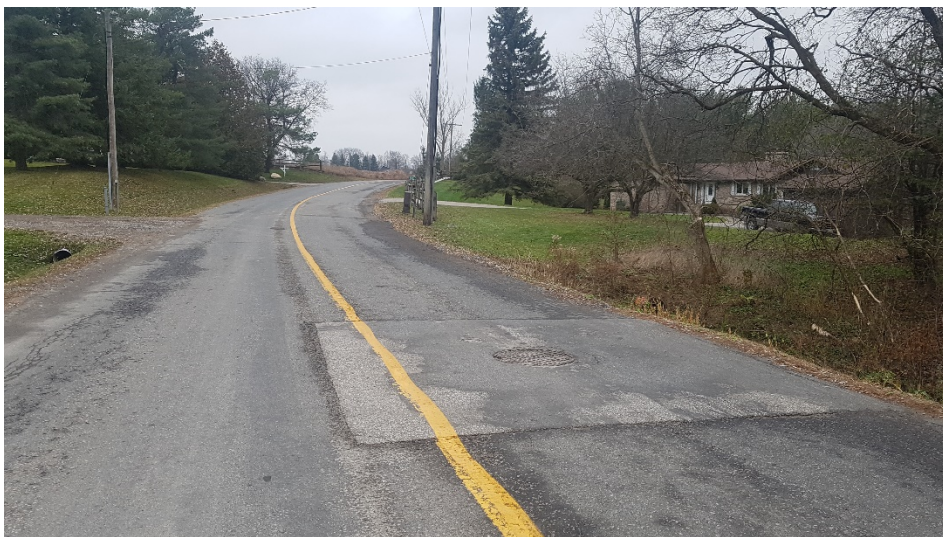
Image 17: View of disturbances associated with the asphalt roadway, intersecting driveways, roadside ditching and residential structures. Manicured lawns retain archaeological potential.

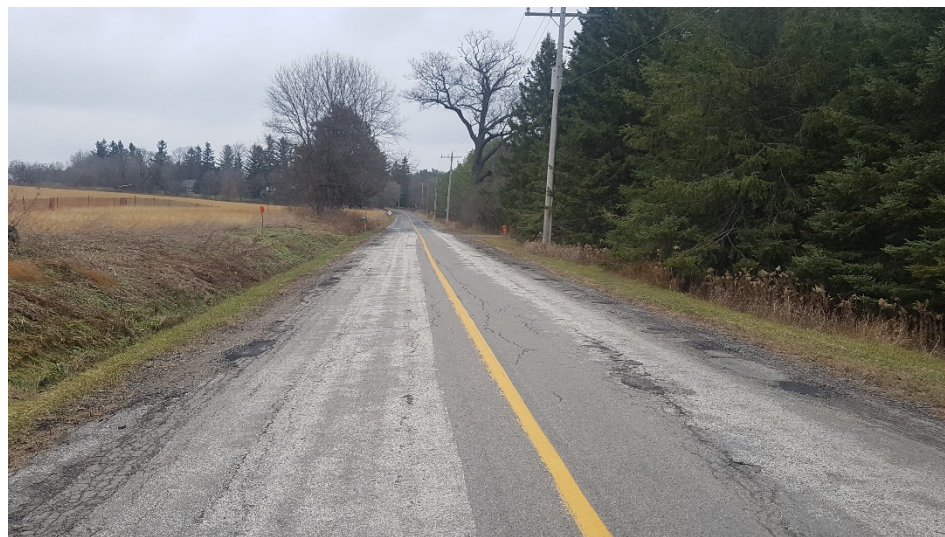
Image 18: View of disturbances associated with the asphalt roadway. Note the cut and embankment of the road bed within the surrounding slightly sloping terrain. Lands beyond the disturbed road ROW retain archaeological potential.

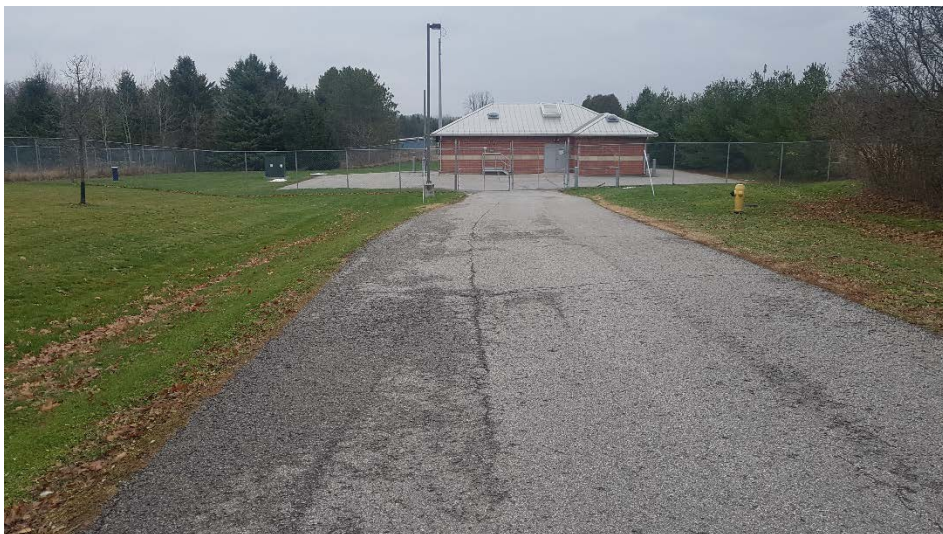
Image 19: View of disturbances associated with regional infrastructure (well 3).

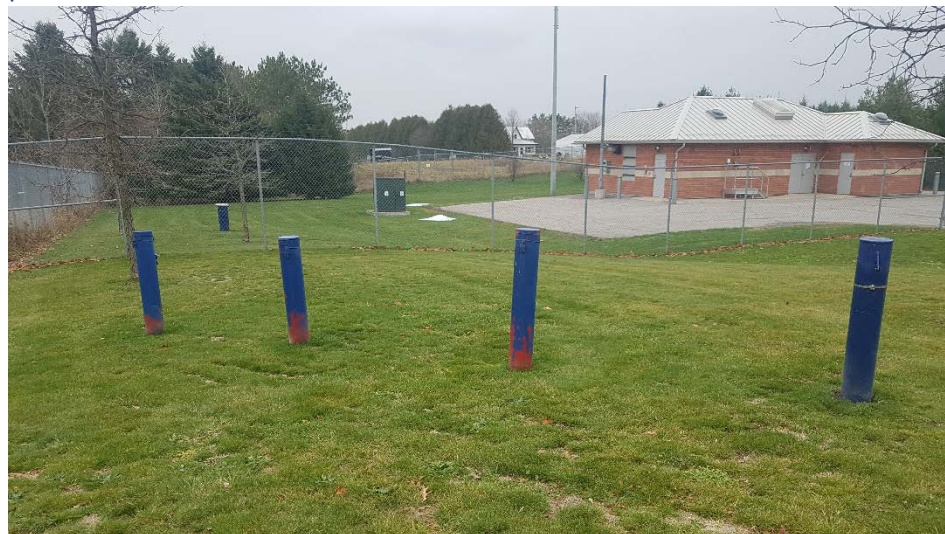
Image 20: View of area subjected to previous grading and construction activities associated with the installation of the well site.

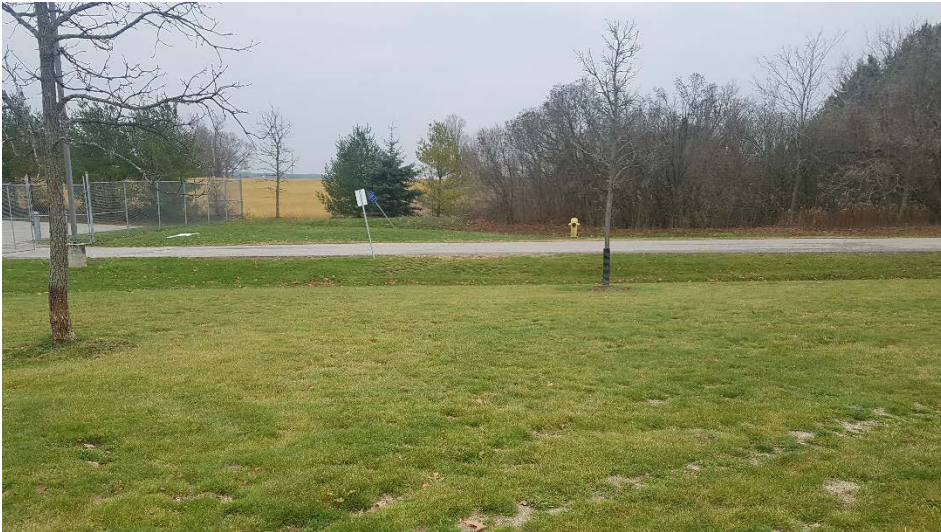
Image 21: View of area subjected to previous grading and construction activities associated with the installation of the well site.

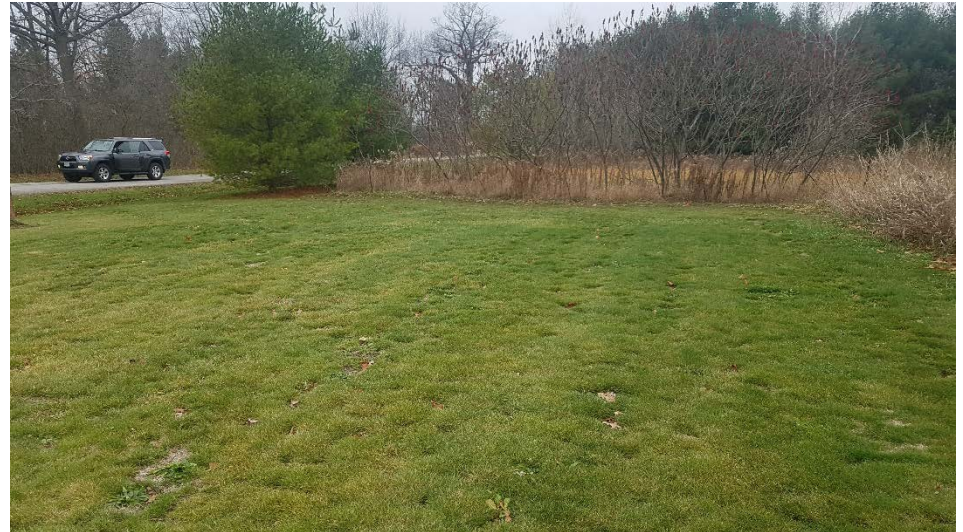
Image 22: View of area subjected to previous grading and construction activities associated with the installation of the well site.

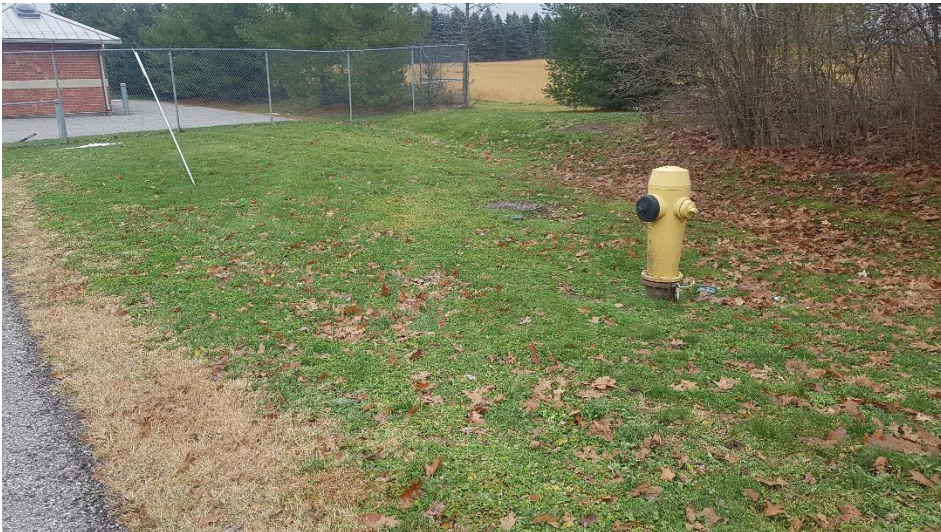
Image 23: View of area subjected to previous grading and construction activities associated with the installation of the well site.

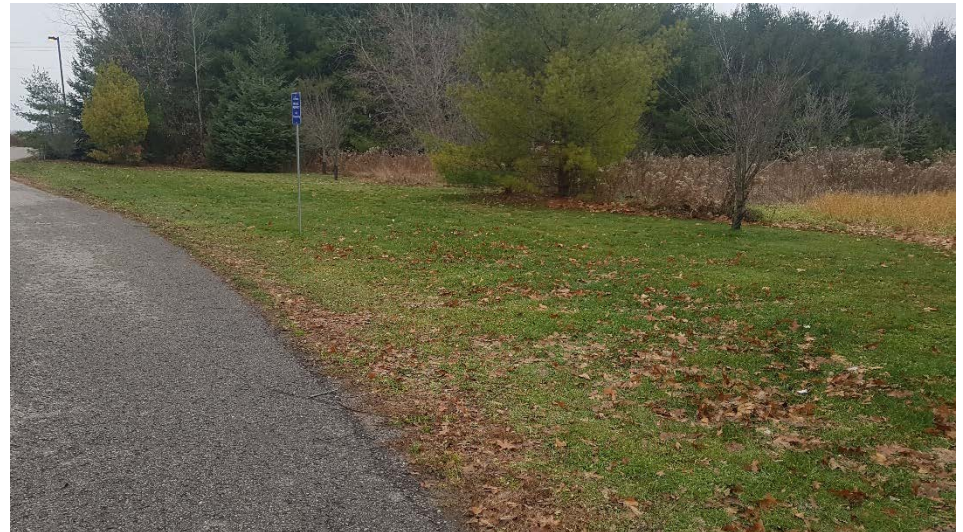
Image 24: View of area subjected to previous grading and construction activities associated with the installation of the well site.

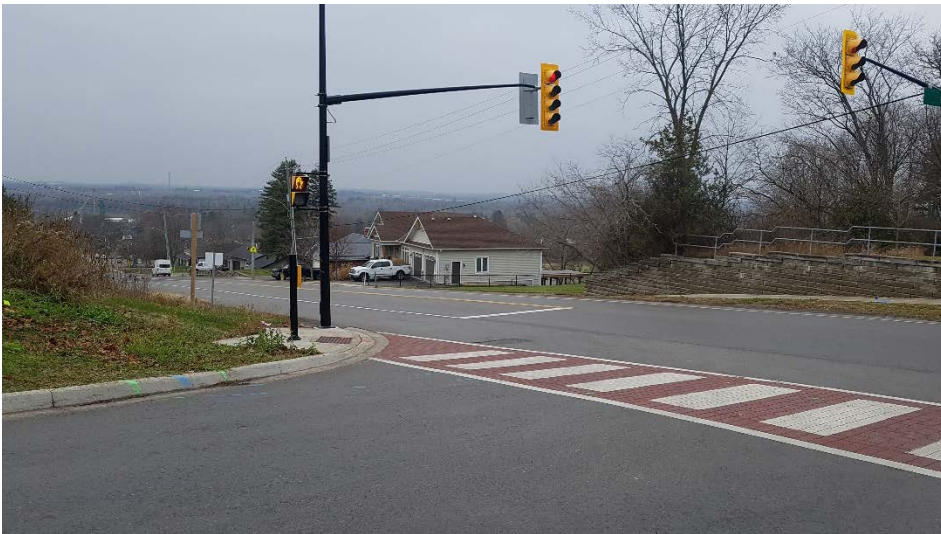
Image 25: View of disturbances associated with previous roadway improvements – asphalt roadway, concrete curbs and sidewalks, buried utilities.

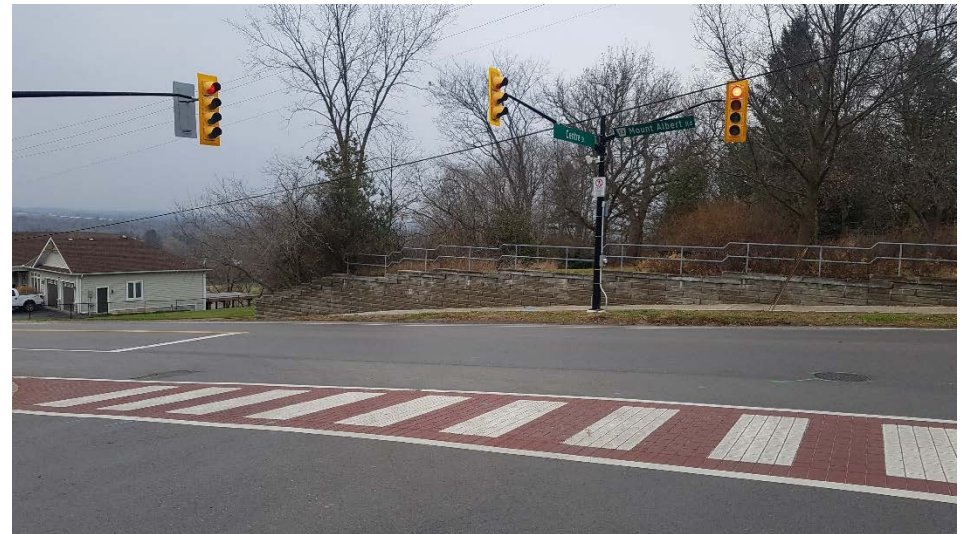
Image 26: View of disturbances associated with a cut slope, barrier wall, and concrete sidewalk adjacent to the Birchard Family Burying Ground.

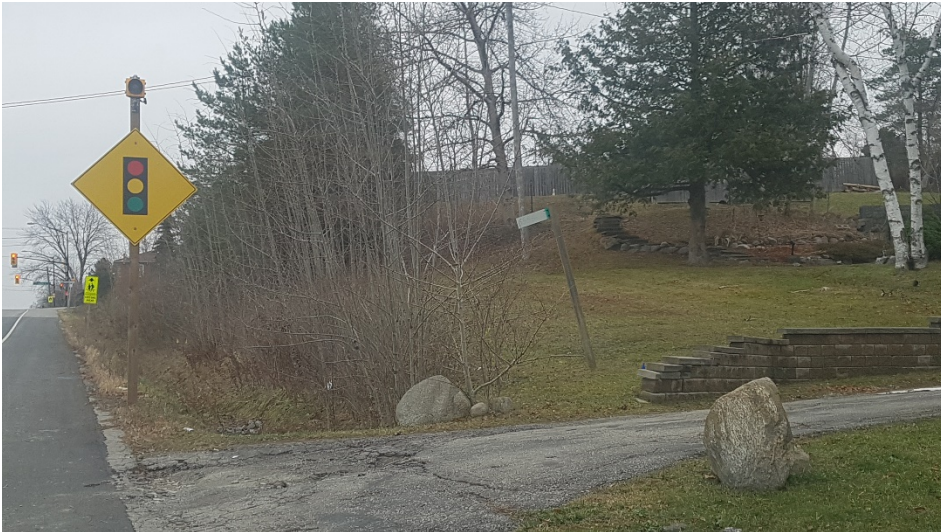
Image 27: View of steeply sloping terrain.

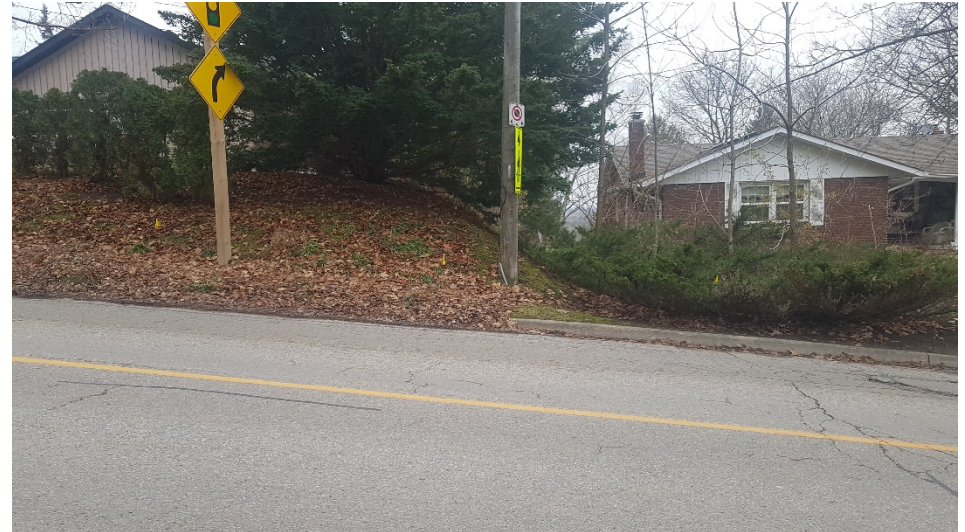
Image 28: View of steeply sloping terrain.

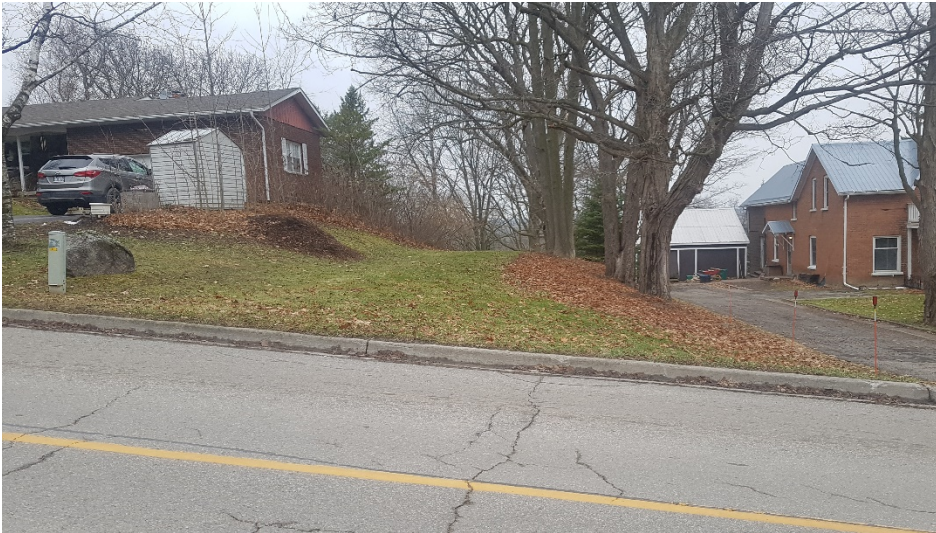
Image 29: View of steeply sloping terrain between two residential properties.

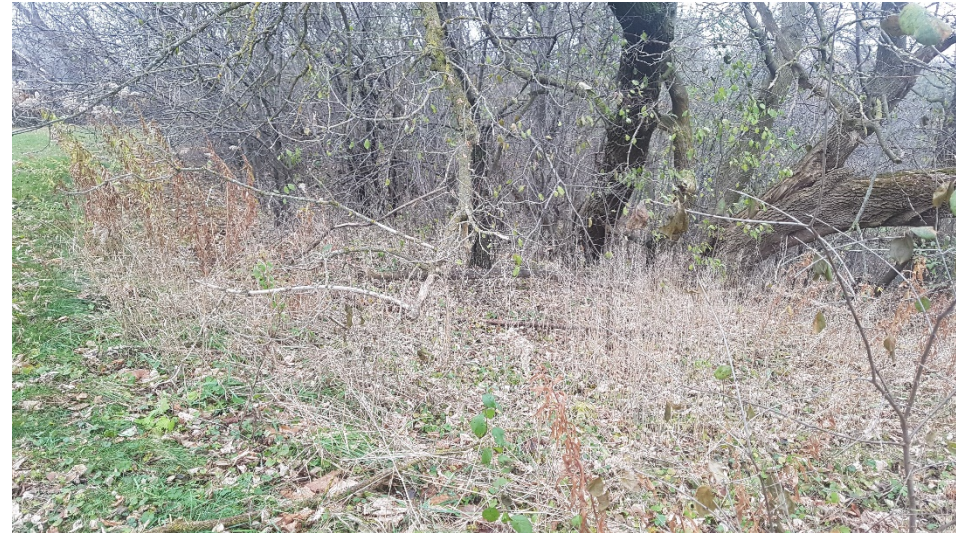
Image 30: View of steeply sloping terrain beyond overgrown vegetation (looking at the base of tree trunks on lower terrain compared to the terrain on which the field reviewer stands).

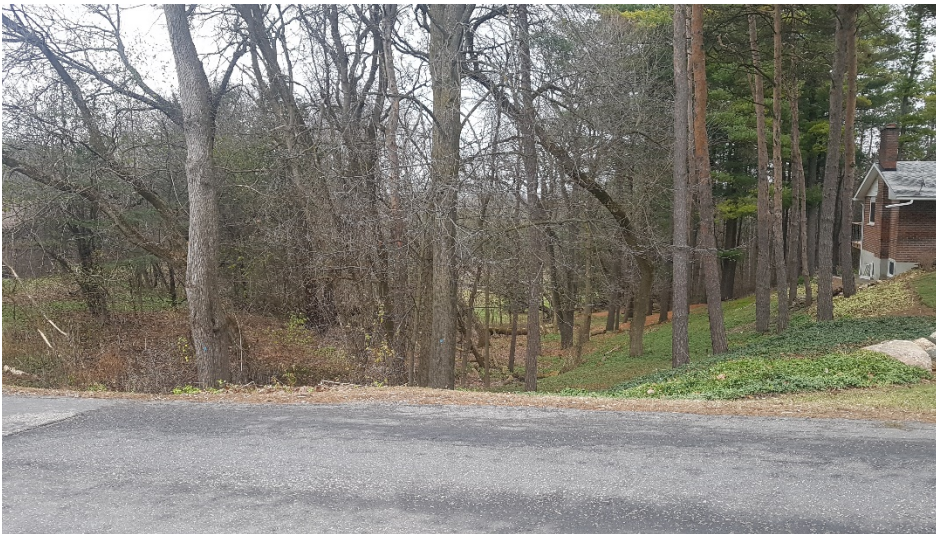
Image 31: View of steeply sloping terrain.

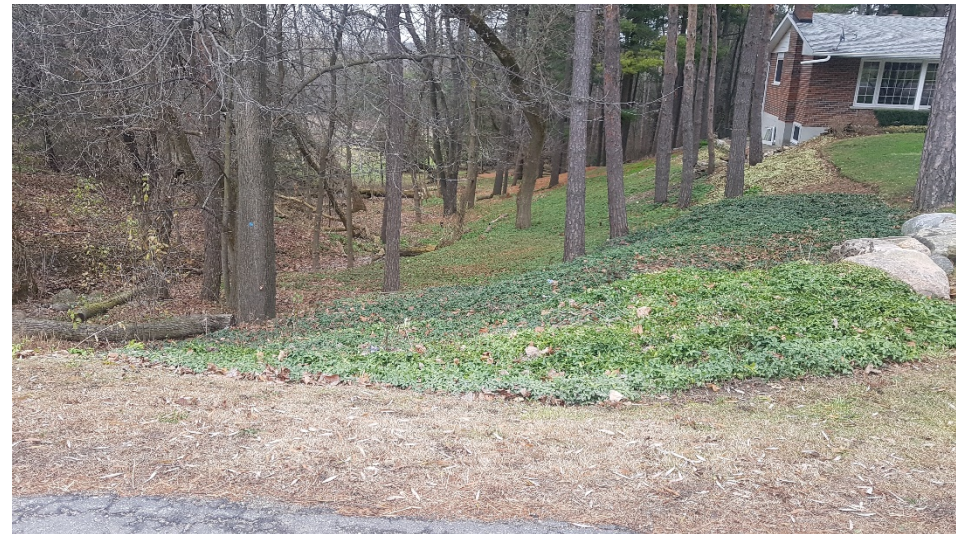
Image 32: View of steeply sloping terrain.

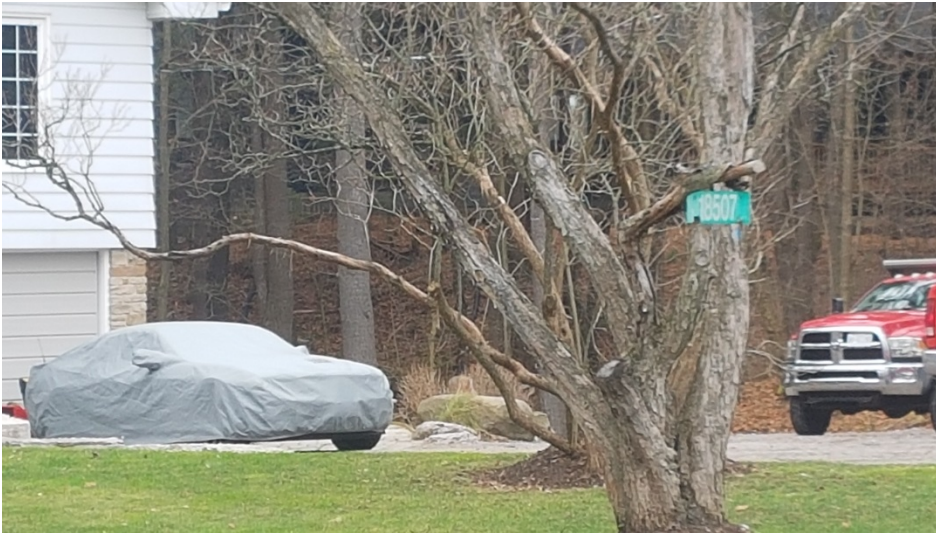
Image 33: View of steeply sloping terrain behind the existing house and driveway.

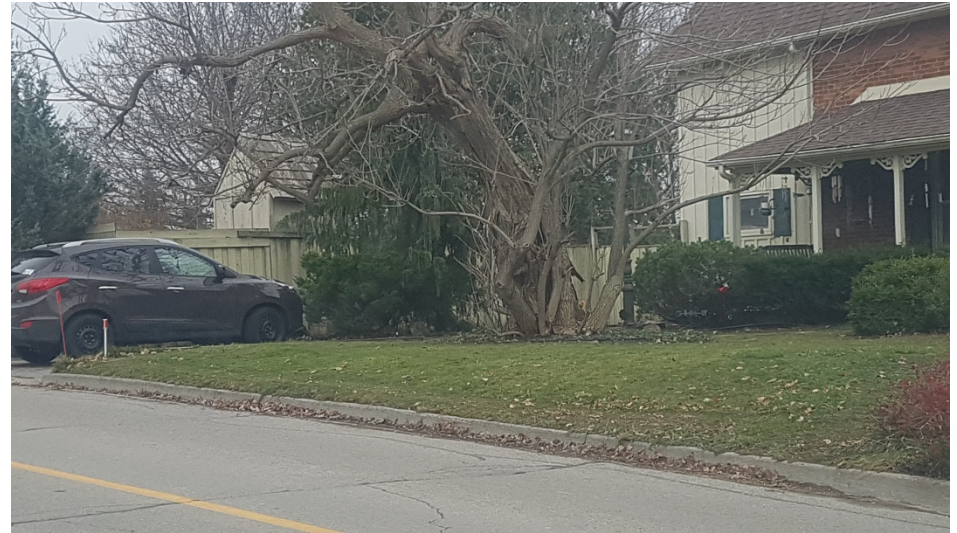
Image 34: View of area of archaeological potential within the manicured front lawn of a residential property.

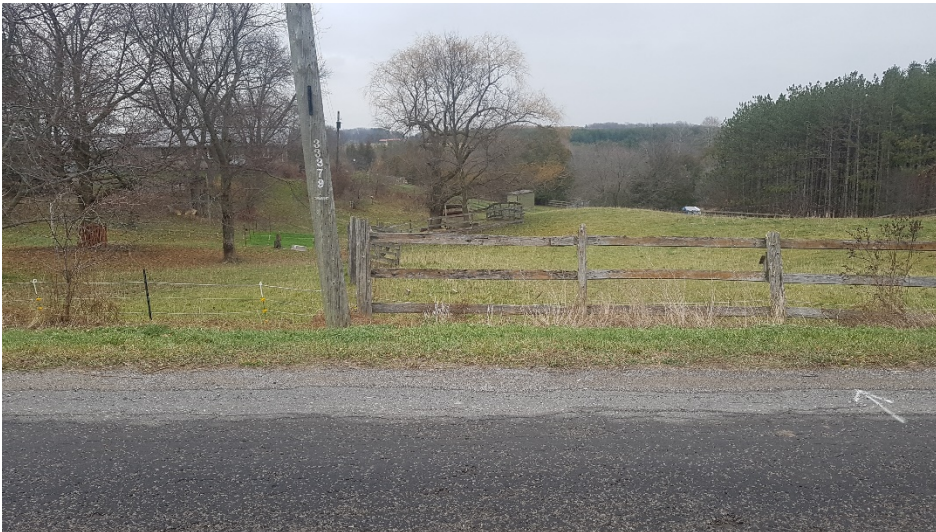
Image 35: View of area of archaeological potential beyond the disturbed ROW. Steeply sloping terrain visible in the background.

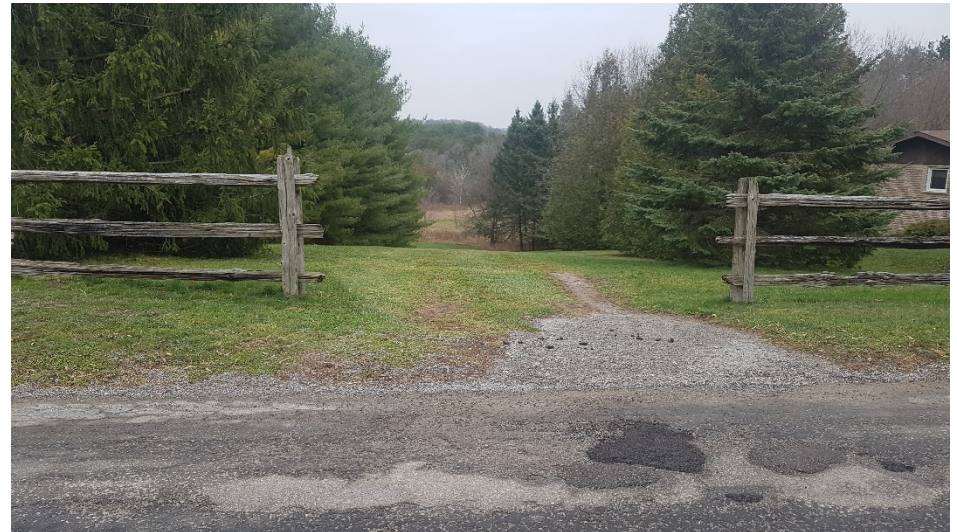
Image 36: View of area of archaeological potential beyond the disturbed ROW. Steeply sloping terrain visible in the background.
