Appendix G – Cultural and Built Heritage Assessment Report

*Kennedy Road Environmental Assessment between
Steeles Avenue and Major Mackenzie Drive*

CULTURAL HERITAGE ASSESSMENT REPORT

**Kennedy Road Municipal Class Environmental
Assessment, Steeles Avenue to Major
Mackenzie Drive, Regional Municipality of York,
Ontario**

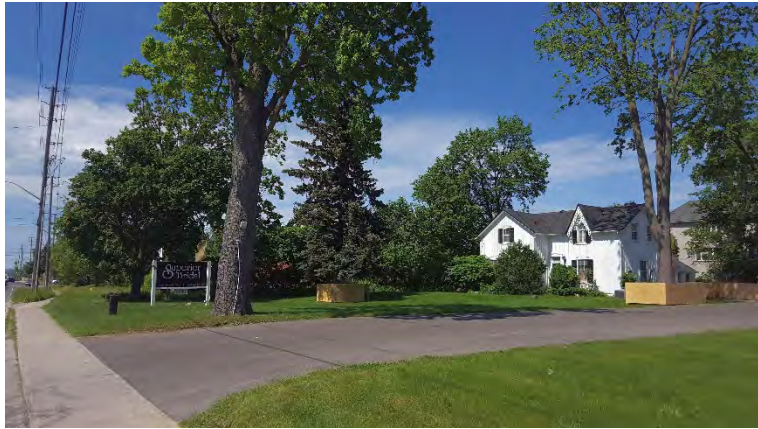
Civic Address	Photograph	Description	CHVI	Heritage Attributes	Recognition
7703 Kennedy Road, Jesse Noble House

<p>Built heritage resource: Single-detached, 1 ½ storey, and 3-bay medium gabled ell Gothic Revival house with T-shaped plan and additional rear wing. The front façade has a central entrance and cross-gable with Gothic arched window, and the building is clad in board & batten. It was built circa 1855.</p> <p>The house is setback a distance from the road and on the north is a windbreak of trees as well as several large trees around the front and rear yards.</p> <p><u>History from City of Markham Register:</u> 'The original crown grant went to Shivers Cozen. In 1826 Ambrose Noble purchased the western 50 acres of this lot as well as the adjacent 50 acres in the north west corner of lot 4, concession 6. The Regional Assessment Office Database lists the date of construction at 1880 (renovated). Ambrose Noble was born in West Springfield, Mass. in 1795. Ambrose married Hannah Badgerow in 1822 and together they had 11 children. Jesse Noble, the second son, of Ambrose and Hannah, married Susanna Button in 1860 and they had one son, William Alfred Noble born in 1860. In 1864, Ambrose granted this property to his son Jesse.'</p>	<p>1) Design or physical value: The house has design value as a representative example of a mid-19th century Gothic Revival gabled ell farmhouse with decorated cross-gable, symmetrical fenestration, and a rear wing.</p> <p>3) Contextual value: Although no longer on a large parcel and associated with farm buildings, the house has contextual value as a remnant of the agricultural development and rural settlement around Hagerman's Corners.</p>	<p>■ 1 ½-storey residence with:</p> <ul style="list-style-type: none">■ Gabled ell T-plan with additional rear wing;■ Cross-gable with curvilinear vergeboard and Gothic arch window;■ Symmetrical fenestration;■ Substantial setback; and,■ Large trees forming a windbreak and placed on the front and rear yards.	Listed on the City of Markham Register

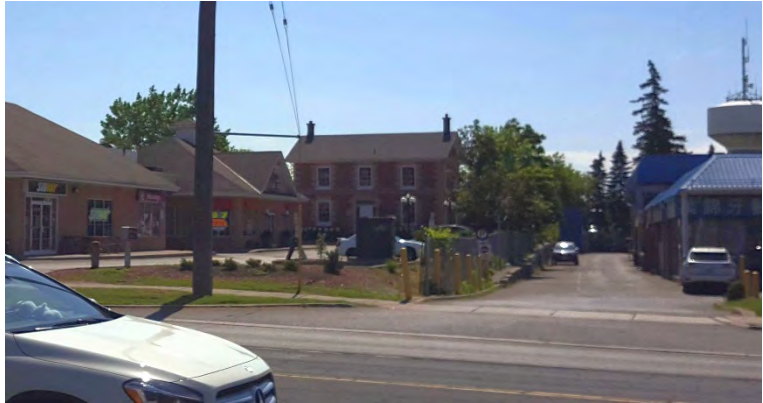
Civic Address	Photograph	Description	CHVI	Heritage Attributes	Recognition
7710 Kennedy Road, Benjamin Milliken House

<p>Built heritage resource: Single-detached, three bay and two storey dichromatic brick Classic Revival house with returned eaves on the low gable roof style, and a central entrance with transom and sidelights. It was built in 1851. The house is setback a considerable distance from the road and has been incorporated into a commercial plaza.</p> <p><u>History from City of Markham Register:</u> Benjamin Milliken, son of a successful local member merchant and tavern keeper, had a distinguished military career. He served in the York Militia during the War of 1812 and saw action at the Queenston Heights. During the Rebellion of 1837, Milliken continued his militia service and untimely attained the rank of Major. Benjamin Milliken was an active and supportive member of his community, providing land for the local school and hosting agricultural fairs on his farm during the 1860s. Circa 1855, Benjamin Milliken constructed this fine, Georgian tradition brick house. Its full two storey height and quality of design and workmanship speak to Milliken's stature in the community. After being vacant for a number of years, the home was carefully restored and successfully converted to serve as a pub and restaurant. The owner's outstanding efforts included preservation of all original windows and interior woodwork, and the restoration of the home's eye-catching patterned brickwork.</p>	<p>1) Design or physical value: From Bylaw 88-94: 'Excellent example of Georgian architecture'.</p> <p>2) Historical or associative value: From Bylaw 88-94: Association with the successful Milliken family and with Benjamin Milliken, who served as a militia officer in the War of 1812 and 1837 Rebellion, donated land for the local school, and hosted agricultural fairs.</p> <p>3) Contextual value: From Bylaw 88-94: 'One of six heritage buildings known to remain in the vicinity of the former hamlet of Hagerman [sic] Corners. As such it is one of the few built reminders of this former Markham Township community'.</p>	<p>■ Excerpted from Bylaw 88-94: 2-storey residence with:</p> <ul style="list-style-type: none">■ Medium gable roof with returned eaves and gable chimneys■ Symmetrical fenestration with radiating buff brick voussoirs■ Central entrance with flat transom and sidelights;■ Dichromatic brick belts, opening surrounds, and quoins; and■ Mix of masonry bonds used for decorative effect.	<p>Designated under Part V of the <i>OHA</i>, By-Law 88-94</p>

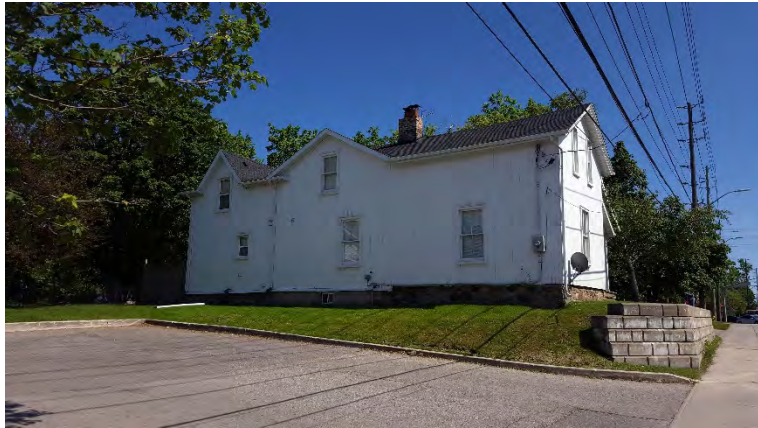
Civic Address	Photograph	Description	CHVI	Heritage Attributes	Recognition
7779-7781 Kennedy Road, Thomas Morely House

<p>Built heritage resource: Single-detached, two bay, and 1 ½ storey gabled ell house with L-shaped plan and open side veranda. The original rear section was built in the Classical Revival style with a low side gable roof with returned eaves, while a rear and front gabled addition have Gothic Revival inspiration. It was originally built in 1851.</p> <p>The house has minimal setback from the road and on the brow of the high ground and road cut north of Hagerman's Corners.</p> <p><u>History from City of Markham Register:</u> Thomas Morely, an English-born shoemaker, purchased this ¼ acre village lot, part of Lot 6 Concession 6, from James Fairless in 1857. It was one of several small parcels created from the western frontage of the west 100 acres of Lot 6 in the 1840s. Fairless was the operator of the general store at Hagerman Corners. By the 1850s, the crossroads hamlet was a busy place with a cluster of businesses and a Methodist Church. The Thomas Morely House is one of the few remaining tangible reminders of the historic hamlet of Hagerman's Corners.'</p>	<p>1) Design or physical value: From Bylaw 37-93: 'A very good example of a typical dwelling found in a 19th century rural crossroads village'</p> <p>3) Contextual value: From Bylaw 37-93: 'One of very few surviving built reminders of the former hamlet of Hagerman's Corners.'</p>	<ul style="list-style-type: none">■ Excerpted from Bylaw 37-93: 1 ½-storey residence with:<ul style="list-style-type: none">■ Classic Revival style altered to the Gothic Revival style■ Returned eaves on the north and south gables; and,■ Original 2/2 double hung rectangular windows.	Designated under Part V of the <i>OHA</i> , By- Law 37-93

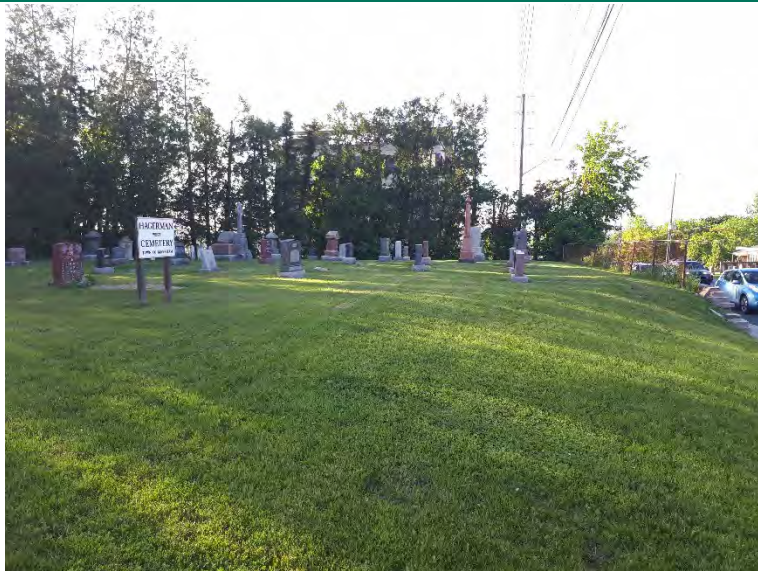
7782 Kennedy Road, Hagerman West Cemetery

<p>Cultural heritage landscape: Small cemetery established in 1832 with a mix of large and small 19th century and 20th century headstones and monuments. The south portion of the cemetery has a semblance of rows but placement of monuments in the north section is less regular.</p> <p>Standing headstones are set back a short distance from the road and the west slope is retained by a recently constructed or repaired masonry wall. The cemetery is on the brow of the high ground and road cut north of Hagerman's Corners.</p> <p><u>History from City of Markham Register:</u> No history provided.</p>	<p>2) Historical or associative value: The cemetery has historical and associative value as a burial ground for Markham's Euro-Canadian settlers from the second quarter of the 19th century to the present, and has potential to contribute to studies of 19th century demographics in Markham.</p> <p>3) Contextual value: The cemetery has contextual value as a remnant of the rural settlement around Hagerman's Corners and for its visual connections with the Hagerman East Cemetery, and for its landmark qualities.</p>	<ul style="list-style-type: none">■ Cemetery with:<ul style="list-style-type: none">■ Headstones and monuments of varying scale, form, and date, not all arranged in rows;■ Prominent location on a high ground; and,■ Visual connections with the Hagerman East Cemetery	Listed on the City of Markham <i>Register</i>

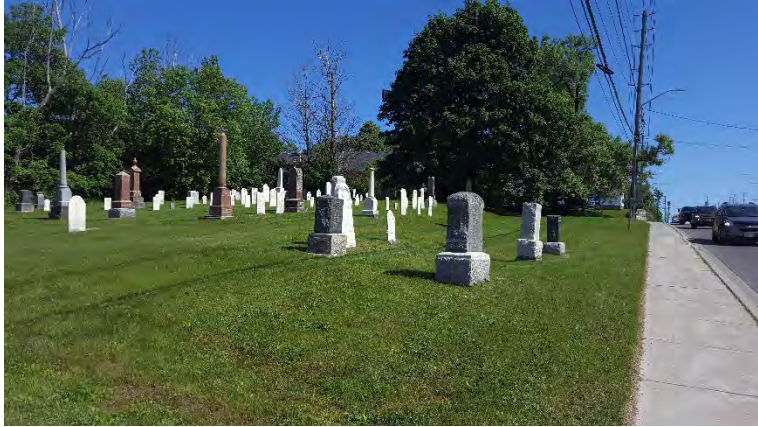
Civic Address	Photograph	Description	CHVI	Heritage Attributes	Recognition
7791 Kennedy Road, Hagerman East Cemetery

<p>Cultural heritage landscape: Small cemetery established as early as 1838 with a mix of large and small 19th century and 20th century headstones and monuments. The south portion of the cemetery has defined rows but placement of monuments in the north section is less regular. Some of the headstone have been relocated to a section in the southeast. Standing headstones in the north are set back a minimal distance from the road. In the southwest is a large tree and a higher and more undulating topography than the north, which slopes gradually to the northwest. <u>History from City of Markham Register:</u> Earliest Marker 1838 - Presbyterian Nicholas Hagerman was one of the prominent Berczy settler families. The community of Hagerman's Corner's takes its name from this family.</p>	<p>2) Historical or associative value: The cemetery has historical and associative value as a burial ground for Markham's Euro-Canadian settlers from the second quarter of the 19th century to the present, and has potential to contribute to studies of 19th century demographics in Markham.</p> <p>3) Contextual value: The cemetery has contextual value as a remnant of the rural settlement around Hagerman's Corners, for its visual connections with the Hagerman West Cemetery, and for its landmark qualities.</p>	<p>■ Cemetery with:</p> <ul style="list-style-type: none">■ Headstones and monuments of varying scale, form, and date, not all arranged in rows;■ Landscape features such as a large tree and undulating topography;■ Minimal setback from the road;■ Visual connections with the Hagerman East Cemetery	Listed on the City of Markham Register

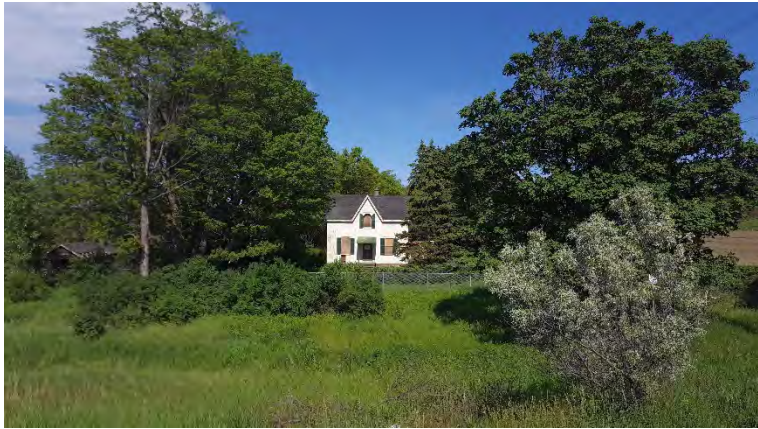
7951 Kennedy Road

<p>Built heritage resource: Single-detached, 1 ½ storey and three bay Gothic Revival house with medium side gable roof and round headed window in the central cross-gable. It has a T-shaped plan formed by a rear wing, and was built in 1877. The house is setback a considerable distance from the road and surrounding by several tall trees. North of the house is a small outbuilding with low gable roof that may have been added in the 20th century. <u>History from City of Markham Register:</u> Robert Armstrong, a local farmer of Irish descent acquired the property in 1876 from Nicholas Hagerman and built the current 1.5 storey, frame house c.1877. The 1891 census lists Armstrong and his family living in a wooden two storey, nine room house matching the present dwelling. The farm remained in the Armstrong family for almost 50 years passing from Robert to son Leslie in 1903. The house is modest example of Ontario vernacular architecture with Gothic Revival features. The property was acquired by the Ontario Government in order to build Highway 407. Infrastructure Ontario currently owns the land (2016) and the address was changed from 7931 to 7951 Kennedy Road.</p>	<p>1) Design or physical value: The house has design value as a representative example of a late 19th century Gothic Revival farmhouse with central cross-gable and symmetrical fenestration.</p> <p>3) Contextual value: Although no longer associated with a farm complex, the house and outbuilding has contextual value as a remnant of the agricultural development and rural settlement around Hagerman's Corners.</p>	<p>■ 1 ½-storey residence with:</p> <ul style="list-style-type: none">■ Round headed window in the central cross gable;■ Symmetrical fenestration;■ T-shaped plan with rear wing■ Substantial setback; and,■ Association with an outbuilding and surrounding large trees.	Listed on the City of Markham Register

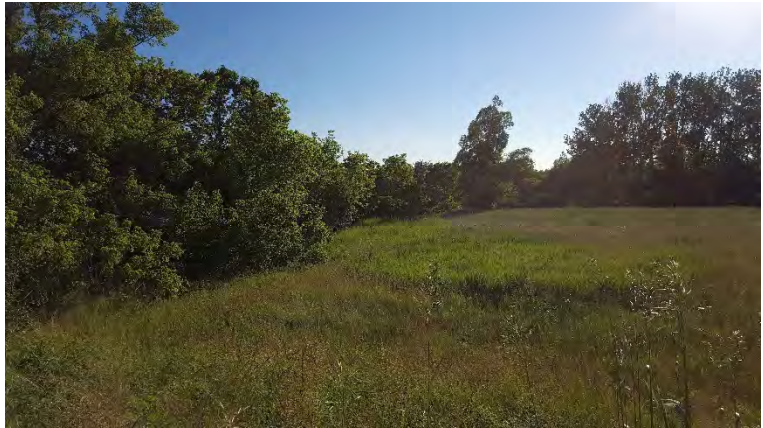
Civic Address	Photograph	Description	CHVI	Heritage Attributes	Recognition
215 Austin Drive

<p>Potential cultural heritage landscape: Railscape lined with tall trees and a cleared meadow transitioning to tall trees lining the Rouge River.</p> <p>History: The Toronto and Nipissing Railway Company established the line between 1869 and 1872.</p>	<p>2) Historical or associative value: The landscape has associative value for its connection to the Toronto and Nipissing Railway, which has remained in use as a transportation route since the 19th century.</p> <p>3) Contextual value: The landscape has contextual value as a remnant of the area's formerly rural landscape.</p>	<p>■ Static and associative potential cultural heritage landscape with:</p> <ul style="list-style-type: none">■ Tree lined railway;■ Cleared meadow; and,■ Natural vegetation along a significant watercourse.	Newly identified
9227 Kennedy Road

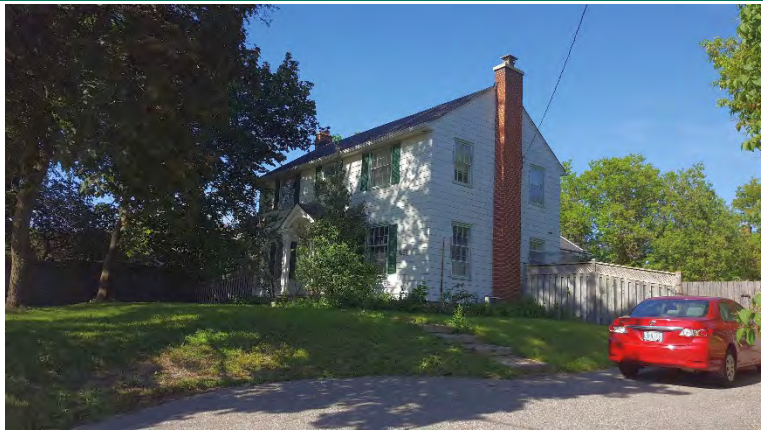
<p>Built heritage resource: Single-detached, three bay and two storey Colonial Revival house with side gable roof, end wall chimneys, and front gabled porch. Unlike all other surrounding residences, the house faces Kennedy Road and is oriented parallel with the road's original alignment. It has a large setback with several mature trees in the front yard.</p> <p>History: The <i>Registry</i> and aerial imagery suggest it was built c. 1955.</p>	<p>1) Design or physical value: The house has design value as a representative example of a Colonial Revival house with two storey massing and symmetrical fenestration and chimney location.</p>	<p>■ Two-storey Classic Revival house with:</p> <ul style="list-style-type: none">■ Three-bay symmetrical façade with central porch;■ Exterior chimneys at both end walls,■ Orientation to the original alignment of Kennedy Road.	Inventoried on City of Markham 'Heritage Buildings' geospatial database

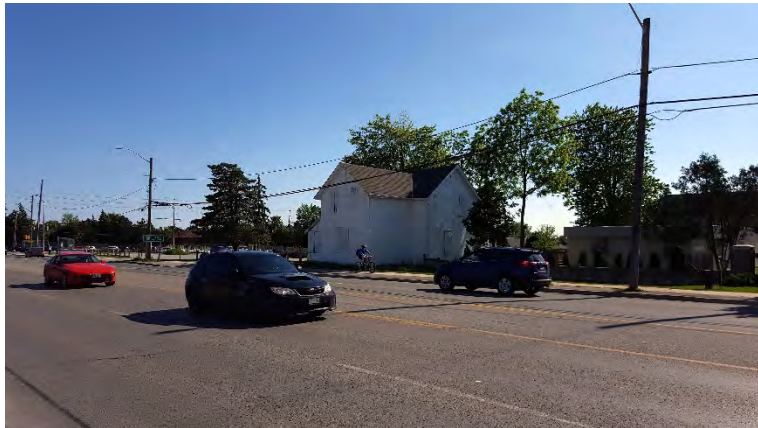
Civic Address	Photograph	Description	CHVI	Heritage Attributes	Recognition
9286 Kennedy Road, George Hunter House

<p>Built heritage resource: Single-detached, two bay, and 1 ½ storey gabled ell house with T-shaped plan and closed side veranda. It was built in a vernacular expression of Neoclassical style but overall lacks decoration, and the east front gabled section may be a later alteration to the west side gabled block. It was built in 1860. The house has minimal setback from the road and is surrounded by recent development.</p> <p><u>History from City of Markham Register:</u> 'The George Hunter House was constructed c. 1860 on land he purchased from Francis Schmidt in 1836 and 1838. Prior to the construction of the house the property was owned and occupied by the families of Marcus Rumohr, Peter Ernst, Martin Holder and Francis Schmidt (Smith), all of whom were original Berczy Settlers. George Hunter was born in 1806 in Scarborough, Yorkshire England and immigrated to Canada in 1830. It is believed that he came to Canada with his brother John Hunter who is listed as residing with George. George Hunter originally worked as an innkeeper but, once he was able to acquire property he practised the trade of blacksmith. George Hunter engaged in the trade of a blacksmith on the property and soon a village emerged around him. It was called Hunter's Corners in his honour. With the arrival of the railway and later the building of Highway 7 the economic heart of the settlement moved southward over the years and became the village of Unionville.'</p>	<p>1) Design or physical value: From Bylaw 14-96: 'an example of a two storey [sic] Vernacular home with influences of the Neo-classical style'.</p> <p>2) Historical or associative value: From Bylaw 14-96: Association with the Hunter's Corners, named for George Hunter and his brother John, and 'the earliest settlement connected to Unionville Village'.</p> <p>3) Contextual value: From Bylaw 14-96: 'One of last reminders of the former settlement of Hunters [sic] Corners'.</p>	<p>■ From Bylaw 14-96: 1 ½ storey vernacular house with:</p> <p>■ 'hipped form and traditional window placement'.</p>	<p>Designated under Part IV of the <i>OHA</i>, By-Law 14-96</p>

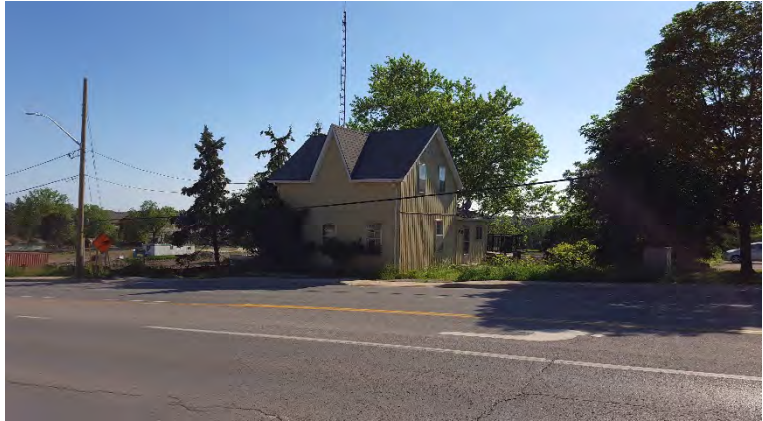
Civic Address	Photograph	Description	CHVI	Heritage Attributes	Recognition
9392 Kennedy Road, Thomas Lownsbrough House

<p>Built heritage resource: Single-detached, 1 ½ storey and three bay Gothic Revival house with medium side gable roof and central cross-gable. The main block was built in 1845 but has a rear addition constructed in the late 20th century. The house has minimal setback from the road and situated on the brow of a hill.</p> <p><u>History from City of Markham Register:</u> 'Located on the east half of Lot 16, concession 5, originally granted to William Berczy in 1804. The land changed hands numerous times until finally reaching Thomas Lownsbrough. The earliest record of Lownsbrough on this property is the 1846-47 Brown's Directory of Toronto and County of York. Thomas Lownsbrough was a shoemaker born in Yorkshire England. His wife, Sarah McDougall was born in Scotland and died in 1844. It appears from the Census Records and the date and place of birth of their eldest daughter, that the Lownsbrough immigrated to Canada before 1832. The 1851 Census lists Thomas with 6 children, occupying a one-storey frame home. Thomas likely constructed the dwelling himself, c. 1845. The second floor and centre gable, given their overall proportion and the height above the main floor windows below the roofline, were likely the result of a later alteration. Thomas Lownsbrough Sr. died in 1891 and is buried with his wife in the Bethesda Lutheran Church Cemetery, located on the opposite side of Kennedy Road.'</p>	<p>1) Design or physical value: The house has design value as a representative example of a mid 19th century Gothic Revival farmhouse with central cross-gable and symmetrical fenestration.</p> <p>3) Contextual value: The house has contextual value as a remnant of the agricultural development and rural settlement around Hunter's Corners and with 'a cluster of features of cultural heritage value or interest sometimes referred to as Settler's Hill' (see 9423 Kennedy Road).</p>	<p>■ 1 ½-storey residence with:</p> <ul style="list-style-type: none">■ Medium side gable roof with central cross gable;■ Symmetrical fenestration; and,■ Minimal setback.	Listed on the City of Markham Register

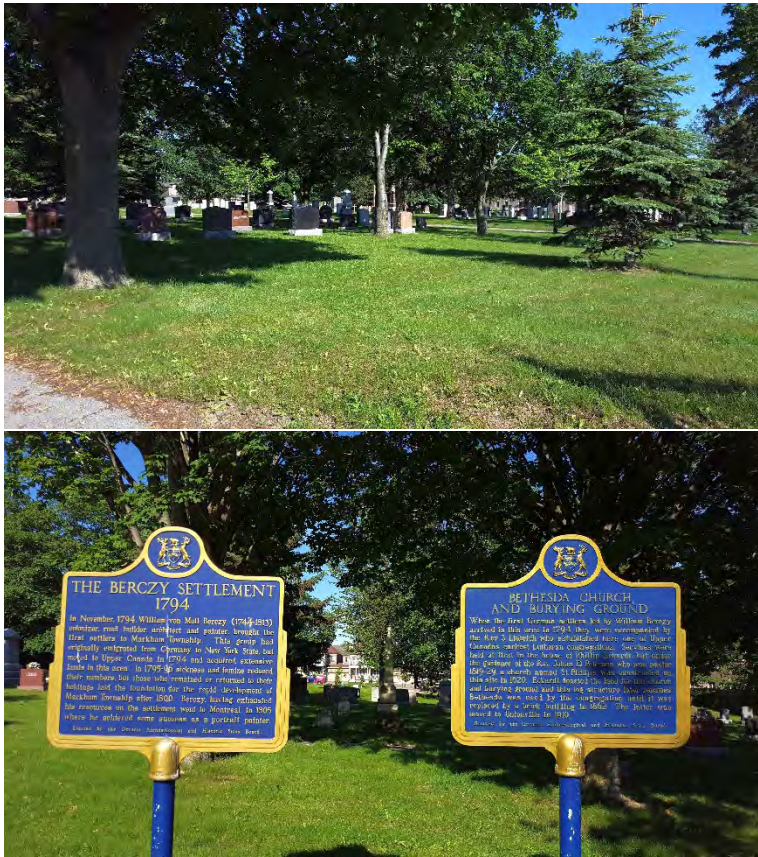
9423 Kennedy
Road, Bethesda
Lutheran Cemetery

Cultural heritage landscape:
Small cemetery established in 1820 with a mix of large and small 19th century and 20th century headstones and monuments. All headstones are arranged in long rows and there are numerous trees also arranged in rows. There is minimal setback from the road and a retaining wall lines the west boundary adjacent to the sidewalk.
In the west centre of the cemetery are two Ontario Archaeological and Historic Sites Board plaques.
History from City of Markham Register:
'The Bethesda Lutheran Cemetery is a traditional church burying ground with standing grave markers, mature trees and a boundary fence on a rise of land on the east side of Kennedy Road, north of 16th Avenue. The Bethesda Lutheran Cemetery is of historical and associative value as the site of Unionville's first Lutheran Church, established on a plot of land given by Philip Eckardt in 1820, who farmed Lot 17, Concession 6 from 1808 to his death in 1845. The church was originally called St. Philips prior to a split in the congregation that occurred as the result of local tensions associated with the Upper Canadian Rebellion of 1837. The first building was a frame structure completed in 1820. A burying ground was established in association with the original church. Many of the Berczy settlers and their descendants are interred there. In 1862, the original church was replaced by a brick church in the Early Gothic Revival Style and officially named "Bethesda Lutheran Church" in 1894. In 1910, the congregation decided to move to a site within the village of Unionville, where building materials from the old church were used in the construction of a new brick church at 20 Union Street. The Bethesda Lutheran Cemetery is of design and physical value as a traditional church burying ground containing numerous stone grave markers of varying ages, materials and styles in a park-like setting with lawns, mature trees and shrubs. The earliest marker, dated 1803, pre-dates the formal establishment of the cemetery. Older grave markers from the 19th century are made of white marble, while grave markers from the early 20th century onward are made of more durable grey, red or black granite. In addition to written inscriptions, many grave markers have decorative motifs such as clasping hands, open bibles, doves, and roses. The

1) Design or physical value:
Excerpted from the *Register*: The cemetery is 'of design and physical value as a traditional church burying ground containing numerous stone grave markers of varying ages, materials and styles in a park-like setting with lawns, mature trees and shrubs. The earliest marker, dated 1803, pre-dates the formal establishment of the cemetery.'

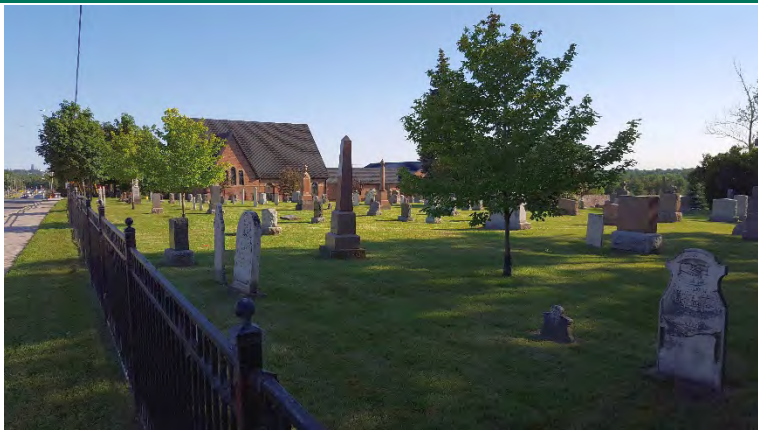
<p>Cultural heritage landscape: Small cemetery established in 1829 with a mix of large and small 19th century and 20th century headstones and monuments. All headstones are arranged in long rows interspersed with a small number of small trees. There is minimal setback from the road and a decorative iron fence lines the east boundary adjacent to the sidewalk. <u>History from City of Markham Register:</u> No description.</p>	<p>2) Historical or associative value: Associated with the Anglican Church, the official religion of British North America, and Settler's Hill.</p> <p>3) Contextual value: Part of the 'cluster of features of cultural heritage value or interest sometimes referred to as "Settler's Hill"' and its association with the 1840 St. Philip's Anglican Church Manse (9418 Kennedy Road).</p>	<ul style="list-style-type: none">■ Cemetery with:<ul style="list-style-type: none">■ Headstones and monuments of varying scale, form, and date, all arranged in rows;■ Minimal setback from the road; and,■ Visual connections with the Bethesda Lutheran Cemetery and St. Phillips Anglican Church Manse.	Listed on the City of Markham Register

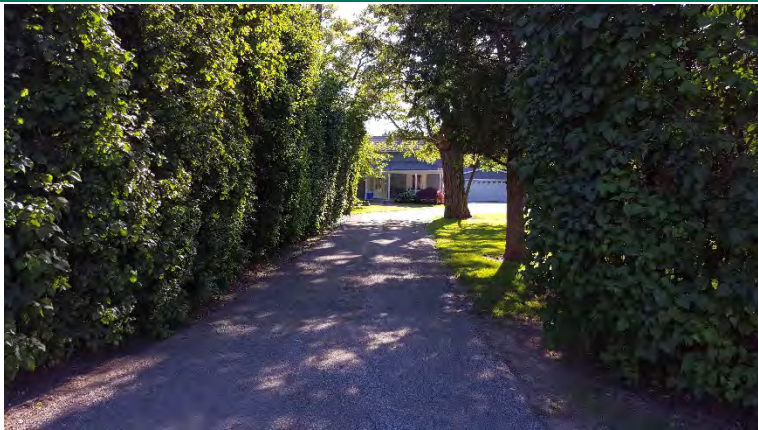
9418 Kennedy Road, St. Philip's Anglican Church Manse

<p>Built heritage resource: Single-detached, 1 ½ storey house with side gable roof, open front verandah, and T-shaped plan with rear wing. Other details could not be discerned from the public right of way but it is described in the <i>Register</i> as built in the 'Georgian tradition'. It was built in 1840. The house has a considerable setback from the road and screened by a tall hedge and trees. <u>History from City of Markham Register:</u> No description.</p>	<p>2) Historical or associative value: Associated with the Anglican Church, the official religion of British North America, and Settler's Hill.</p> <p>3) Contextual value: Part of the 'cluster of features of cultural heritage value or interest sometimes referred to as "Settler's Hill"' and its association with the St. Phillip's Anglican Church Cemetery (9400 Kennedy Road).</p>	<ul style="list-style-type: none">■ 1 ½-storey residence with:<ul style="list-style-type: none">■ Side gable roof;■ Open front verandah;■ Substantial setback; and,■ Extensive vegetation and tall front hedge.	Listed on the City of Markham Register

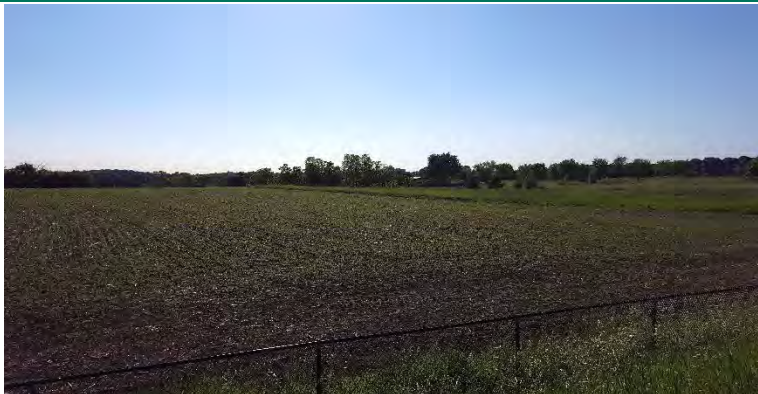
4134 16 th Avenue, York Downs Golf & Country Club

<p>Built heritage resource: One storey outbuilding with low gable roof of unknown date of construction.</p> <p>Cultural heritage landscape: Relict farmscape with central complex surrounded by divided fields, a woodlot and isolated large trees. History: No history provided.</p>	<p>3) Contextual value: The outbuilding and landscape have contextual value as a remnant of the area's formerly rural landscape.</p>	<ul style="list-style-type: none">■ 1-storey outbuilding with:<ul style="list-style-type: none">■ Low gable roof.■ Relict cultural landscape with:<ul style="list-style-type: none">■ Divided fields, a wood lot and isolated large trees.	Inventoried on City of Markham 'Heritage Buildings' geospatial database

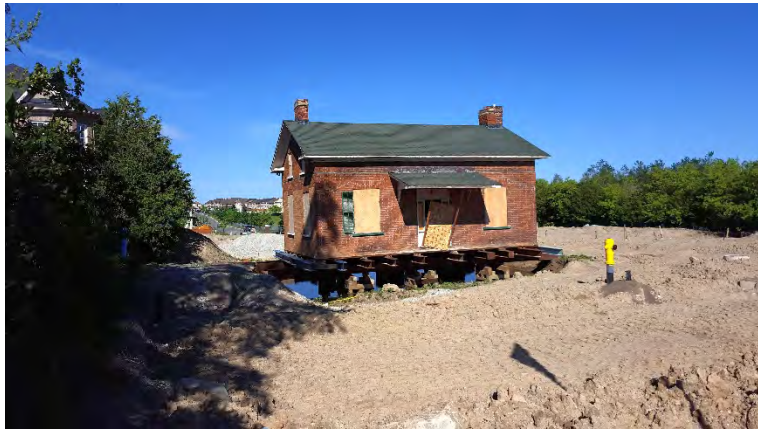
Civic Address	Photograph	Description	CHVI	Heritage Attributes	Recognition
9721 Kennedy Road, Stiver Tenant House

<p>Built heritage resource: Single-detached, 1 ½ storey and three bay red brick Classic Revival house with low side gable roof and eave returns. At both end walls are interior chimneys It was built in 1857. The house was originally situated on the brow of a hill but is currently being relocated to the east.</p> <p><u>History from City of Markham Register:</u> Located on the west half of Lot 19, Concession 6, which was originally granted to William Weeks in 1804. Christian Henricks acquired the western 100 acres in 1830 and subdivided the half lot into several parcels. In 1835, Alexander S. Thompson purchased the south western 2 acres from Henricks. Alexander S. Thompson is listed at this location on the 1846-47 and 1850-51 Commercial Directories but is not listed at this location on the 1851 Census Report. Only one brick house is described at this location on the 1851 Census: the Henry Pingle Senior House at 11 Tannis Street (formerly 9767 Kennedy Road). Ann Catherine nee Stiver Lee was William Stiver's sister. She married Thomas Lee on May 27, 1857. William Stiver likely had this home constructed for the couple in 1857 and then rented the property to them.</p>	<p>1) Design or physical value: From Bylaw 2010-24: 'Well-preserved, representative example of a mid-19th century rural dwelling in red brick, laid in ornamental Flemish bond on the façade. The architecture has design value as a typical example of a vernacular building reflecting the Georgian architectural tradition and Classic Revival style'.</p> <p>3) Contextual value: From Bylaw 14-96: 'One of a cluster of 19th century buildings that are found in the vicinity of the historic crossroads community of Colty Corners'.</p>	<p>■ From Bylaw 2010-24: Residence with:</p> <ul style="list-style-type: none">■ 'Overall form of the building, with its rectangular plan, 3 by 2 bay arrangement of opening and one and a half storey height;■ Fieldstone foundation;■ Red brick walls with brick arches over openings;■ Medium pitched gable roof with eave returns and boxed overhanging eaves with wood soffits and bedmould;■ Single stack, gable end red brick chimneys;■ Flat arched 6 over 6 wood sash windows with projecting wood sills, with the windows on the ground floor noticeably larger than those on the second floor;■ Louvered, wood shutters on the front windows;■ Wood front door, with flat headed transom light (currently boarded over) and multi-paned sidelights	<p>Designated under Part IV of the OHA, By-Law 2010-24</p>

Property of Known or Potential CHVI	Risk of Adverse Impact to Heritage Attributes	Recommended Conservation or Mitigation Measures
9721 Kennedy Road, Stiver Tenant House	<p>No risk for direct or indirect impact to heritage attributes that is irreversible, short term, infrequent, and widespread.</p> <p>Rationale: The built heritage resource is being relocated over 60 m away from the existing ROW, resulting in no risk of direct impact from construction vibration (see Carman <i>et al.</i> 2012:31).</p> <p>There is low to no risk of indirect impact to heritage attributes since future road improvements are not predicted to substantially change the setting of the built heritage resource.</p>	No conservation or mitigation measures required.
10000 Kennedy Road/ 4465 Major Mackenzie Drive, S.S. # 11 Colty Corners School House	<p>High risk for direct impact to heritage attributes that is irreversible, short term, infrequent, and widespread.</p> <p>Rationale: The built heritage resource is within 10 m of the existing ROW and at high risk of direct impact from construction vibration (see Carman <i>et al.</i> 2012:31) if the property cannot be avoided.</p> <p>There is low to no risk of indirect impact to heritage attributes since future road improvements are not predicted to substantially change the property's existing setting.</p>	<p>DESIGN PHASE:</p> <p>If the property cannot be avoided and will be physically impacted by construction:</p> <p>Conduct an HIA: An HIA to determine the impact of the proposed detailed design on the property's heritage attributes will be required.</p> <p>DURING CONSTRUCTION</p> <p>If the property can be avoided, the following measures are recommended:</p> <p>Site plan control & communication: The property and specifically the footprint of the house should be clearly marked on project mapping and communicated to all project personnel for avoidance during design, construction and subsequent operation.</p> <p>Create a physical buffer: Temporary fencing should be erected at a 10 m distance from the property line to ensure that all excavation, installation and associated vehicle traffic during construction or subsequent operational work will not impact the heritage attributes of the property.</p> <p>Monitor for vibration impact: Continuous ground vibration monitoring should be carried out near the foundations of the house using a digital seismograph capable of measuring and recording ground vibration intensities in digital format in each of three (3) orthogonal directions. The instrument should also be equipped with a wireless cellular modem for remote access and transmission of data.</p> <p>The installed instrument should be programmed to record continuously, providing peak ground vibration levels at a specified time interval (e.g. 5 minutes) as well as waveform signatures of any ground vibrations exceeding a threshold level that would be determined during monitoring. The instrument should also be programmed to provide a warning should the peak ground vibration level exceed the guideline limits specified. In the event of either a threshold trigger or exceedance warning, data would be retrieved remotely and forwarded to designated recipients.</p>

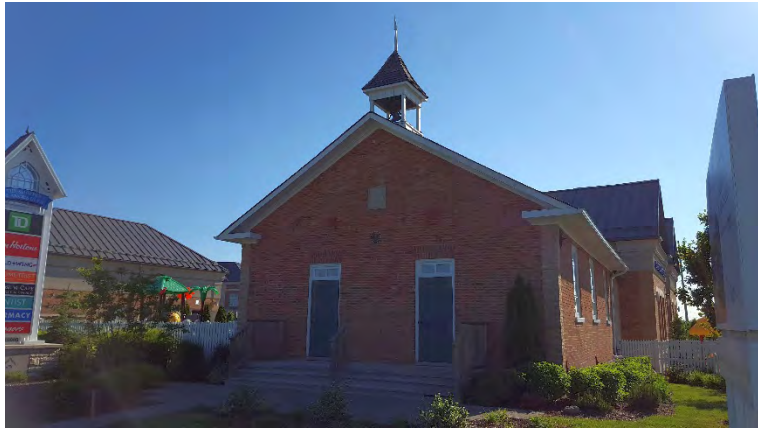
Civic Address	Photograph	Description	CHVI	Heritage Attributes	Recognition
10000 Kennedy Road/ 4465 Major Mackenzie Drive, S.S. # 11 Colty Corners School House

<p>Built heritage resource: Unrelated attached (originally single-detached) one storey and two bay red brick Classic Revival schoolhouse with medium front gable roof, returned eaves, bell tower and double doors that may have been to enforced gender separation (i.e. separate boys' and girls' entrances). The school house has a central date stone in the gable recording the date of construction as 1862.</p> <p>The original 'Regency' or bellcast verandah has been removed and the building attached to a commercial building within a commercial plaza.</p> <p><u>History from City of Markham Register:</u> The original school building at the crossroads of Kennedy Road and 17th Avenue, concession 5 dates back to 1837. At that time a school building was built on the south west corner of Lot 21, Concession 6 on the lot of Jacob Pingle, a Berczy Settler. By 1850, some 40 students were in attendance. The school house #11 is a rectangular brick building, one storey in height, which sits on a fieldstone foundation. Across the front of the building runs a one storey verandah with a Regency Style roof, raised details on the frieze board and four evenly placed wooden Doric columns.</p>	<p>1) Design or physical value: From Bylaw 307-83: 'The oldest surviving schoolhouse in the Town of Markham' with 'several unique architectural features...including a bell tower, eaves [sic] returns, multi-paned windows and a Regency style front verandah [latter since removed].</p>	<ul style="list-style-type: none">■ 1-storey schoolhouse with:<ul style="list-style-type: none">■ Bell tower;■ Returned eaves;■ Double, gender-specific entrances;■ Dichromatic brick masonry with date stone; and,■ Flat arch, guaged brick voussoirs;■ Prominent location at a crossroads	<p>Designated under Part IV of the <i>OHA</i>, By-Law 307-83</p>

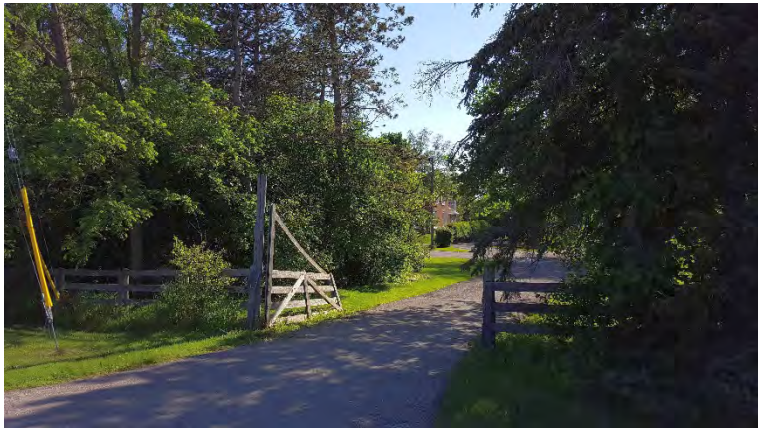
10060 Kennedy Road, George Pingle House

<p>Built heritage resource: Single-detached and three bay 1 ½ storey dichromatic brick Neoclassical house with side gable roof, front entrance with sidelights and segmental arch transom, and front ‘belly-flop’ window. It has a T-shaped plan formed by a rear wing, and was built in 1875. The house is setback a moderate setback from the road and screened by thick vegetation on the east property boundary. Other outbuildings on the property were not documented but may be related to the property’s agricultural land use and there is a small paddock enclosed by a wood fence that continues along the east boundary of the property.</p> <p><u>History from City of Markham Register:</u> ‘The John Pingle House is located at 10060 Kennedy Road in on Lot 20, Concession 5E, in the vicinity of the community of Colty Corners. The Pingle family were among the original Berczy settlers, who came to Markham in 1794 from Schleswig-Holstein or Demark. Joachim Pingle, then 54 years of age, his wife Anna Maria, and five children came to Philadelphia with Berczy on board the Catharina. Joachim was 64 in the 1804 Census and Maria was 59. Joachim and Maria drew Lot 22, Concession 6, son George drew Lot 21, Concession 6, while son John Henry drew Lot 22, Concession 7. These three farms were all patented between 1804 and 1807. George Pingle also leased the land at Lot 20, Concession 5 from the Crown. George’s brother, Henry Pingle is a notable figure for his contribution to the Militia in the early part of the nineteenth century. As a Sergeant Pingle led a detachment of Button’s 1st York Cavalry to Detroit in August of 1812 to participate in General Brock’s capture of the American settlement and fort there. George Pingle and his wife had a son, John who was born on Lot 21, Concession 5 in 1804, and as he grew up he assisted his family in clearing the bush in the area. John attended the German School in the district during the winter months and served his father on the farm in summer. In 1827, John married Miss Jane Hunter, and together they had eight children. It is believed that soon after the marriage John and Jane Pingle established a residence and farmed the land on the leased property at Lot 20, Concession 5. While the Pingles were originally active members of Lutheran Congregation, John eventually became a very active member of the local Anglican Church,</p>	<p>1) Design or physical value: The house has design value as a representative example of Neoclassical farmhouse with dichromatic brick decoration, ornamented central entrance, and unusual second level ‘belly flop’ window.</p> <p>2) Historical or associative value: The property is associated with the locally important Pingle family.</p> <p>3) Contextual value: The property is has contextual value as ‘one of a cluster of 19th century buildings that are found in the vicinity of the historic crossroads community of Colty Corners’ and as a remnant of the area’s agricultural development and rural settlement in the 19th to early 20th centuries.</p>	<p>■ 1 ½-storey residence with:</p> <ul style="list-style-type: none">■ Dichromatic brick decoration;■ Front entrance with sidelights and segmental arch transom;■ Second level central ‘belly flop window’■ Rear wing;■ Moderate setback;■ Association with a number of outbuildings possibly relating to the property’s use as a farm;■ Wood fences and paddock; and,■ Extensive vegetation around the house and front yard.	Listed on the City of Markham Register
