Appendix H.4 – Heritage Impact Assessment Report – Thomas Morley House

*Kennedy Road Environmental Assessment between
Steeles Avenue and Major Mackenzie Drive*

**Thomas Morley House, 7779-81 Kennedy Road, City of
Markham, Ontario**

Heritage Impact Assessment

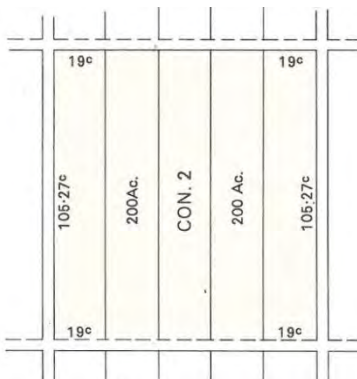
Figure 2: The single front survey system, used from 1783 to 1818. As depicted here, each lot is 200 acres (Ac.), created from surveying 19 chains by 105.27 chains (1 chain = 66 feet/ 20.12 metres; Dean & Matthews 1969:99)

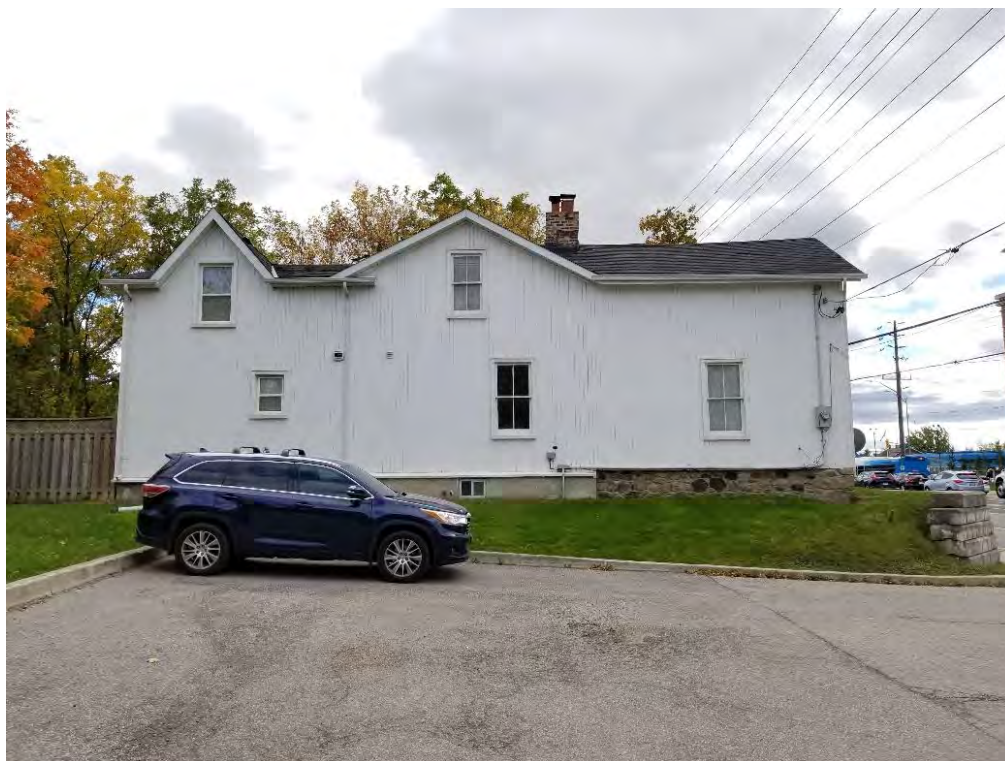
Figure 10: North façade of the Thomas Morley House.

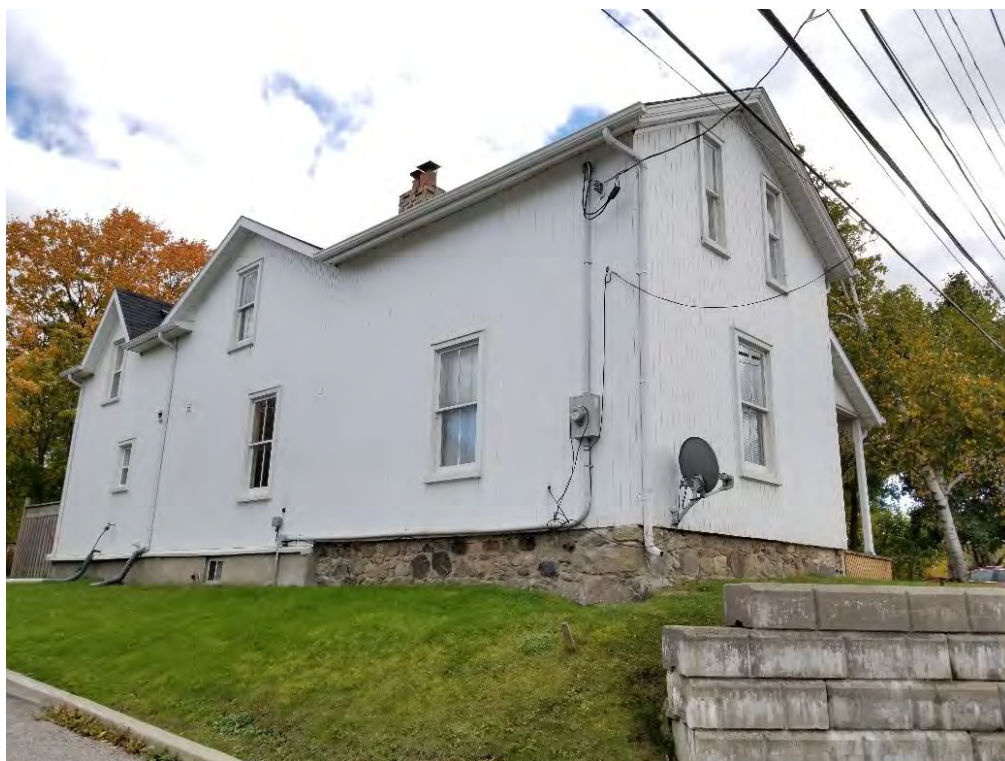
Figure 11: North and west façades of the Thomas Morley House.

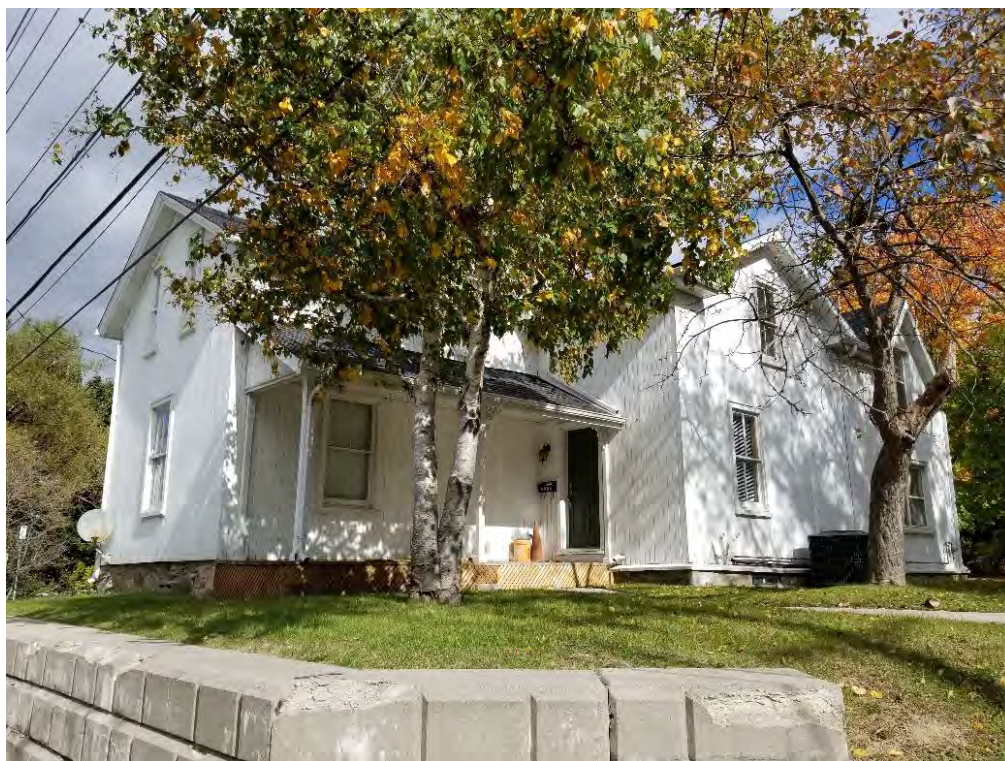
Figure 12: West and south façades of the Thomas Morley House.

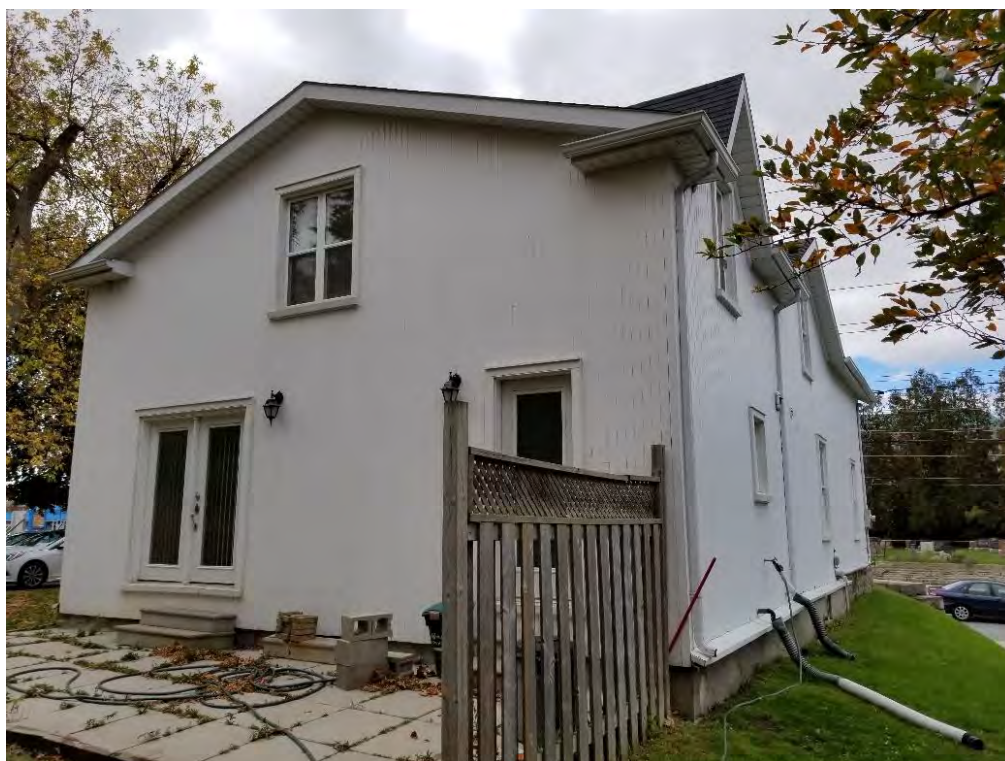
Figure 13: East and north façades of the Thomas Morley House.

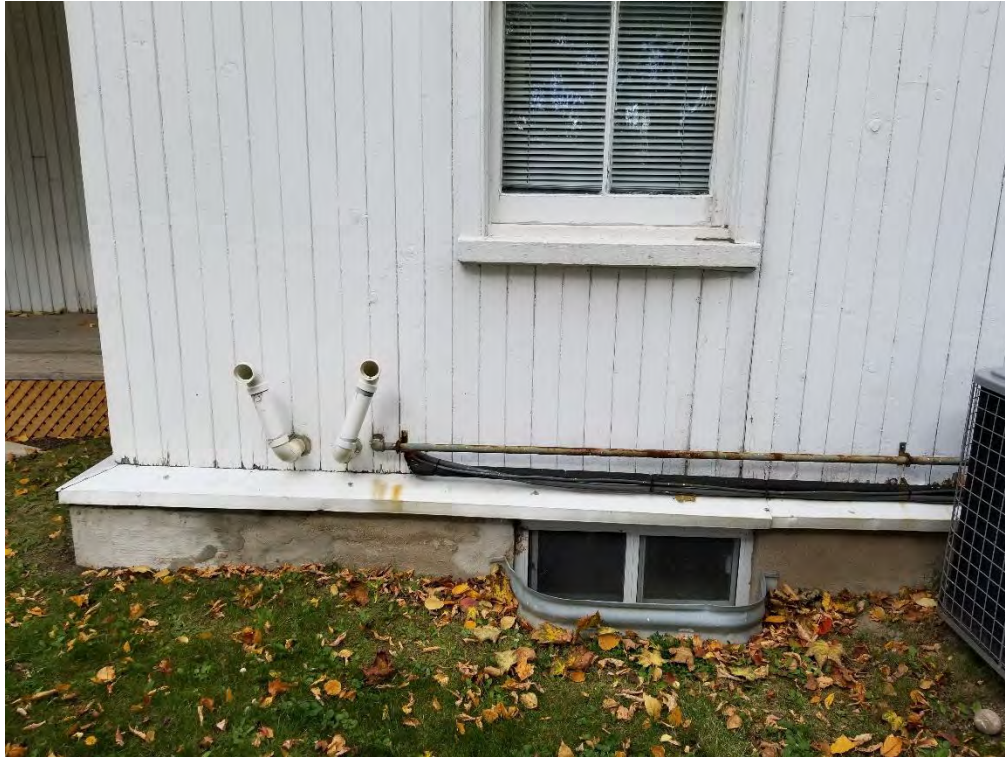
Figure 14: Concrete parging on the Main Block foundation.

The Main Block sits on a stone foundation parged with concrete (Figure 14). The exterior is clad in wood vertical plank board with minimal details. Over the north-south oriented long walls is a low gable asphalt shingled roof with returned eaves (Figure 15). All the windows are tall, with flat heads, plain trim and two-over-two sashes. A single-leaf panelled door fills the off-centre entrance on the west façade, and it has a flat head and moulded wood architrave (Figure 16).

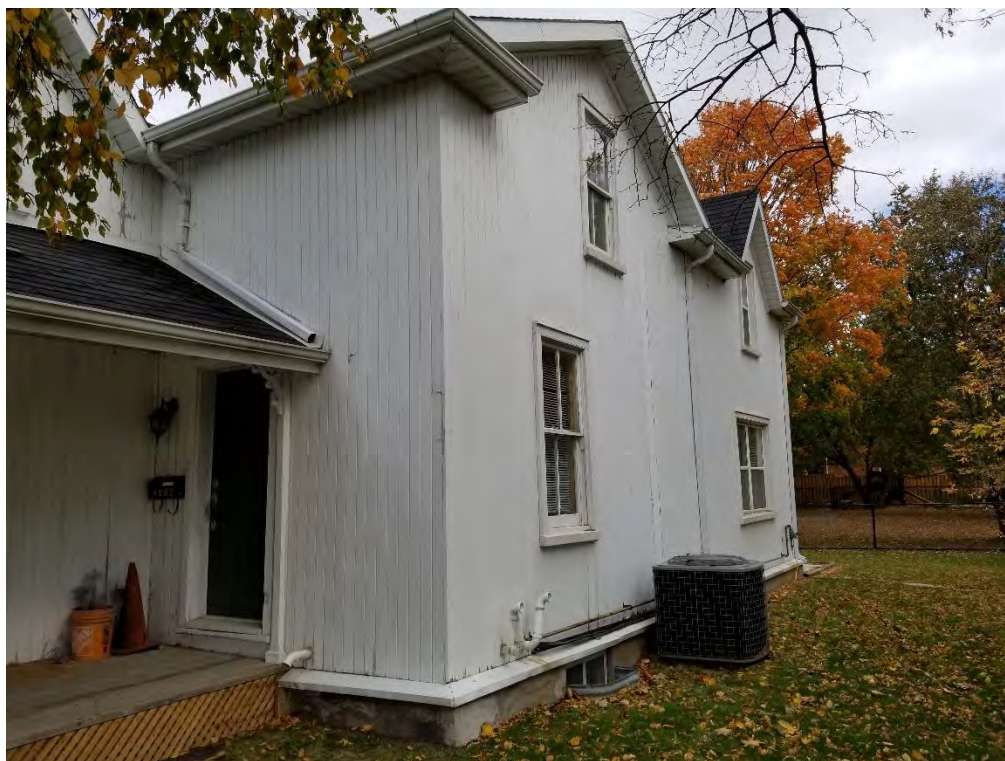
Figure 15: South end wall of the Main Block.

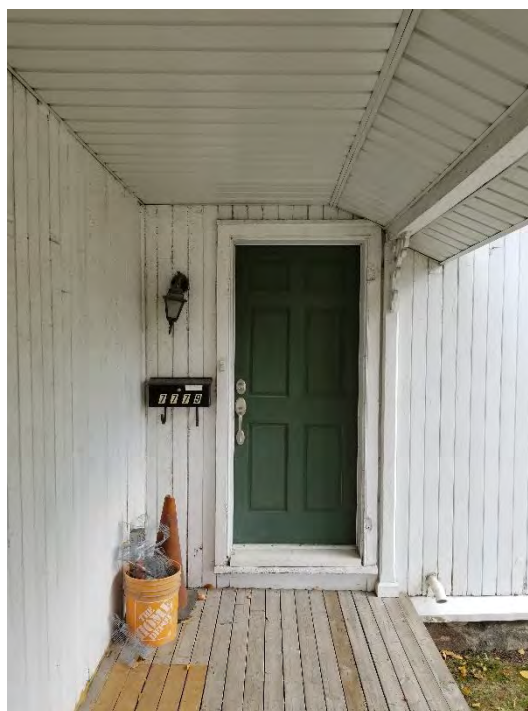
Figure 16: One leaf, panelled main entrance on the west façade of Main Block.

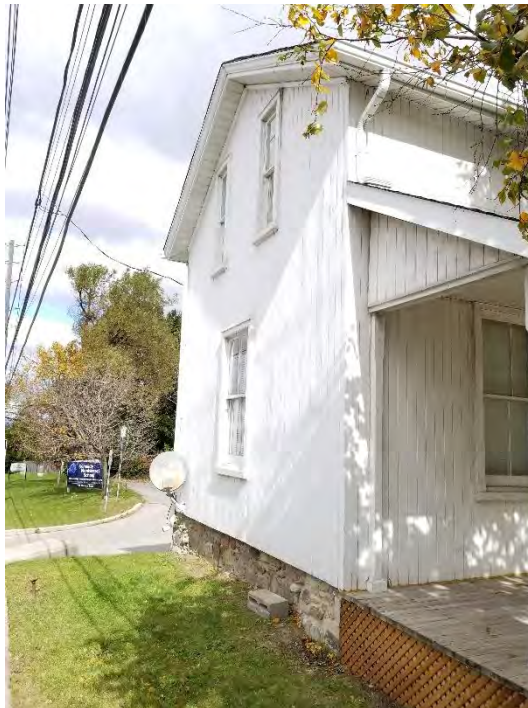
Figure 17: Random rubble fieldstone foundation of the West Wing.

The West Wing sits on a random rubble fieldstone foundation (Figure 17). All façades are clad in wood vertical plank board with minimal details. The medium gable roof is clad with asphalt shingles and has projecting metal eaves and plain fascia and soffit, with an offset gable located on the south façade (Figure 18). A single brick chimney is located to the offset front left. Fenestration is irregular, and most windows are tall, two-over-two with flat heads, plain wood trim and plain slip sill (Figure 19). The South Porch is open with decorated posts (Figure 20).

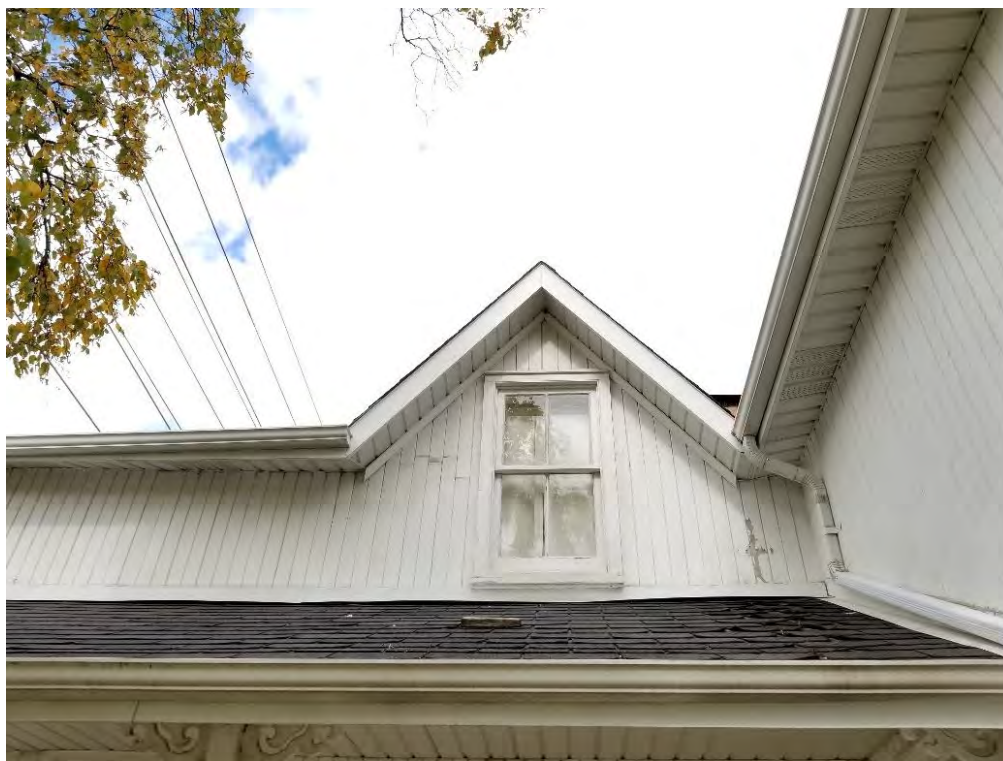
Figure 18: Offset cross-gable roof on the south façade of West Wing.

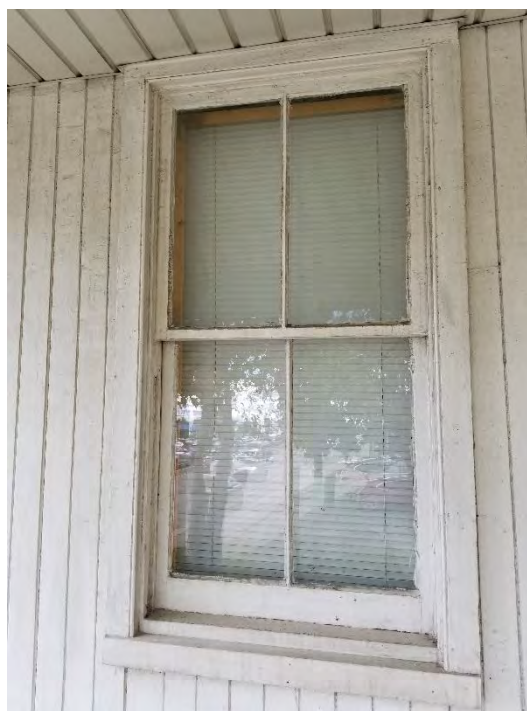
Figure 19: Typical two-over-two, double-hung wood window.

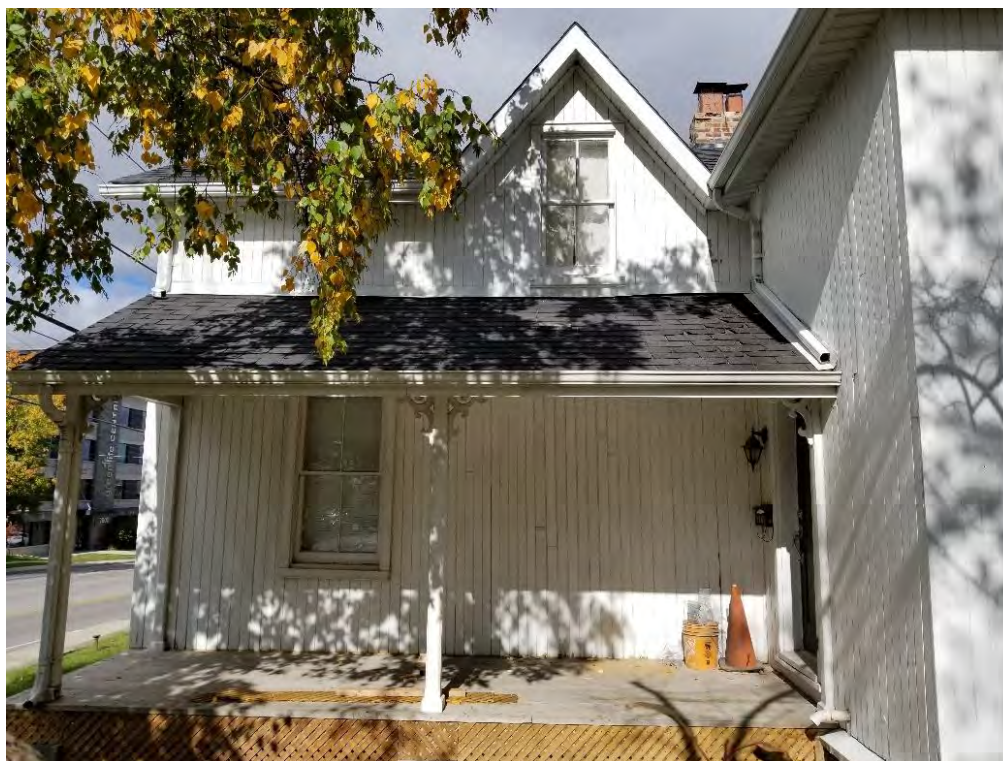
Figure 20: South Porch with decorated posts on the south façade.

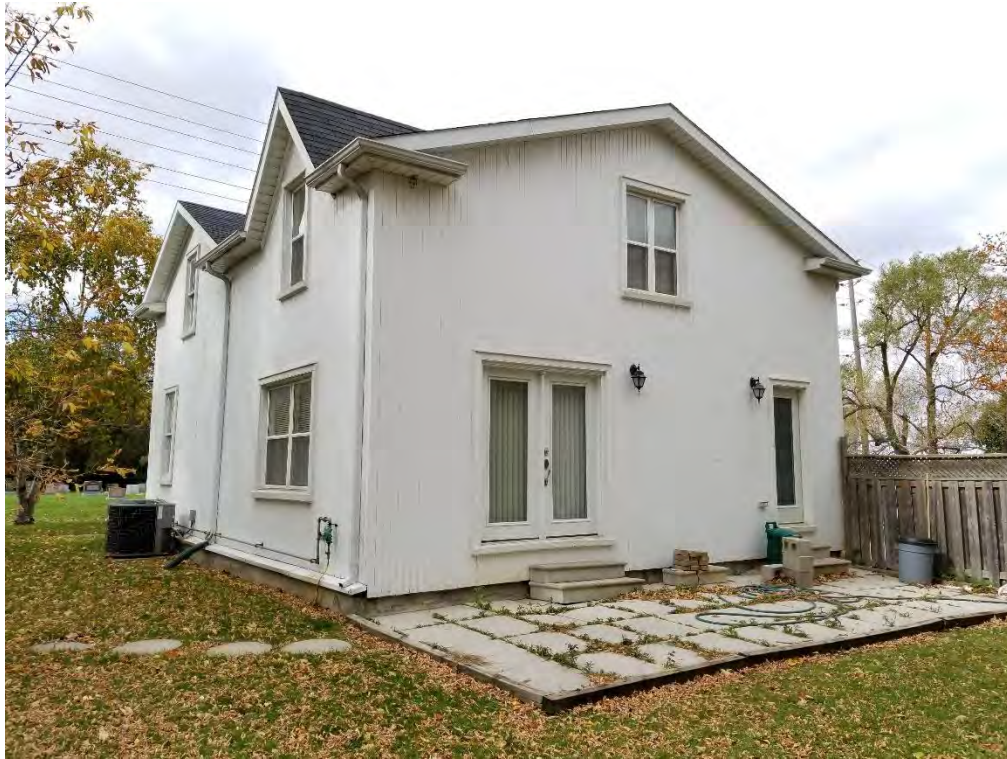
Figure 21: South façade of East Wing with cross-gable and east end wall with low gable and cornice returns.

The East Wing sits on a foundation faced with concrete and has the same wood vertical plank board cladding as the rest of the structure. The east façade has a low gable roof with returned eaves, with cross gables on the north and south façades. Windows are two-over-two sash with a flat head and plain trim. Two entrances are located on the east end wall, both of which are vinyl and glazed. A single-leaf entrance is on the north portion of the end wall while in the south portion is a double-leaf entrance (Figure 21). Straight concrete stairs with no railings lead to each entrance.

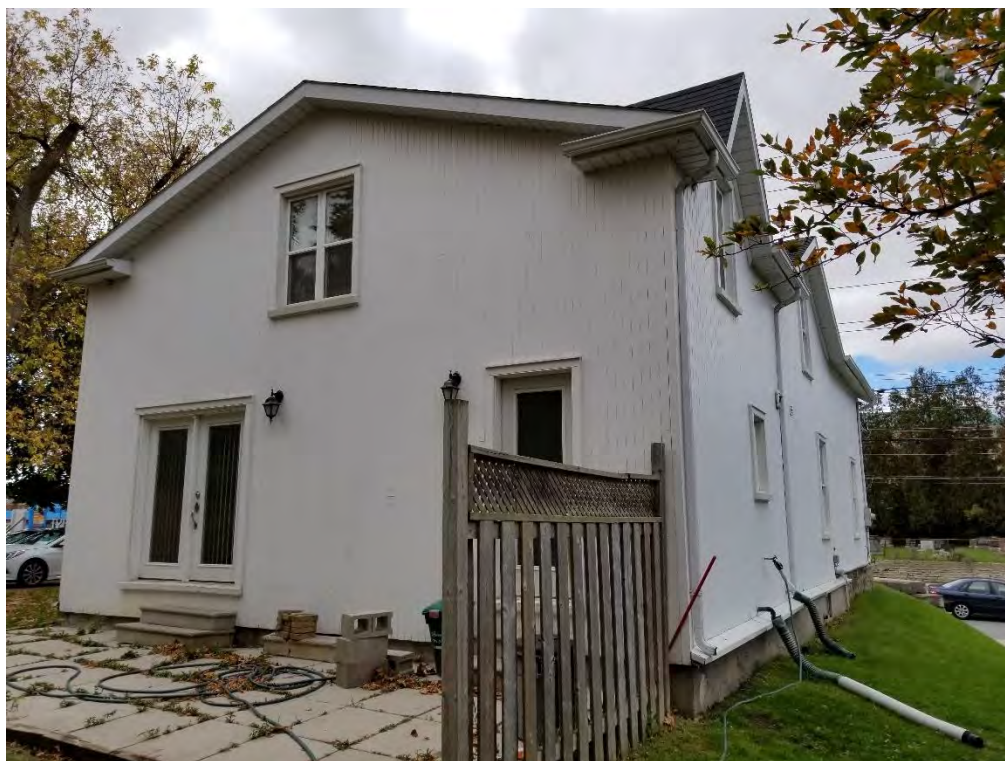
Figure 22: East end wall and north façade of the East Wing.

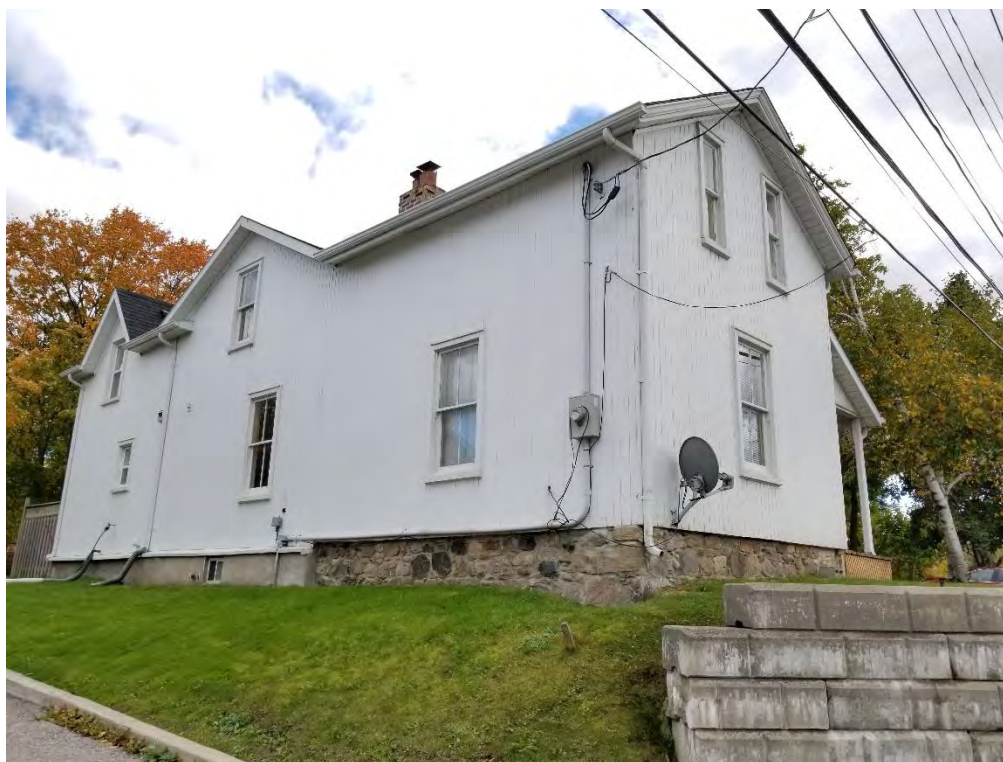
Figure 23: Thomas Morley House with retaining wall to the right.

A retaining wall is approximately 2 m west of the West Wing (Figure 23). It is constructed of large concrete blocks and runs approximately 11 m along the boundary of the public right-of-way boundary, angling at the curve of driveways to the north and south.

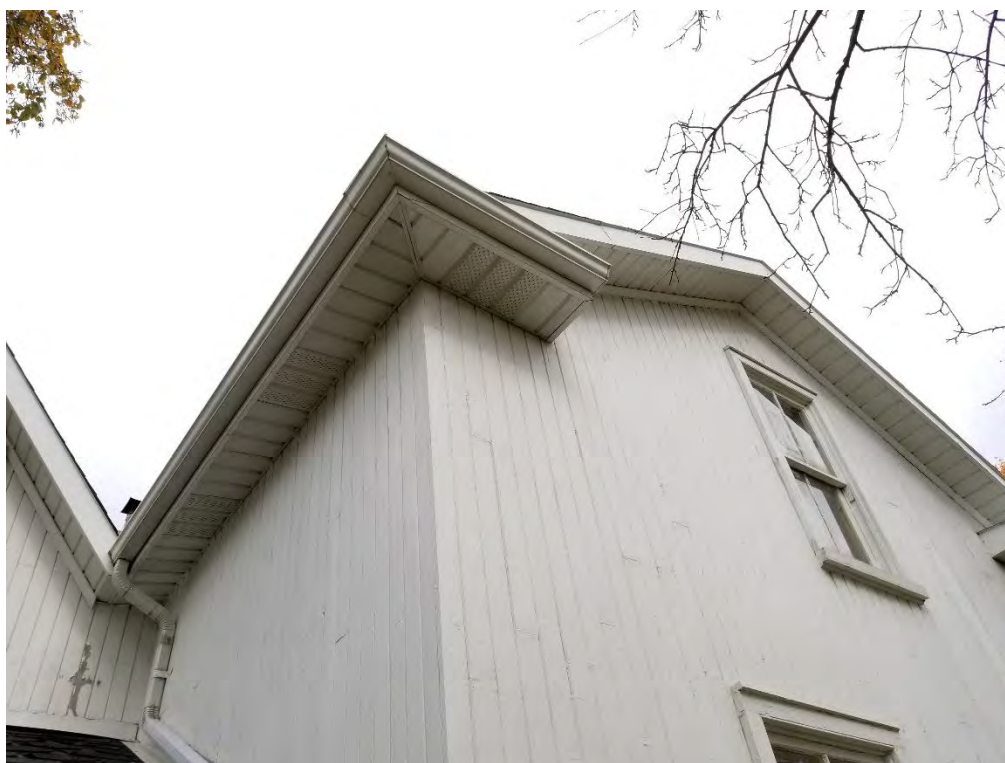
Figure 24: Soffit and fascia at the south gable of the Main Block.

Element	Observed Conditions
	<ul style="list-style-type: none"> No areas of visible damage on roof, fascia or soffits (Figure 24).
Rainwater disposal	<ul style="list-style-type: none"> All gutters and downpipes appear to be in good condition.
Walls, foundations & chimneys, exterior features	<ul style="list-style-type: none"> The fieldstone foundation does not show evidence of cracking. The concrete foundation appears to be in fair condition (Figure 14). The chimney appears to be in fair condition. Wood vertical boards are in good condition. The South Porch is in good condition.
Windows & doors	<ul style="list-style-type: none"> All wood windows appear to be in good condition. Exterior doors are in good condition.
Building services	<ul style="list-style-type: none"> All building services are operational and in good condition.
Site & environment	<ul style="list-style-type: none"> Majority of property is paved parking lot with modern structure to the rear of the building.
