APPENDIX F.1 – Arborist Report

Arborist Report

Individual Environmental Assessment of the Teston Road Area (Y.R.49) between Highway 400 and Bathurst Street (Y.R.38)

Report No. 190261800
March 14, 2023

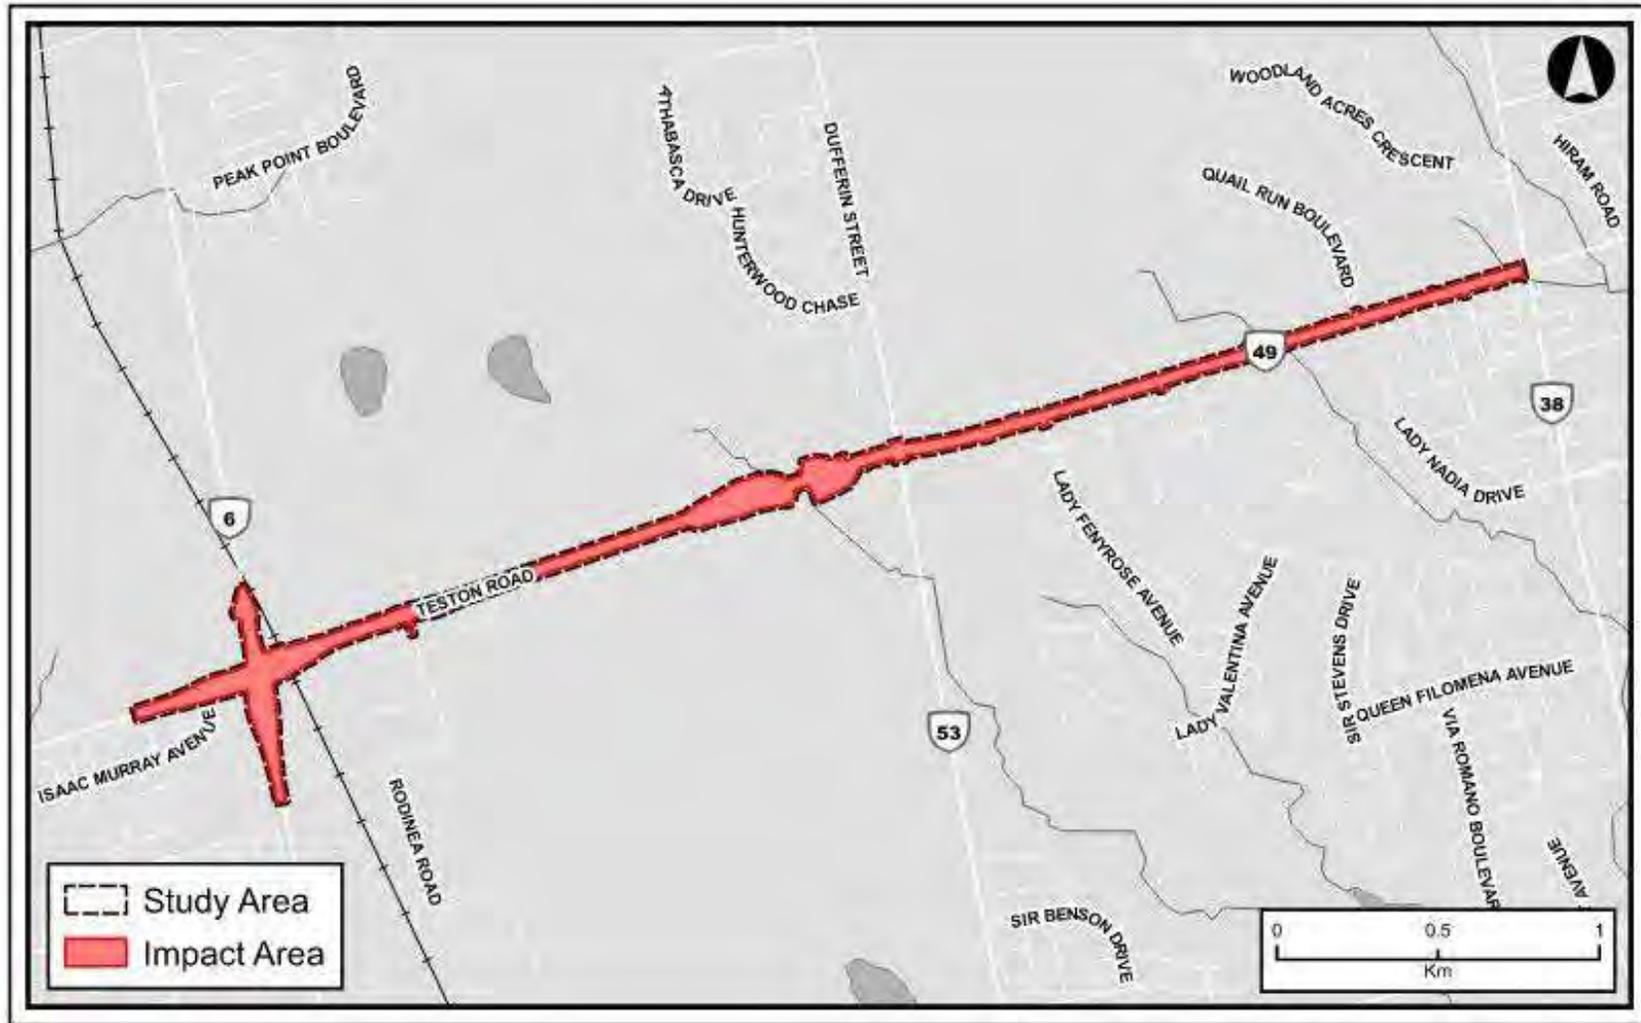
Figure 1: Key Map of the Study Area using the Preliminary Design

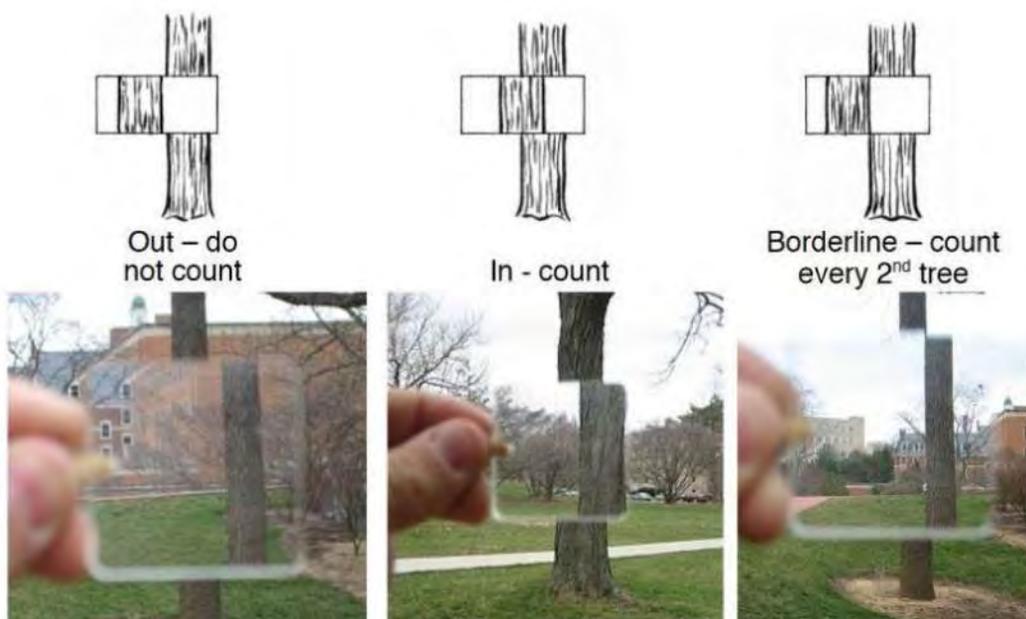
Figure 2: Identifying trees using BAF2 prism during prism sweep (University of Houston-Clear Lake, 2023)

After navigating to a prism sweep plot, an MH ISA Certified Arborist would use a BAF2 metric prism to conduct the prism sweep. When using the prism, the refraction of light through the prism causes the portion of the tree below breast-height to appear separated. For all trees who appear superimposed, as $\frac{1}{2}$ or those which touched the edge of the glass would be recorded within the survey plot. With one eye closed, the arborist would stand in the middle of the prism sweep plot holding the prism to their eye and turn in a circle, tallying each tree species that were considered 'in' the prism. **Figure 2** illustrates which trees are tallied within a prism sweep.
