# **Teston Road Area Transportation Improvements Individual Environmental Assessment**

## **Phase One Environmental Site Assessment, Property 3, Teston Road, Maple, Ontario**

Report No. 190261800

October 11, 2023

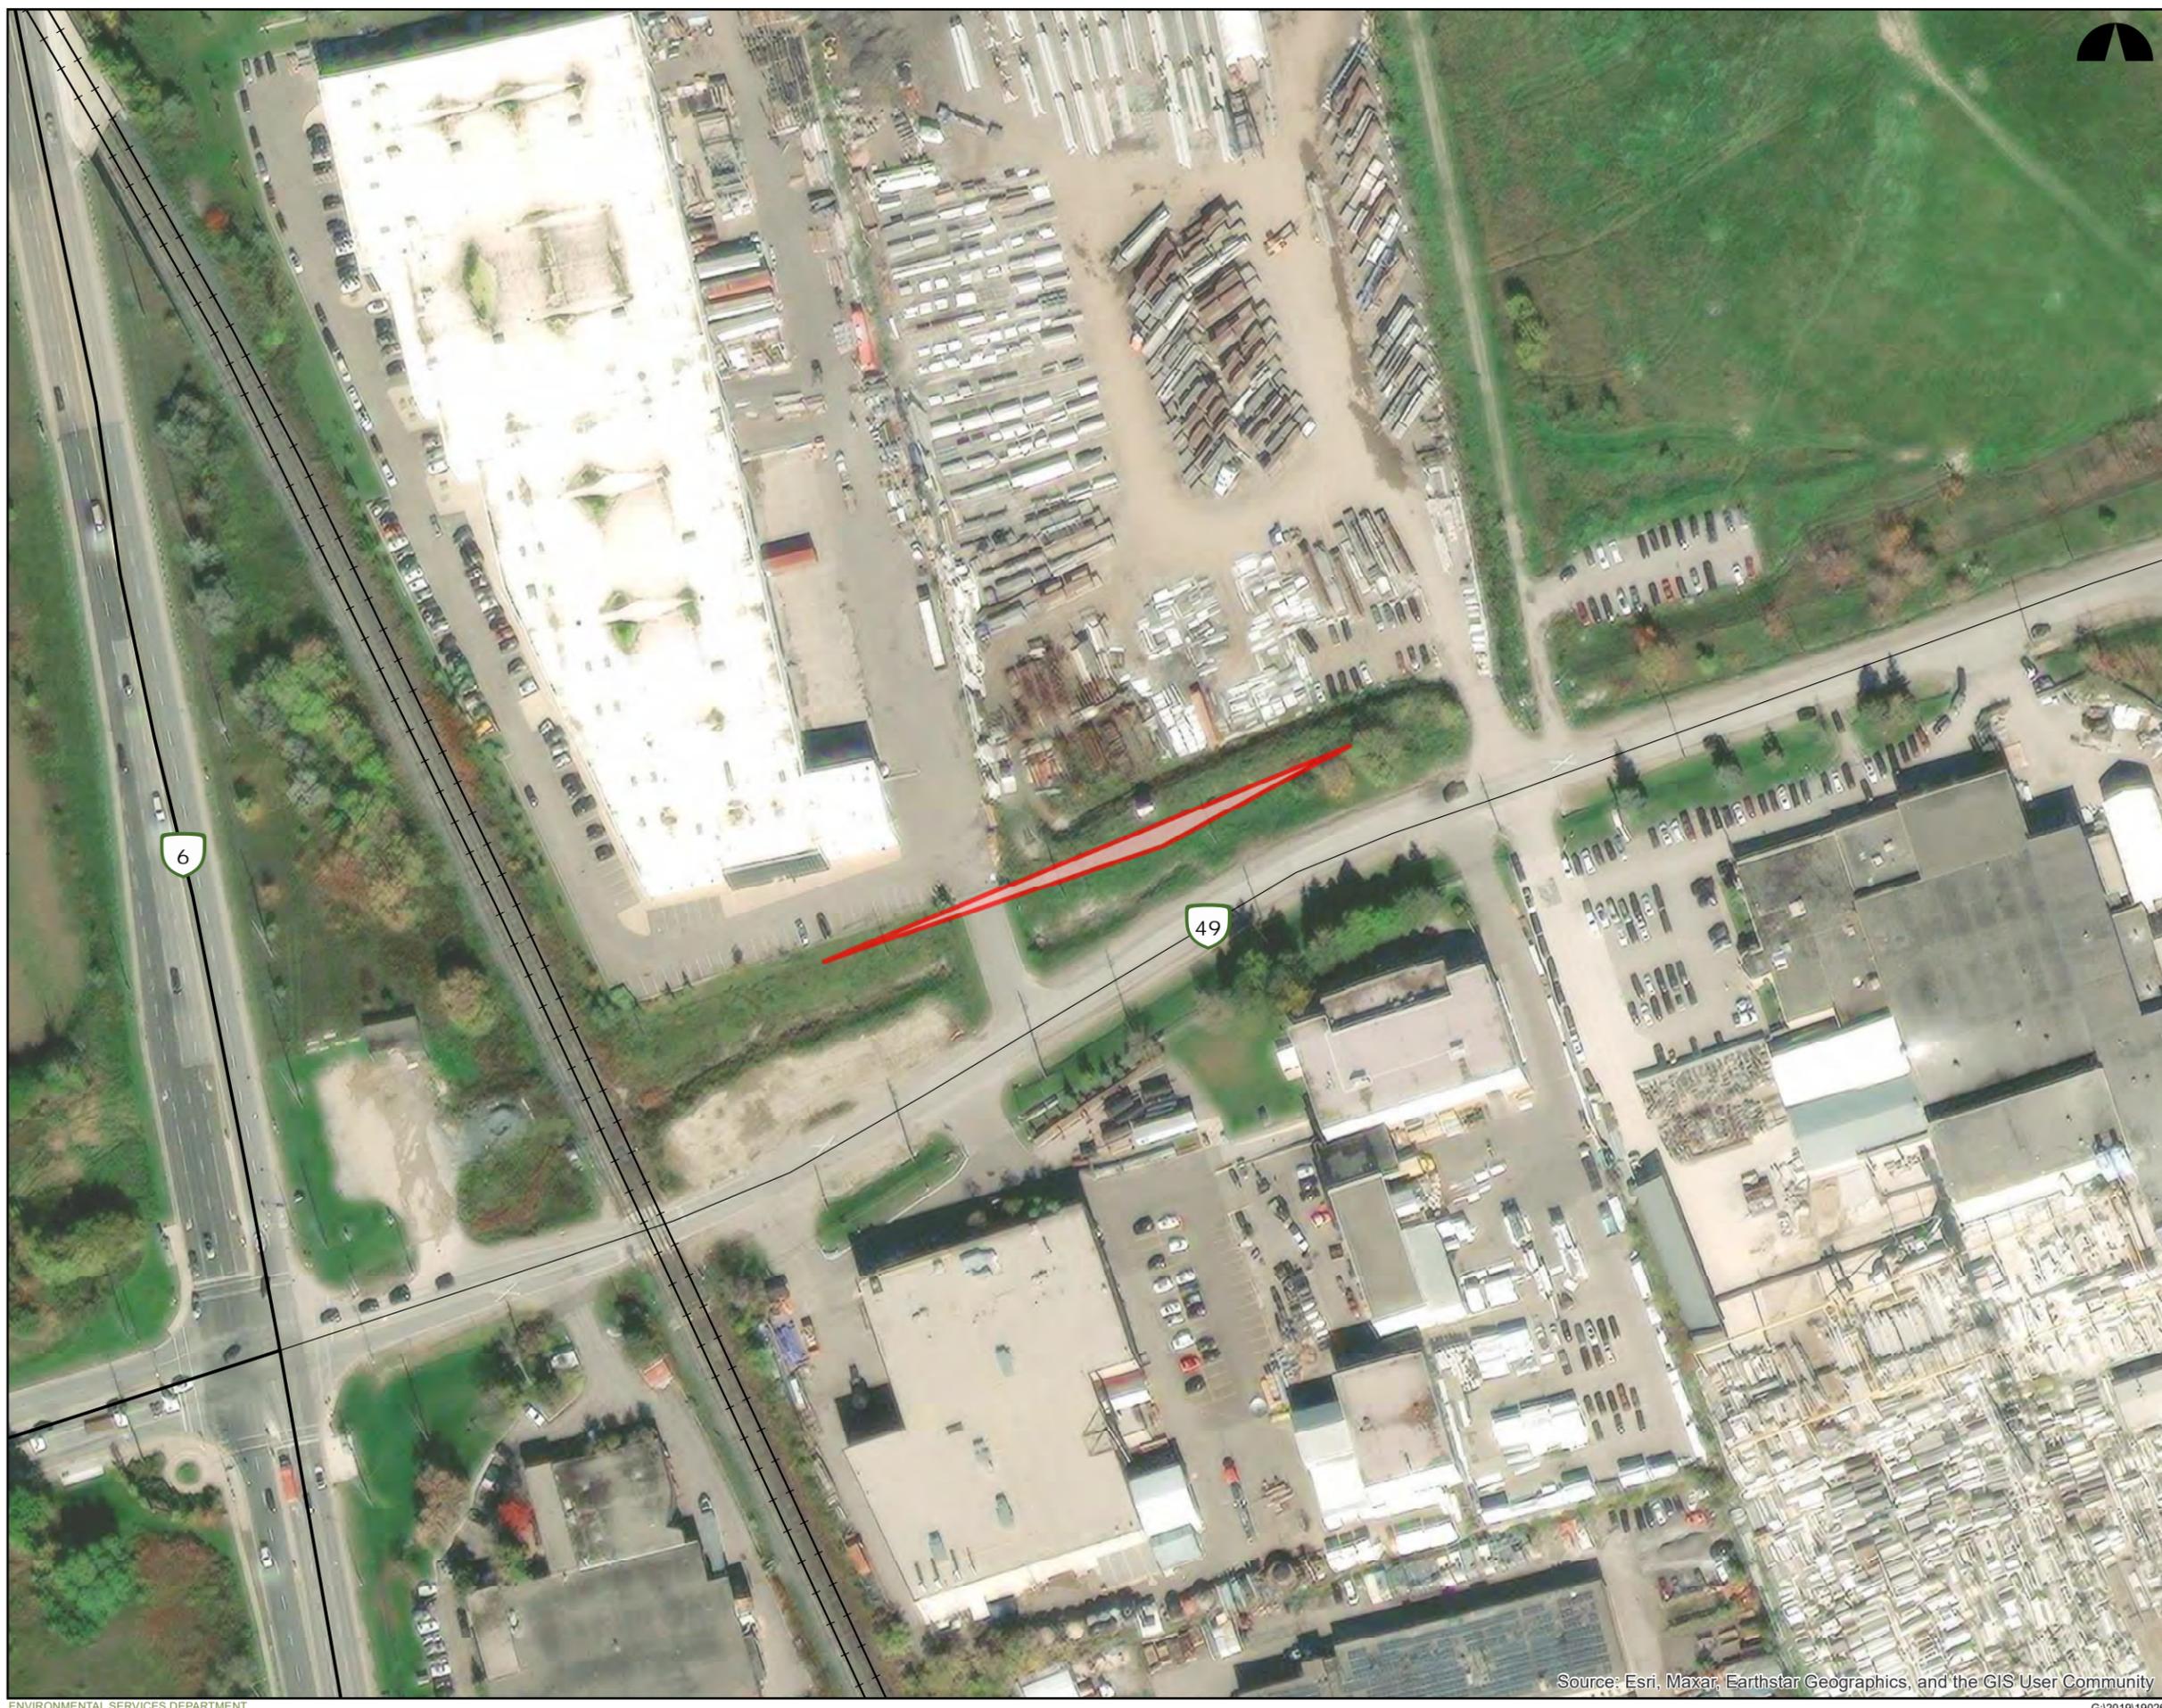
TITLE:  
**Site Layout**

The Phase One Property is an irregular shaped of land covering approximately an area of 350 square meters (m<sup>2</sup>). The Phase One Property is mostly paved with surficial soil/grass and asphalt, while the eastern portion of the Phase One Property is covered with overgrown vegetation. A small portion in the middle of the Phase One Property is paved as an asphalt driveway and is used to enter into the commercial property at 2190 Teston Road. The latter property is currently occupied by Sutong Tire Resources Inc. and is used as a tire warehouse and distribution facility. According to York Region Official Plan, Map 1A – Land Use Designation (July 2022), the Phase One Property is zoned by as Employment Area. A general location map is provided as **Figure 1** and a site plan is included as **Figure 2** in **Appendix A**.

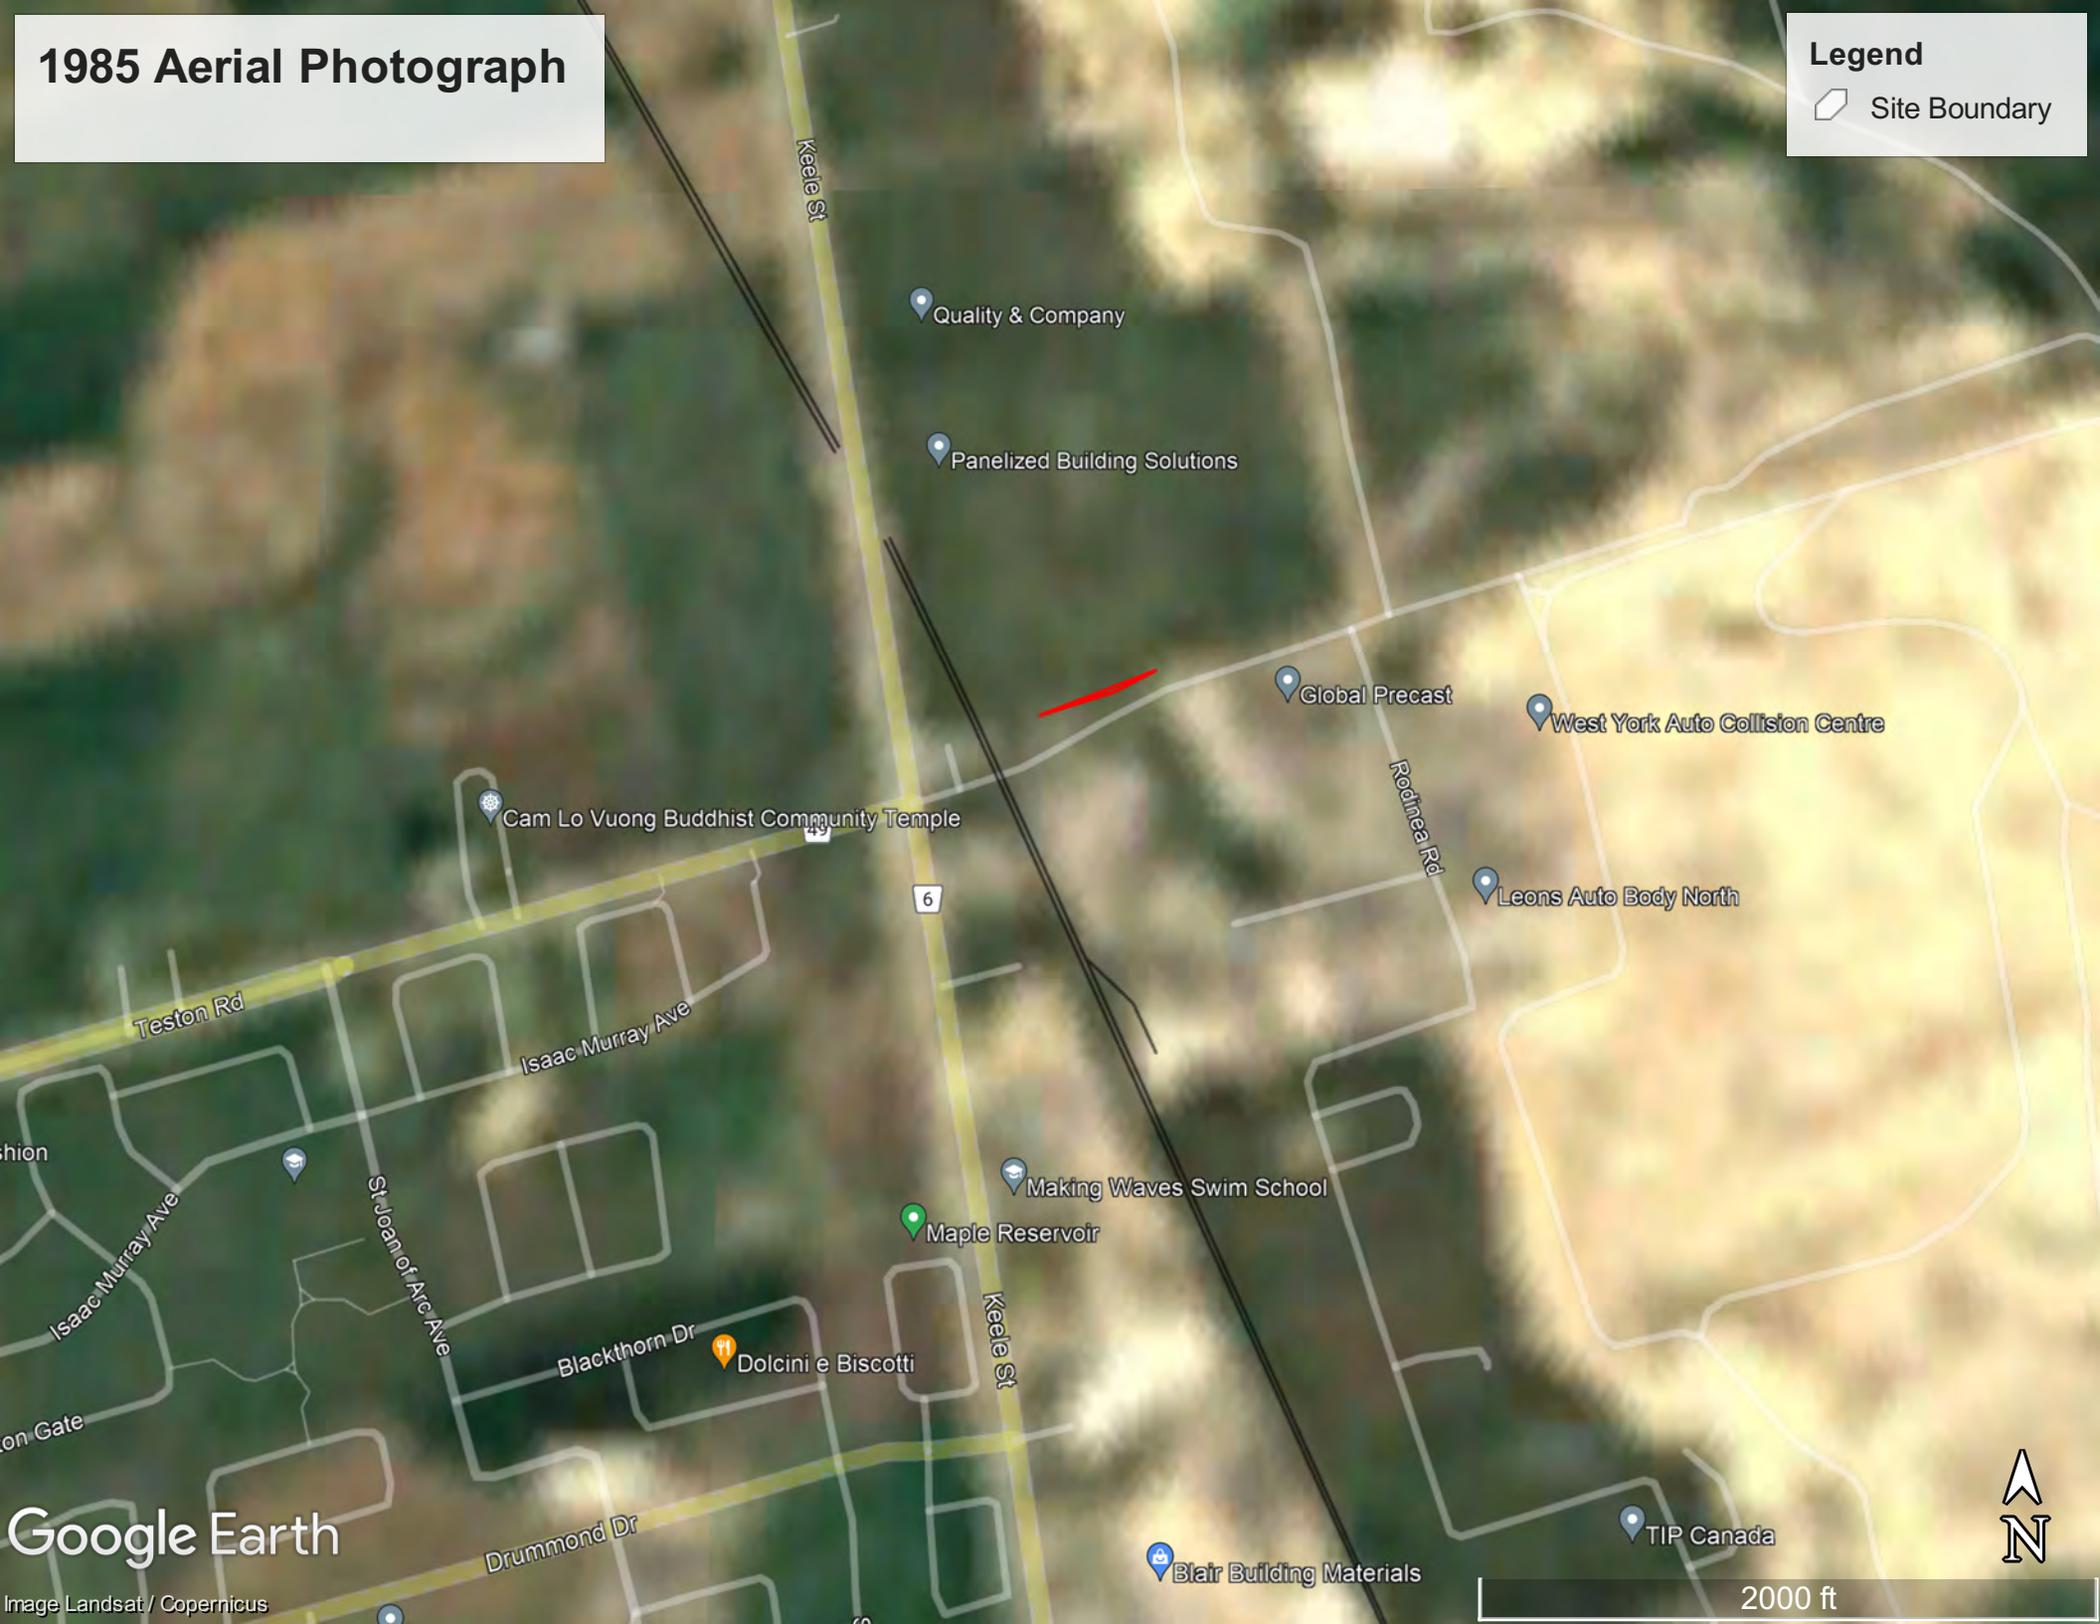
# 1985 Aerial Photograph

Year	Phase One Property	Surrounding Properties
		<b>West:</b> No significant changes noted from the previous aerial photograph.
1985	No significant changes noted from the previous aerial photograph.	<b>North:</b> No significant changes noted from the previous aerial photograph. <b>East:</b> No significant changes noted from the previous aerial photograph. <b>South:</b> Commercial properties are noted to be developed south of the Phase One Property, across the Teston Road. <b>West:</b> No significant changes noted from the previous aerial photograph.
2002	Soil disturbance is noted at the Phase One Property.	<b>North:</b> Soil disturbance is noted north of the Phase One Property. Residential house north of the Phase One Property has been demolished. <b>East:</b> The property appears to be vacant land. <b>South:</b> No significant changes noted from the previous aerial photograph. <b>West:</b> A commercial property is developed across the railway line.

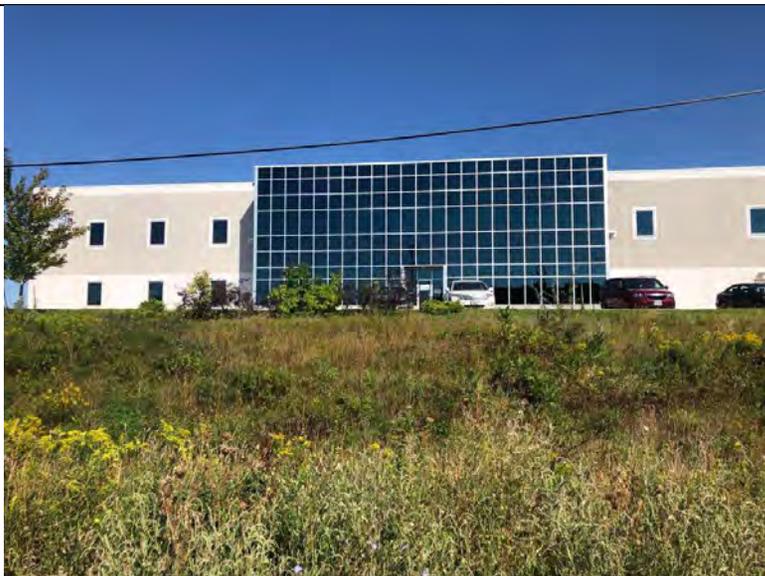
Photo 1: View of the Site and north adjacent property, facing north

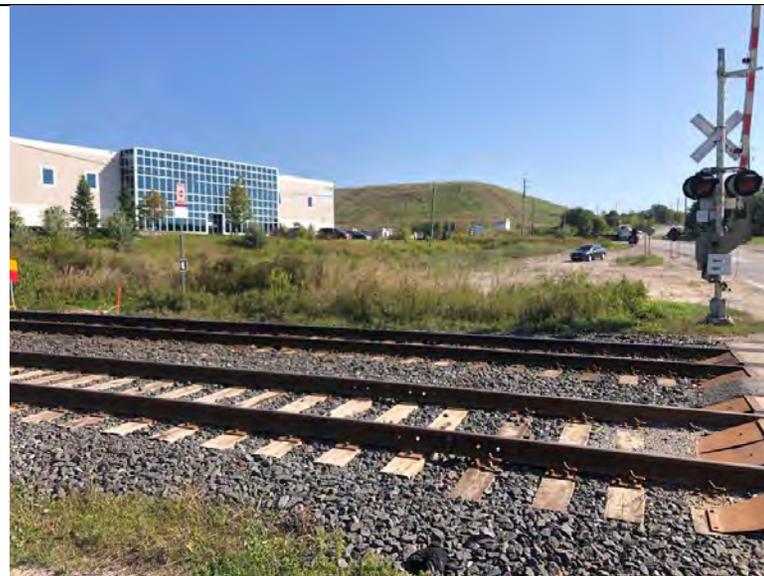
Photo 2: View of the Site and the west adjacent railway tracks, facing east-northeast

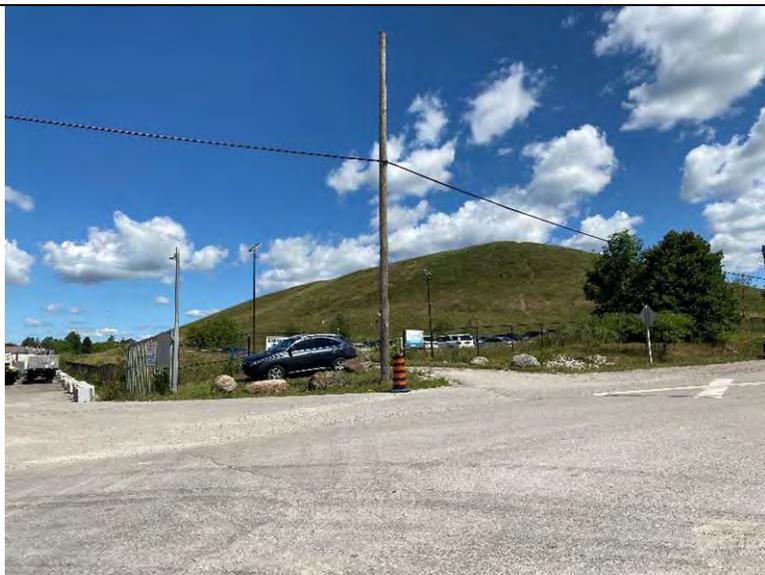
- **PCA#58: Waste Disposal and Waste Management, including thermal treatment, landfilling and transfer of waste, other than use of biosoils as soil conditioners**, based on the private landfill occupied by Disposal Services Landfill, located 50 m east of the Phase One Property.

Photo 5: View of the private landfill located farther east of the Site, facing northwest

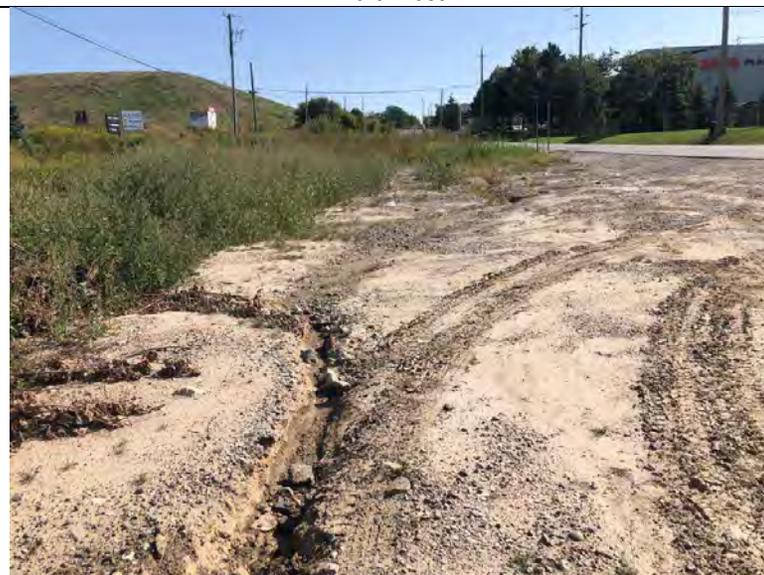
The Phase One Property was inspected for areas of stained soil, vegetation or pavement; areas of stressed vegetation; areas of placed fill or debris; potentially contaminating activities; and unidentified substances. No stained soil, signs of dumping, or stressed vegetation was observed.

Photo 8: Typical ground surface on and around the Site
