FINAL REPORT

Teston Road Area Transportation Improvements Individual Environmental Assessment

Phase One Environmental Site Assessment, Property 8, Teston Road, Maple, Ontario

Report No. 190261800

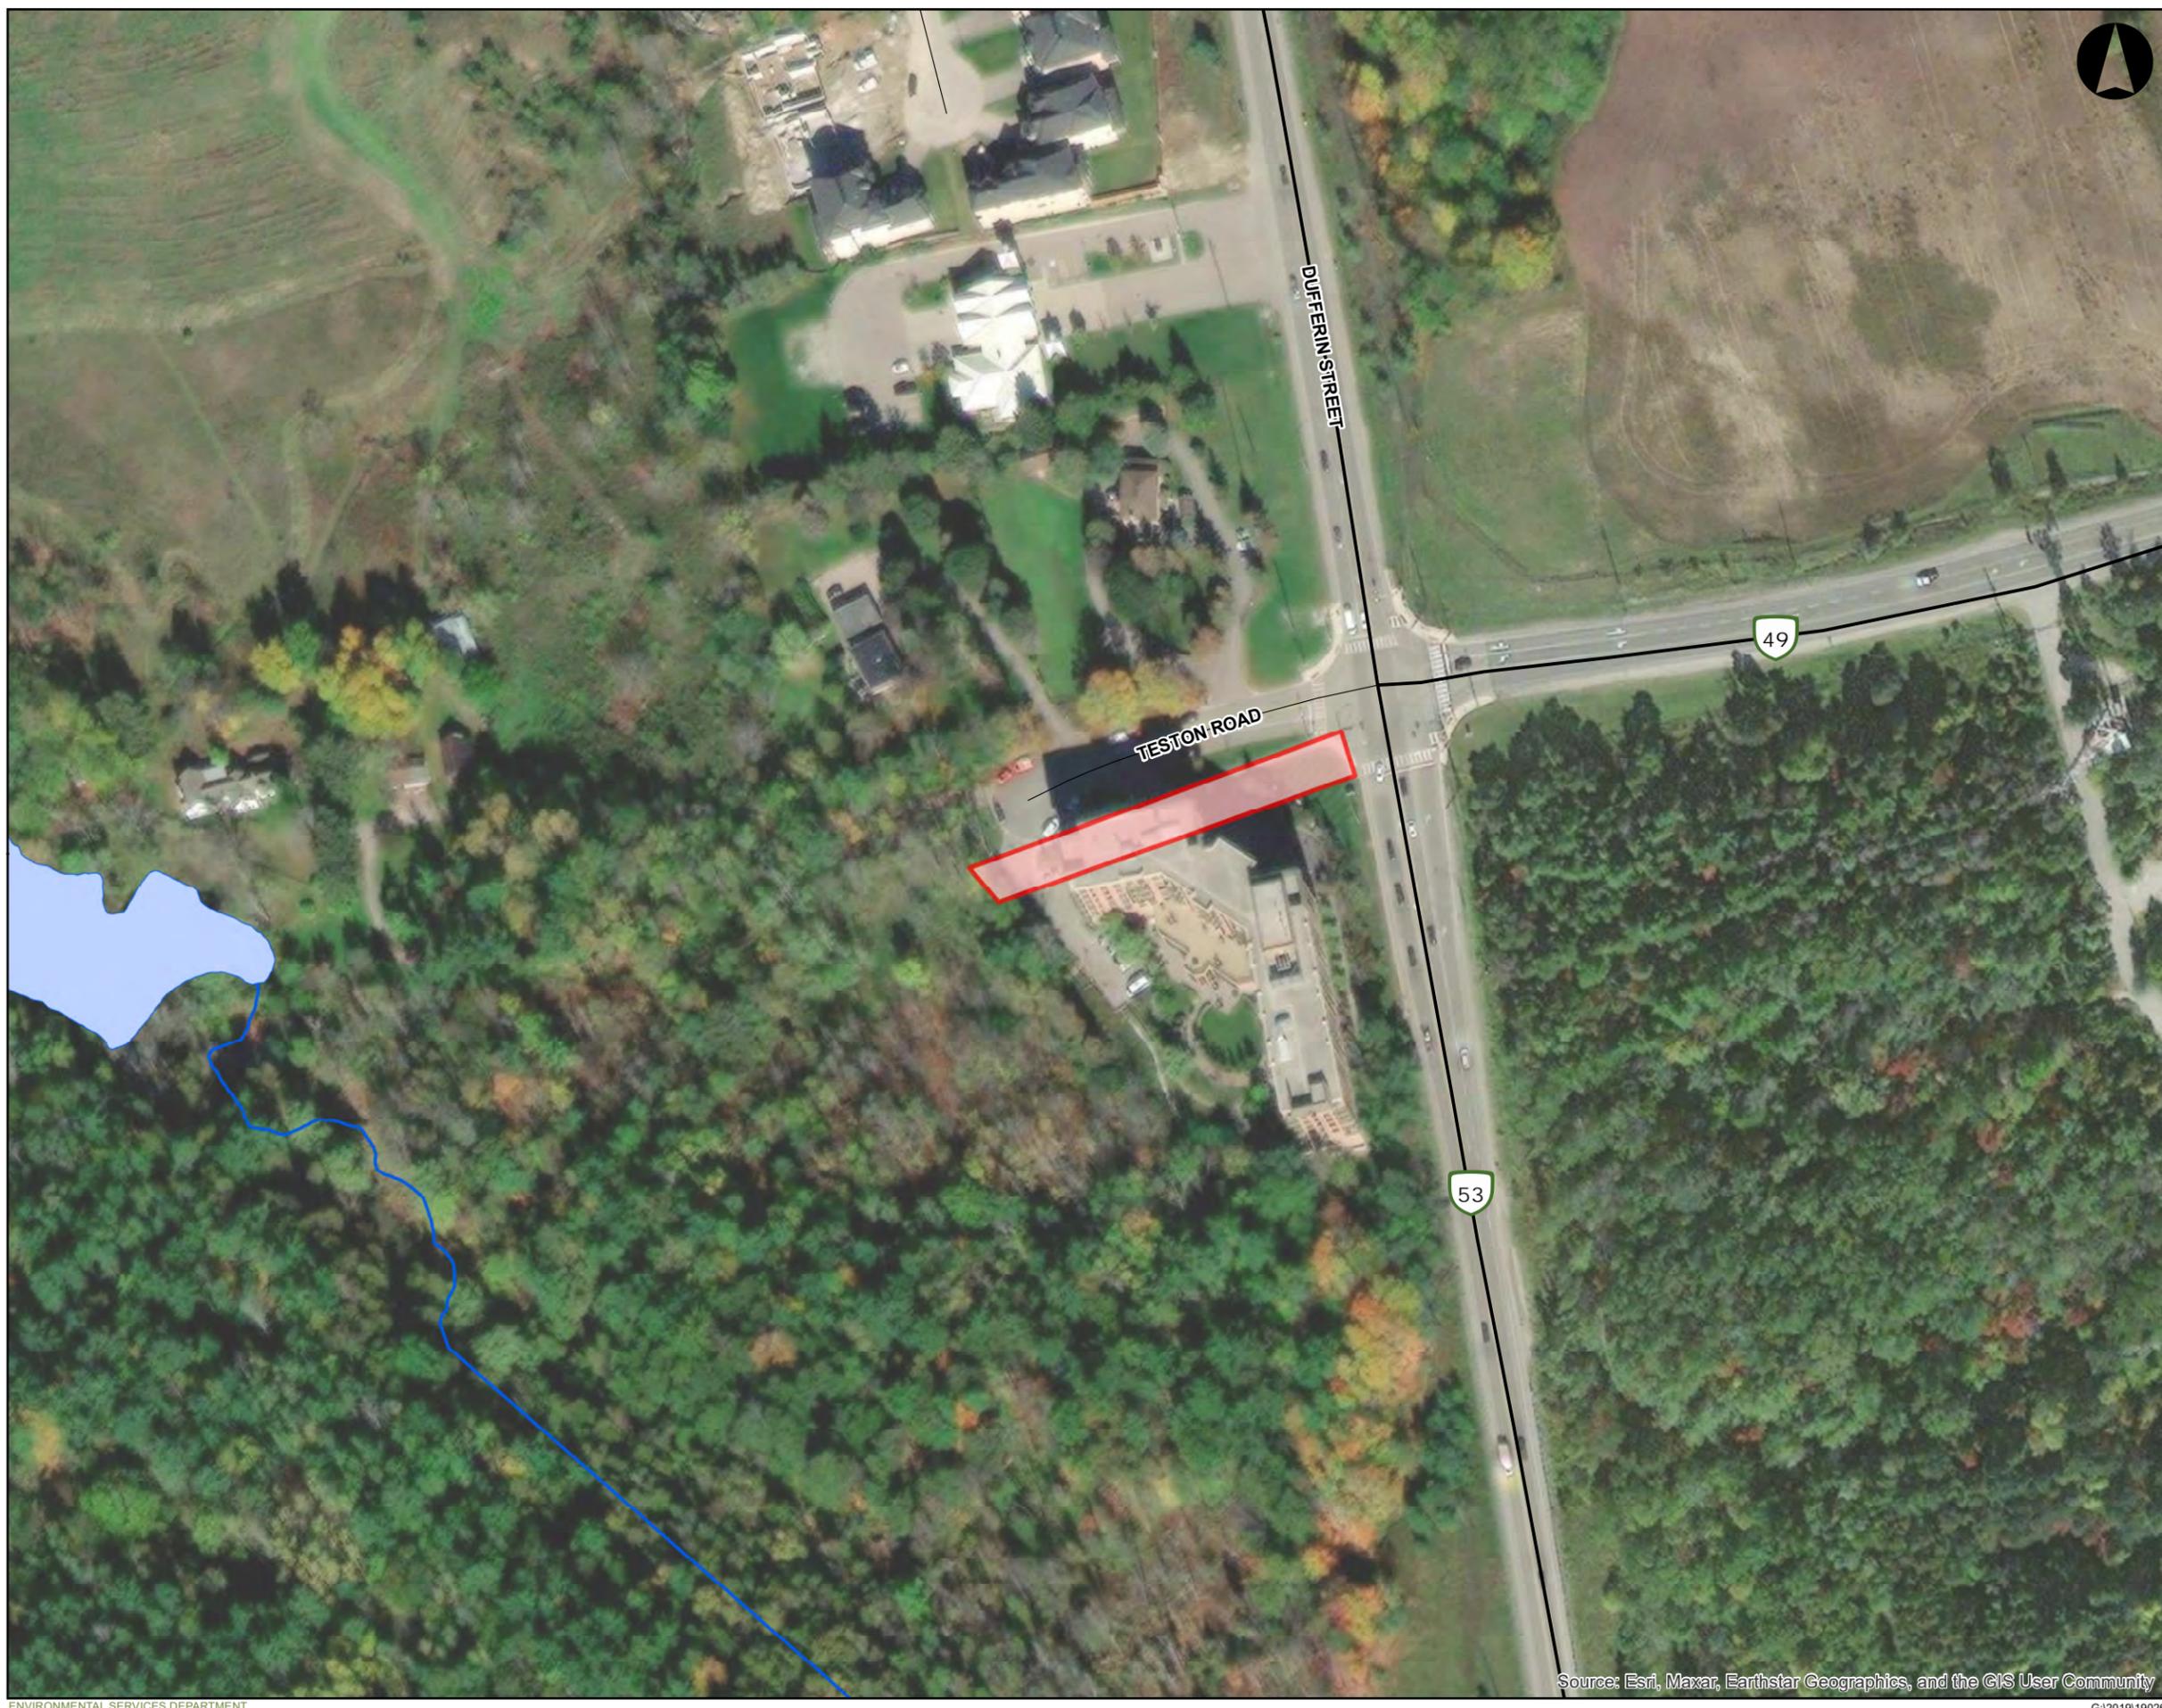
DATE: **March 2023** **Figure 2**

A general location map is provided as **Figure 1** and a site plan is included as **Figure 2** in **Appendix A**. The selected photographs of the Phase One Property are included in **Appendix G**.

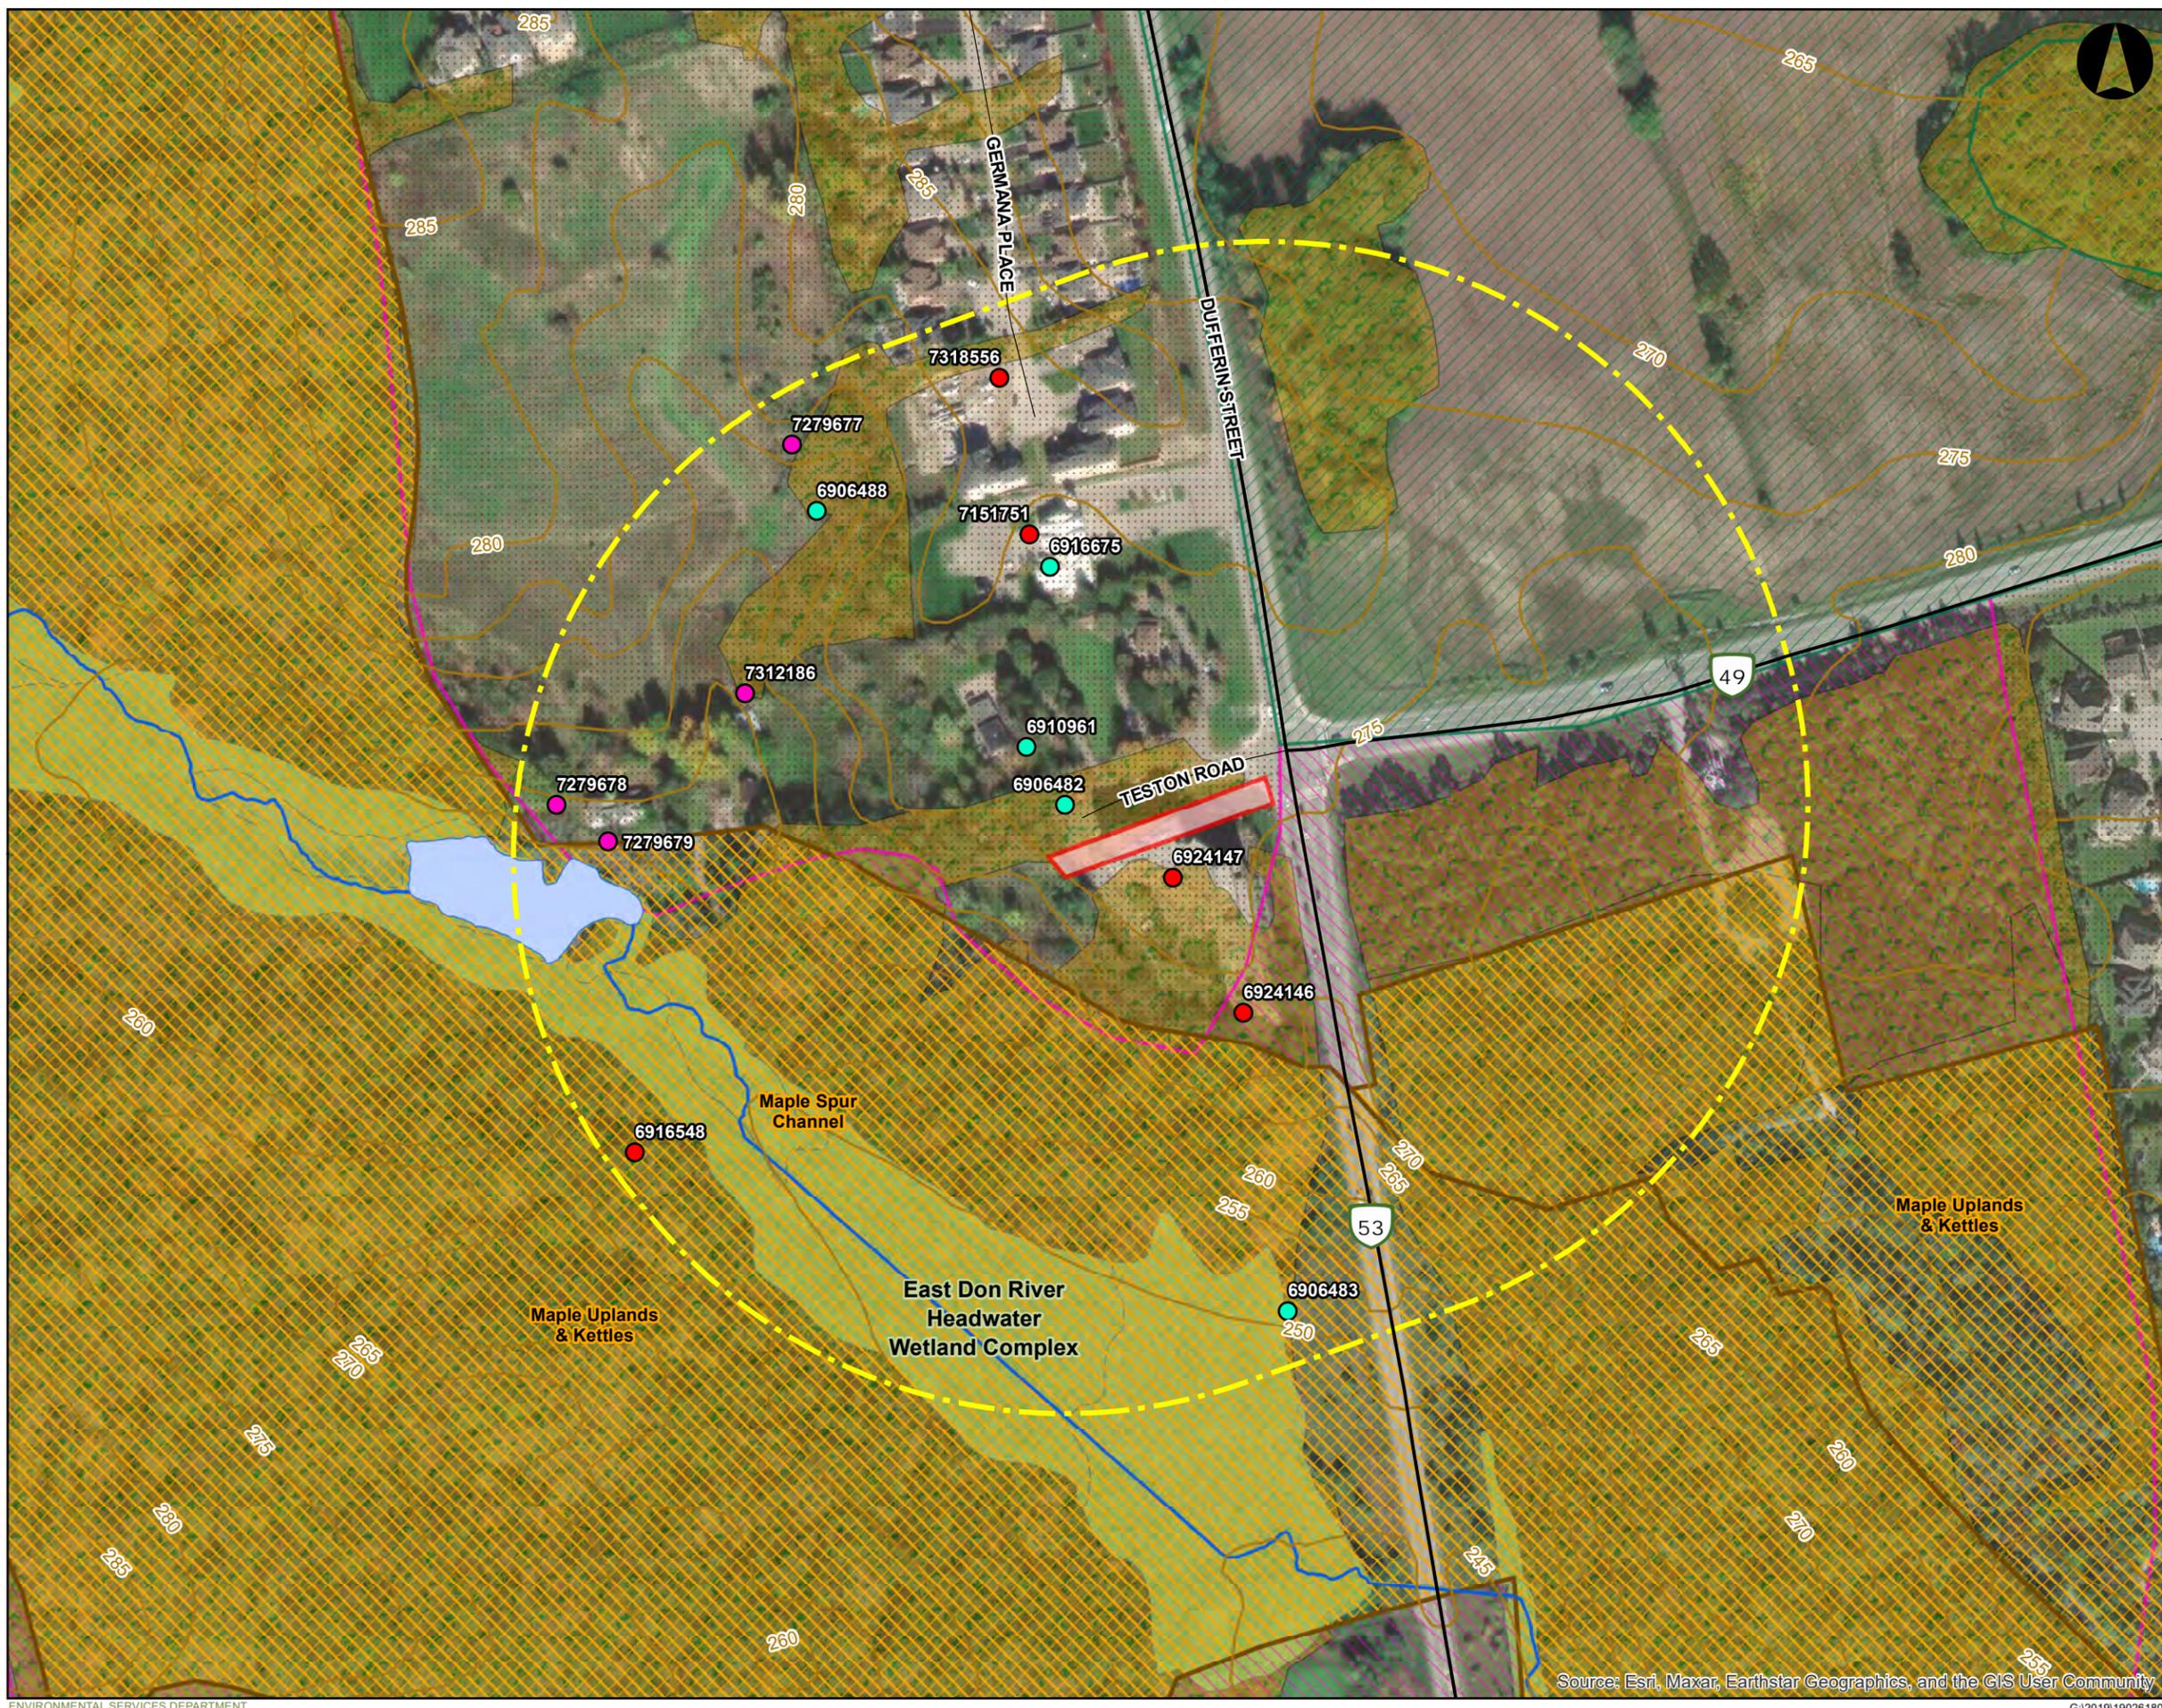
DATE: **March 2023** **Figure 3**

The Phase One Study Area comprises the Phase One Property and surrounding properties wholly or partly within 250 meters (m) of the property boundaries as shown on **Figure 3** in **Appendix A**. The 250 m radius was used to gain an understanding of the current and past uses of surrounding properties to determine whether such uses may have contributed to subsurface environmental impacts at the Phase One Property.

The WWIS locations are shown on **Figure 3 in Appendix A**. It should be noted that the margin of error for the location of these well records ranges from 100 to 300 metres.

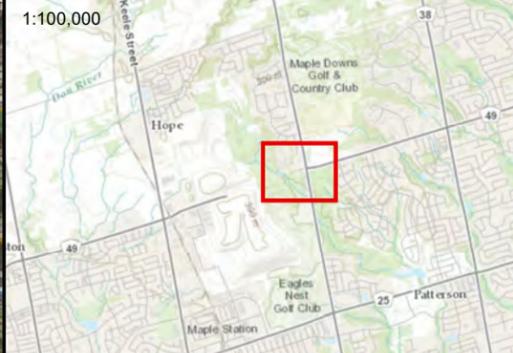
The Phase One Property is at an elevation of approximately 265 metres above sea level (mASL) (Toporama). The elevation of the Phase One Study Area to the east of the Phase One Property is 275 mASL and Phase One Study Area to the west drops to 253 mASL at the nearest surface water body. The nearest waterbody is a tributary of Don River East Branch running from northwest to southwest of the Phase One Property, located approximately 200 m west of the Phase One Property. Based on topographic maps, the direction of regional groundwater flow is to the west towards Don River East Branch. However, underground features such as utility corridors may locally influence groundwater flow. The actual groundwater flow direction and depth at the Phase One Property cannot be determined without site-specific groundwater monitoring well data. **Figure 3** presents the topographic details.

The Phase One Conceptual Site Model (CSM) was compiled from the information provided in **Table 5** and information shown on **Figure 1** through **Figure 4**. A site location plan providing the names of roadways within the Phase One Study Area and showing adjacent properties is provided as **Figure 3**.

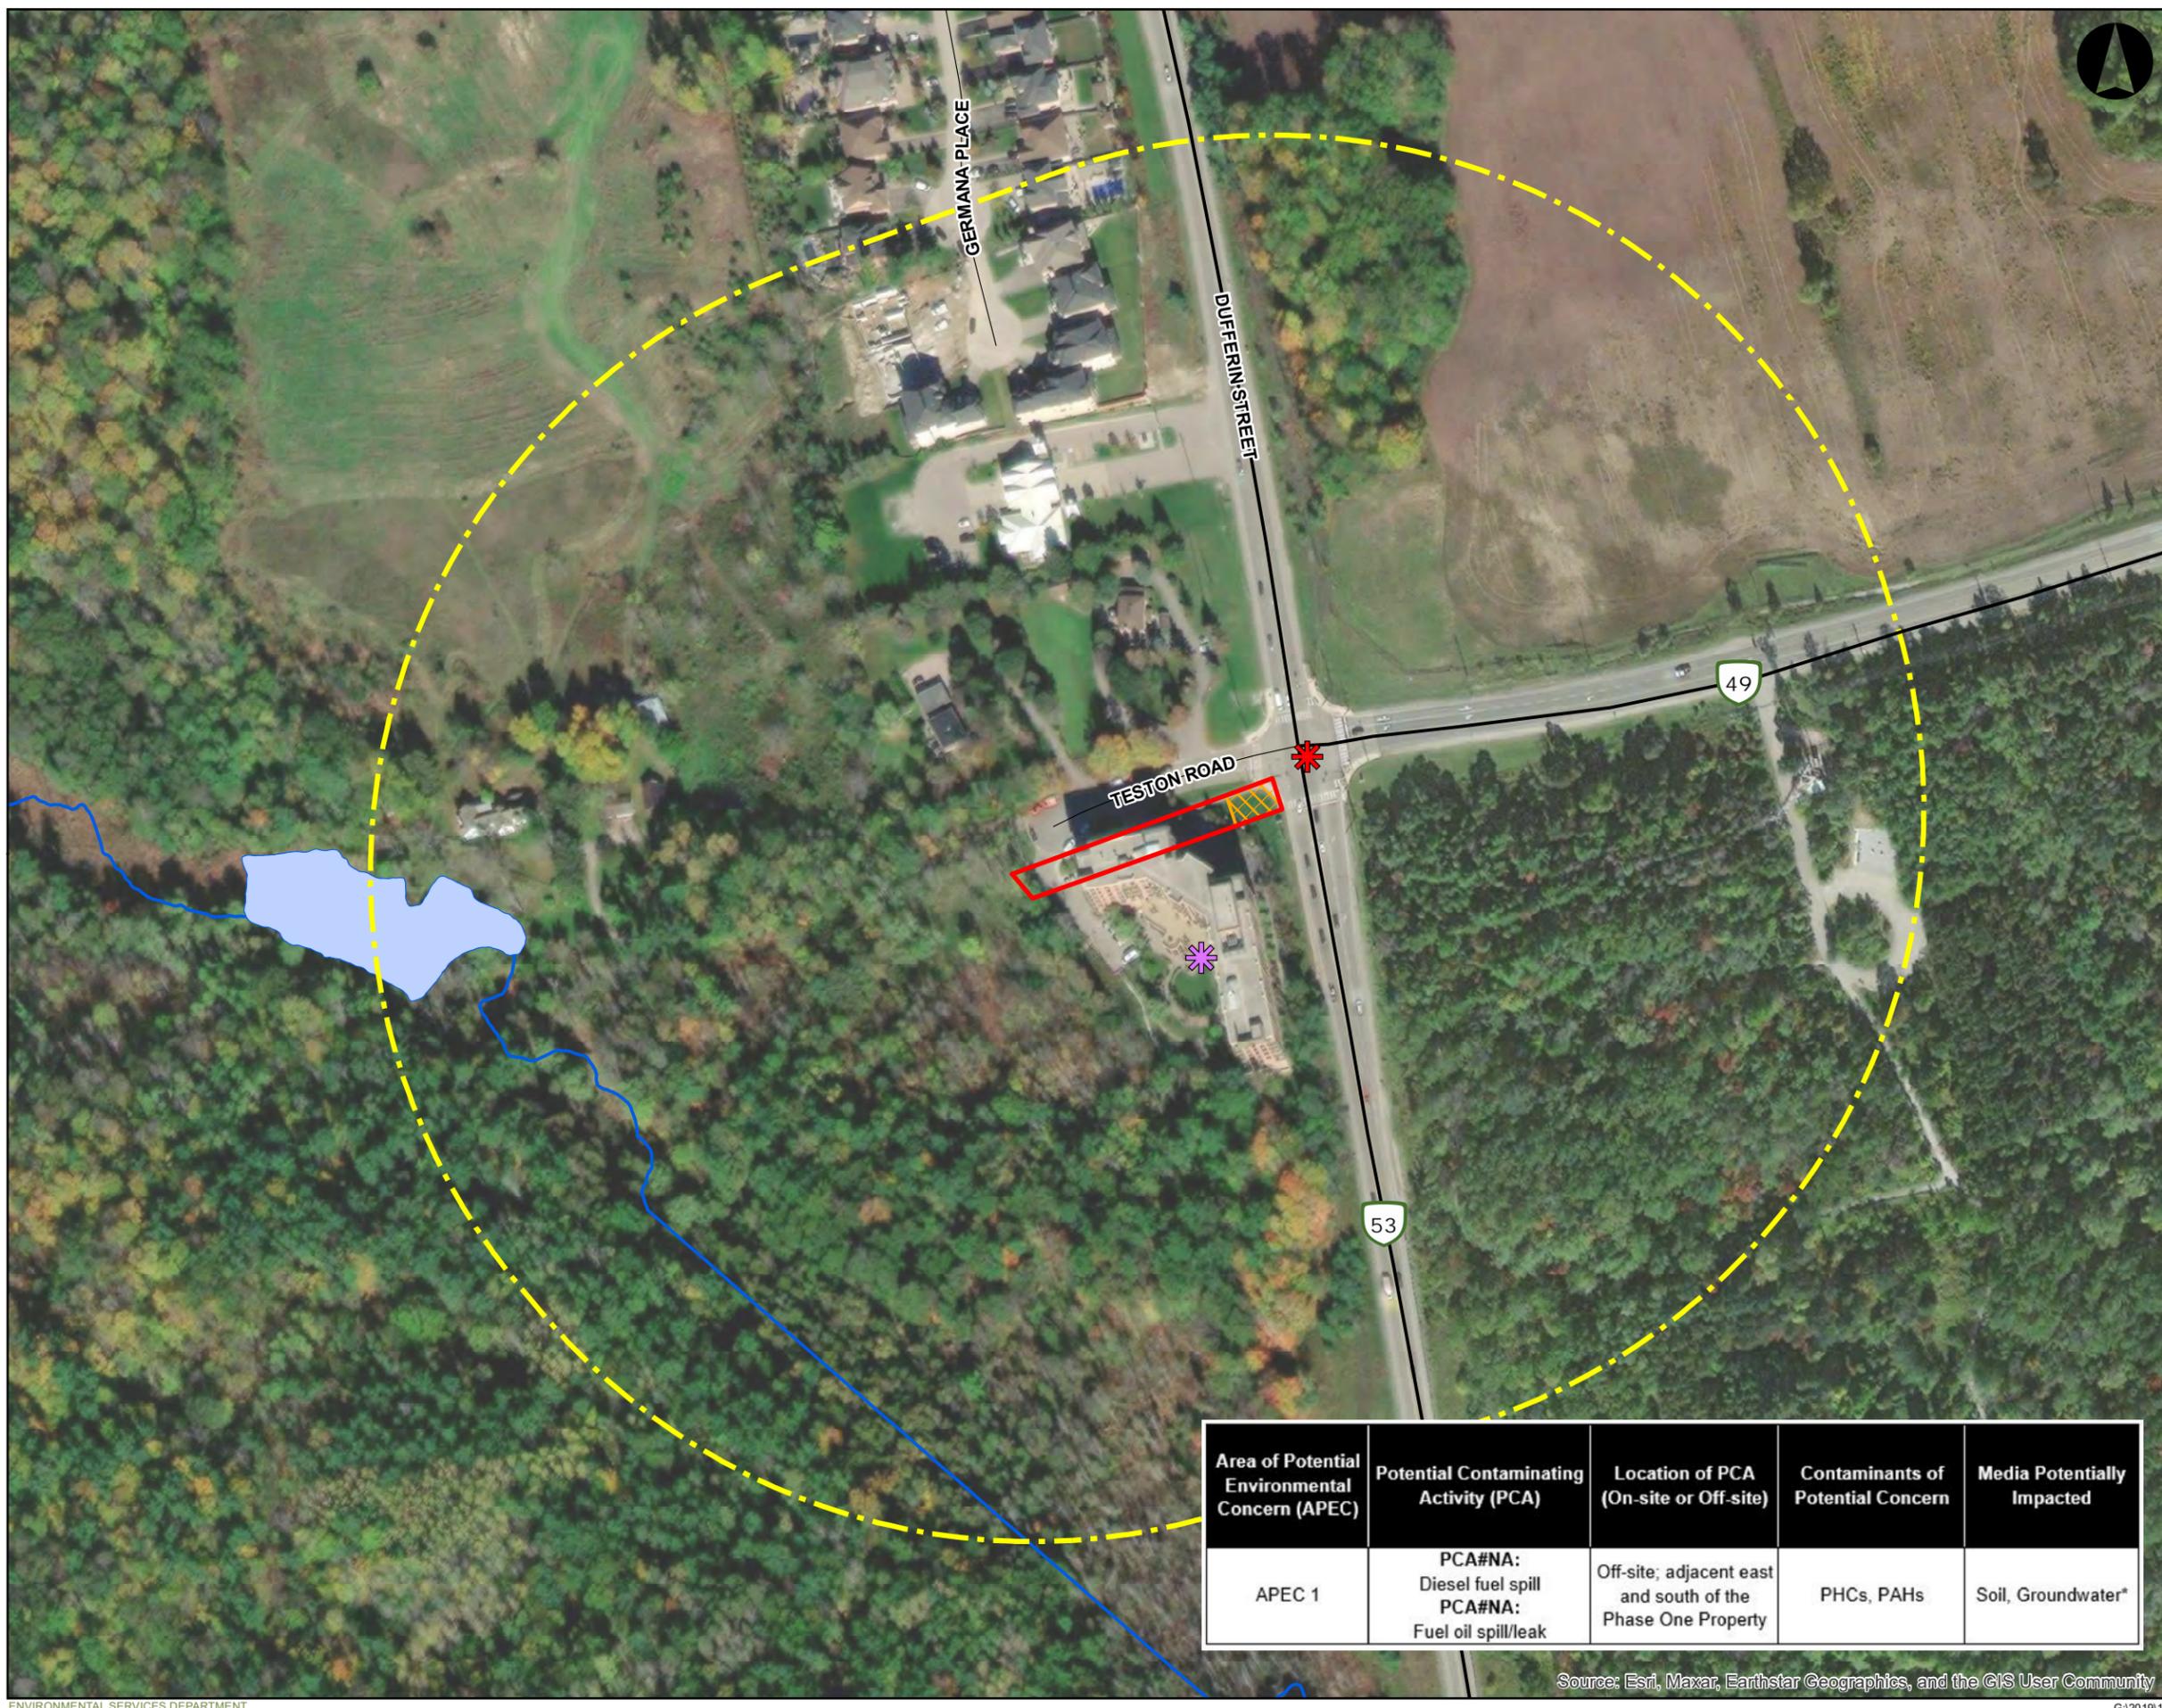
- LEGEND**
- Site Boundaries
 - Phase One Study Area (250 m)
 - APEC 1
- Potentially Contaminating Activities**
- * PCA#NA - Diesel Fuel Spill
 - * PCA#NA - Fuel Oil Spill/Leak
- Land Information Ontario Data**
- Watercourses
 - Waterbodies
- Transportation Network**
- Arterial / Collector
 - Local Roads

Area of Potential Environmental Concern (APEC)	Potential Contaminating Activity (PCA)	Location of PCA (On-site or Off-site)	Contaminants of Potential Concern	Media Potentially Impacted
APEC 1	PCA#NA: Diesel fuel spill PCA#NA: Fuel oil spill/leak	Off-site; adjacent east and south of the Phase One Property	PHCs, PAHs	Soil, Groundwater*

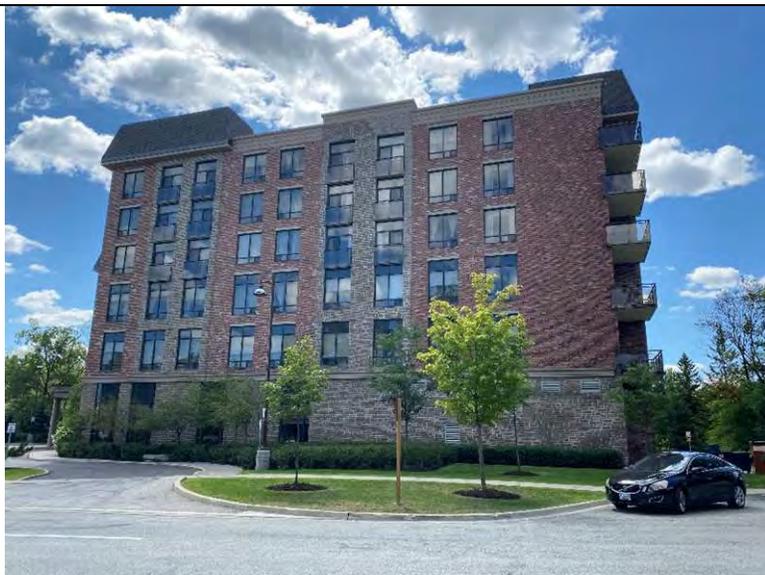
Photo 1: View of the Site facing south-southeast

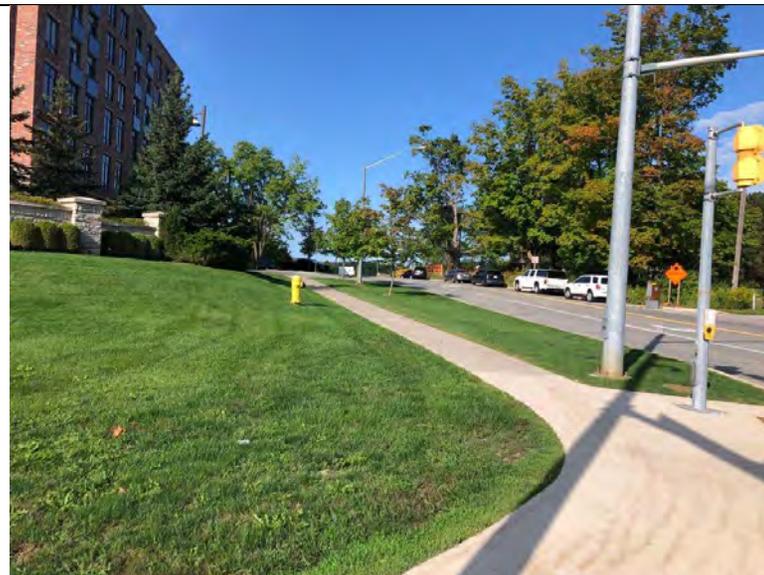
Photo 2: View of the Site facing west

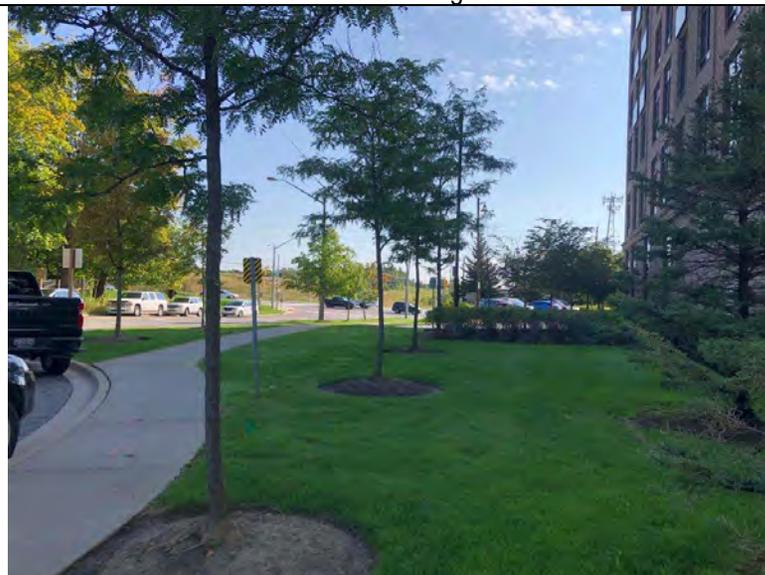
Photo 3: View of the Site, facing east
