Teston Road Area Transportation Improvements Individual Environmental Assessment

Contamination Overview Study

Report No. 1902618.00

October 29, 2025

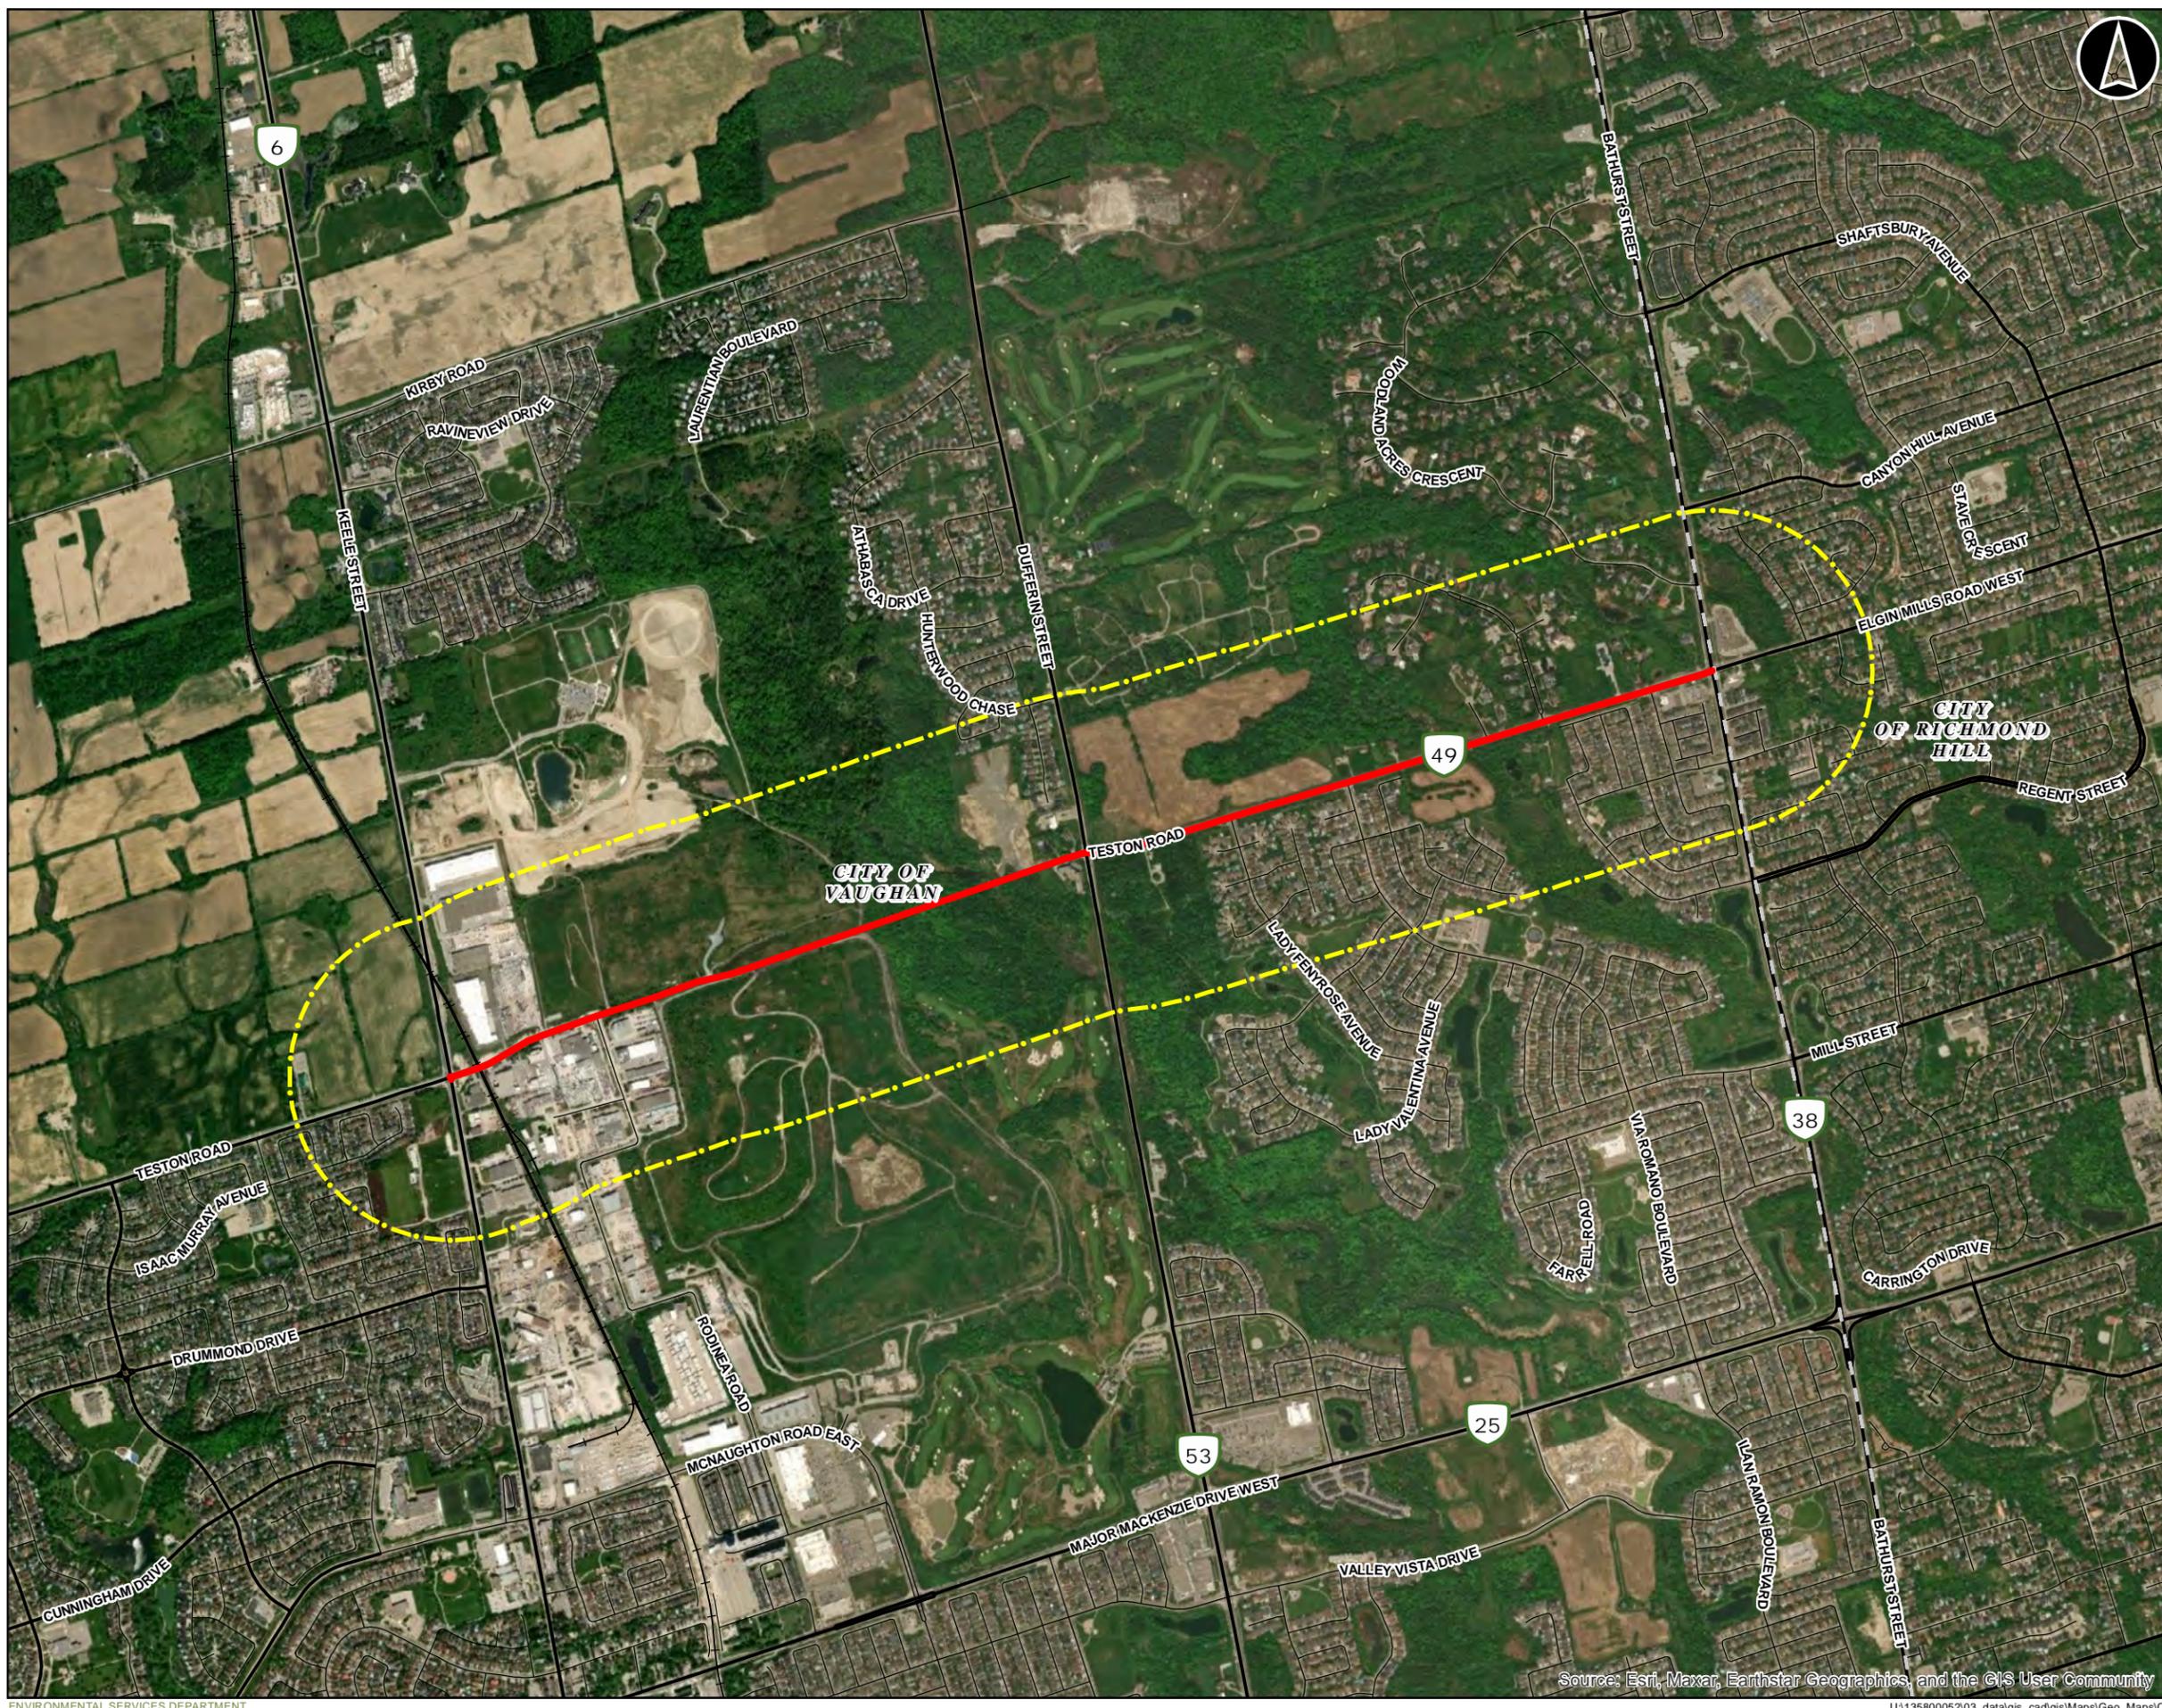
DATE: January 2025 **Figure 1**

The Study Area includes the surrounding areas within a 500 meter (m) buffer around the Subject Property. A locality plan is provided as **Figure 1** in **Appendix B**.

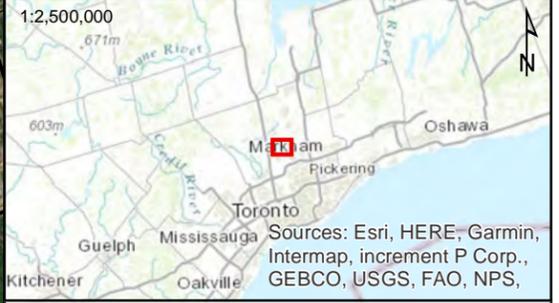
- LEGEND**
- Subject Property
 - - - Environmental Study Area (500 m Buffer)
 - Municipal Boundaries
- Transportation Network**
- Arterial / Collector
 - Local Roads
 - Railway

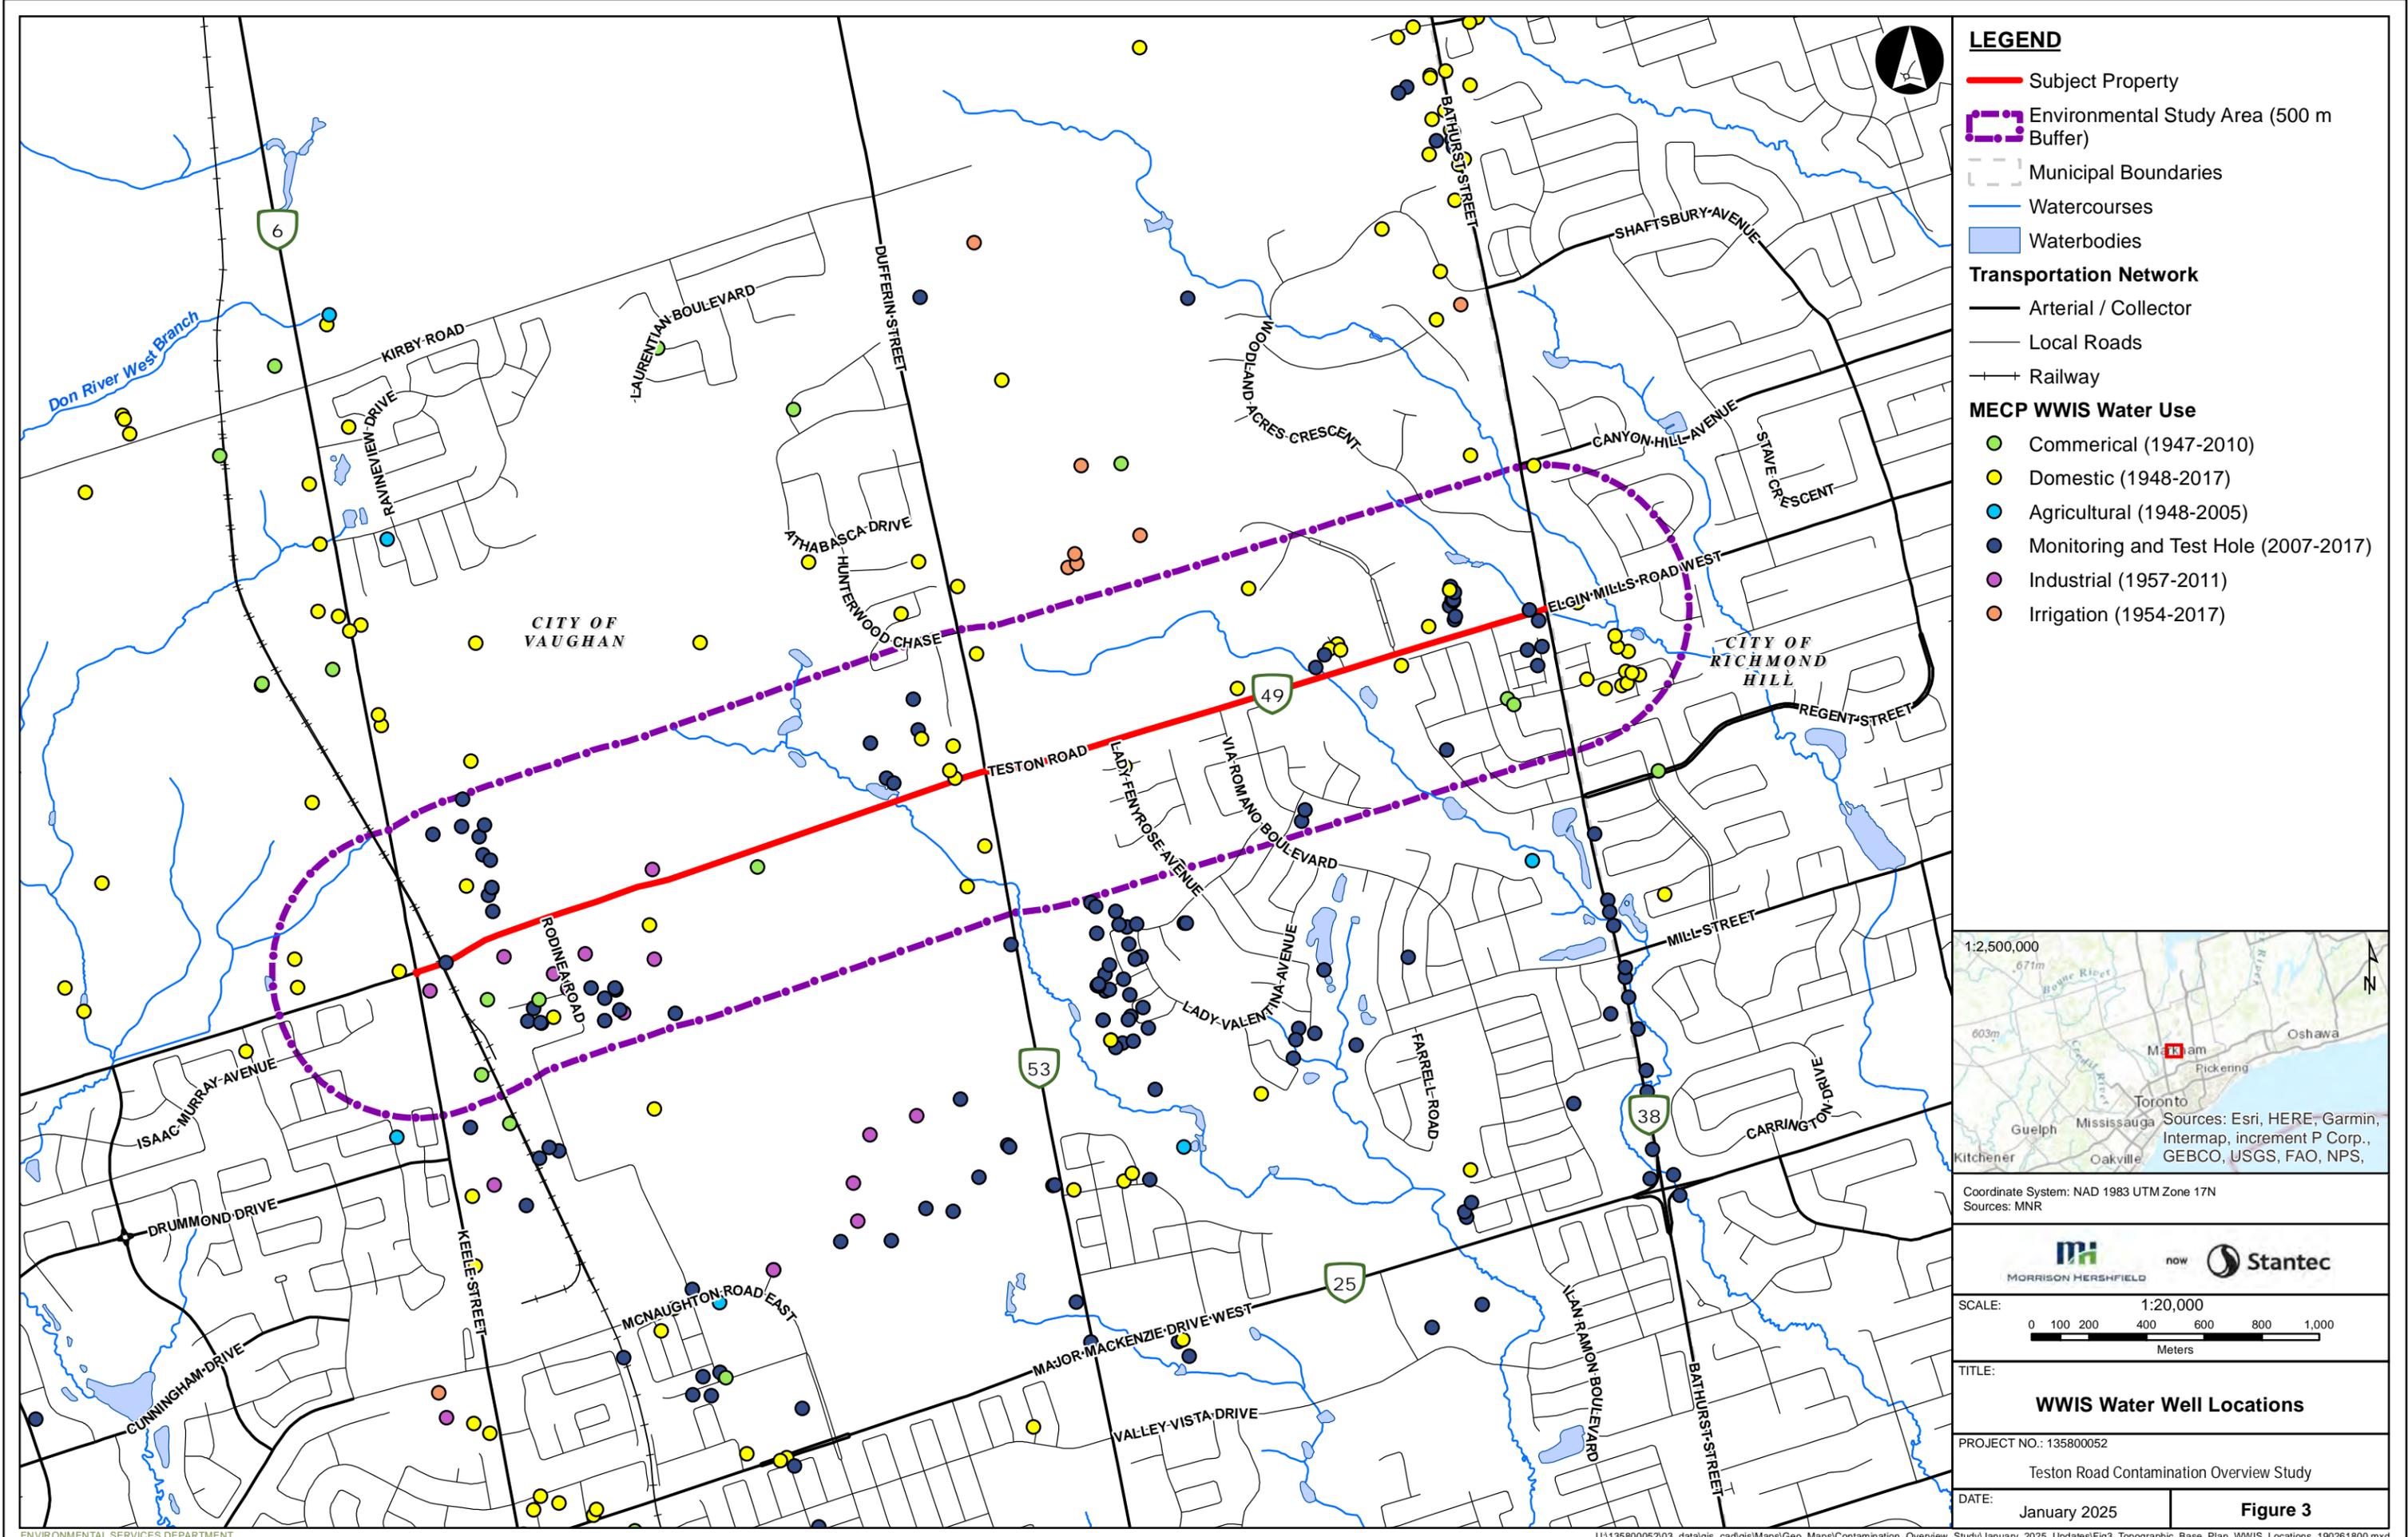
DATE: January 2025 **Figure 3**

The map of MECP water well locations is provided on **Figure 3** in **Appendix B**. It is noted that the margin of error of the locations of MECP well records ranges from 100 to 300 meters.

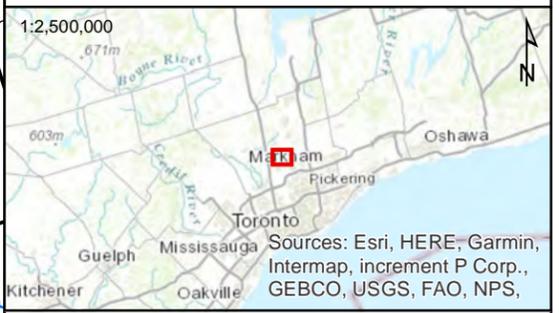
MECP WWIS Water Use

- Commercial (1947-2010)
- Domestic (1948-2017)
- Agricultural (1948-2005)
- Monitoring and Test Hole (2007-2017)
- Industrial (1957-2011)
- Irrigation (1954-2017)

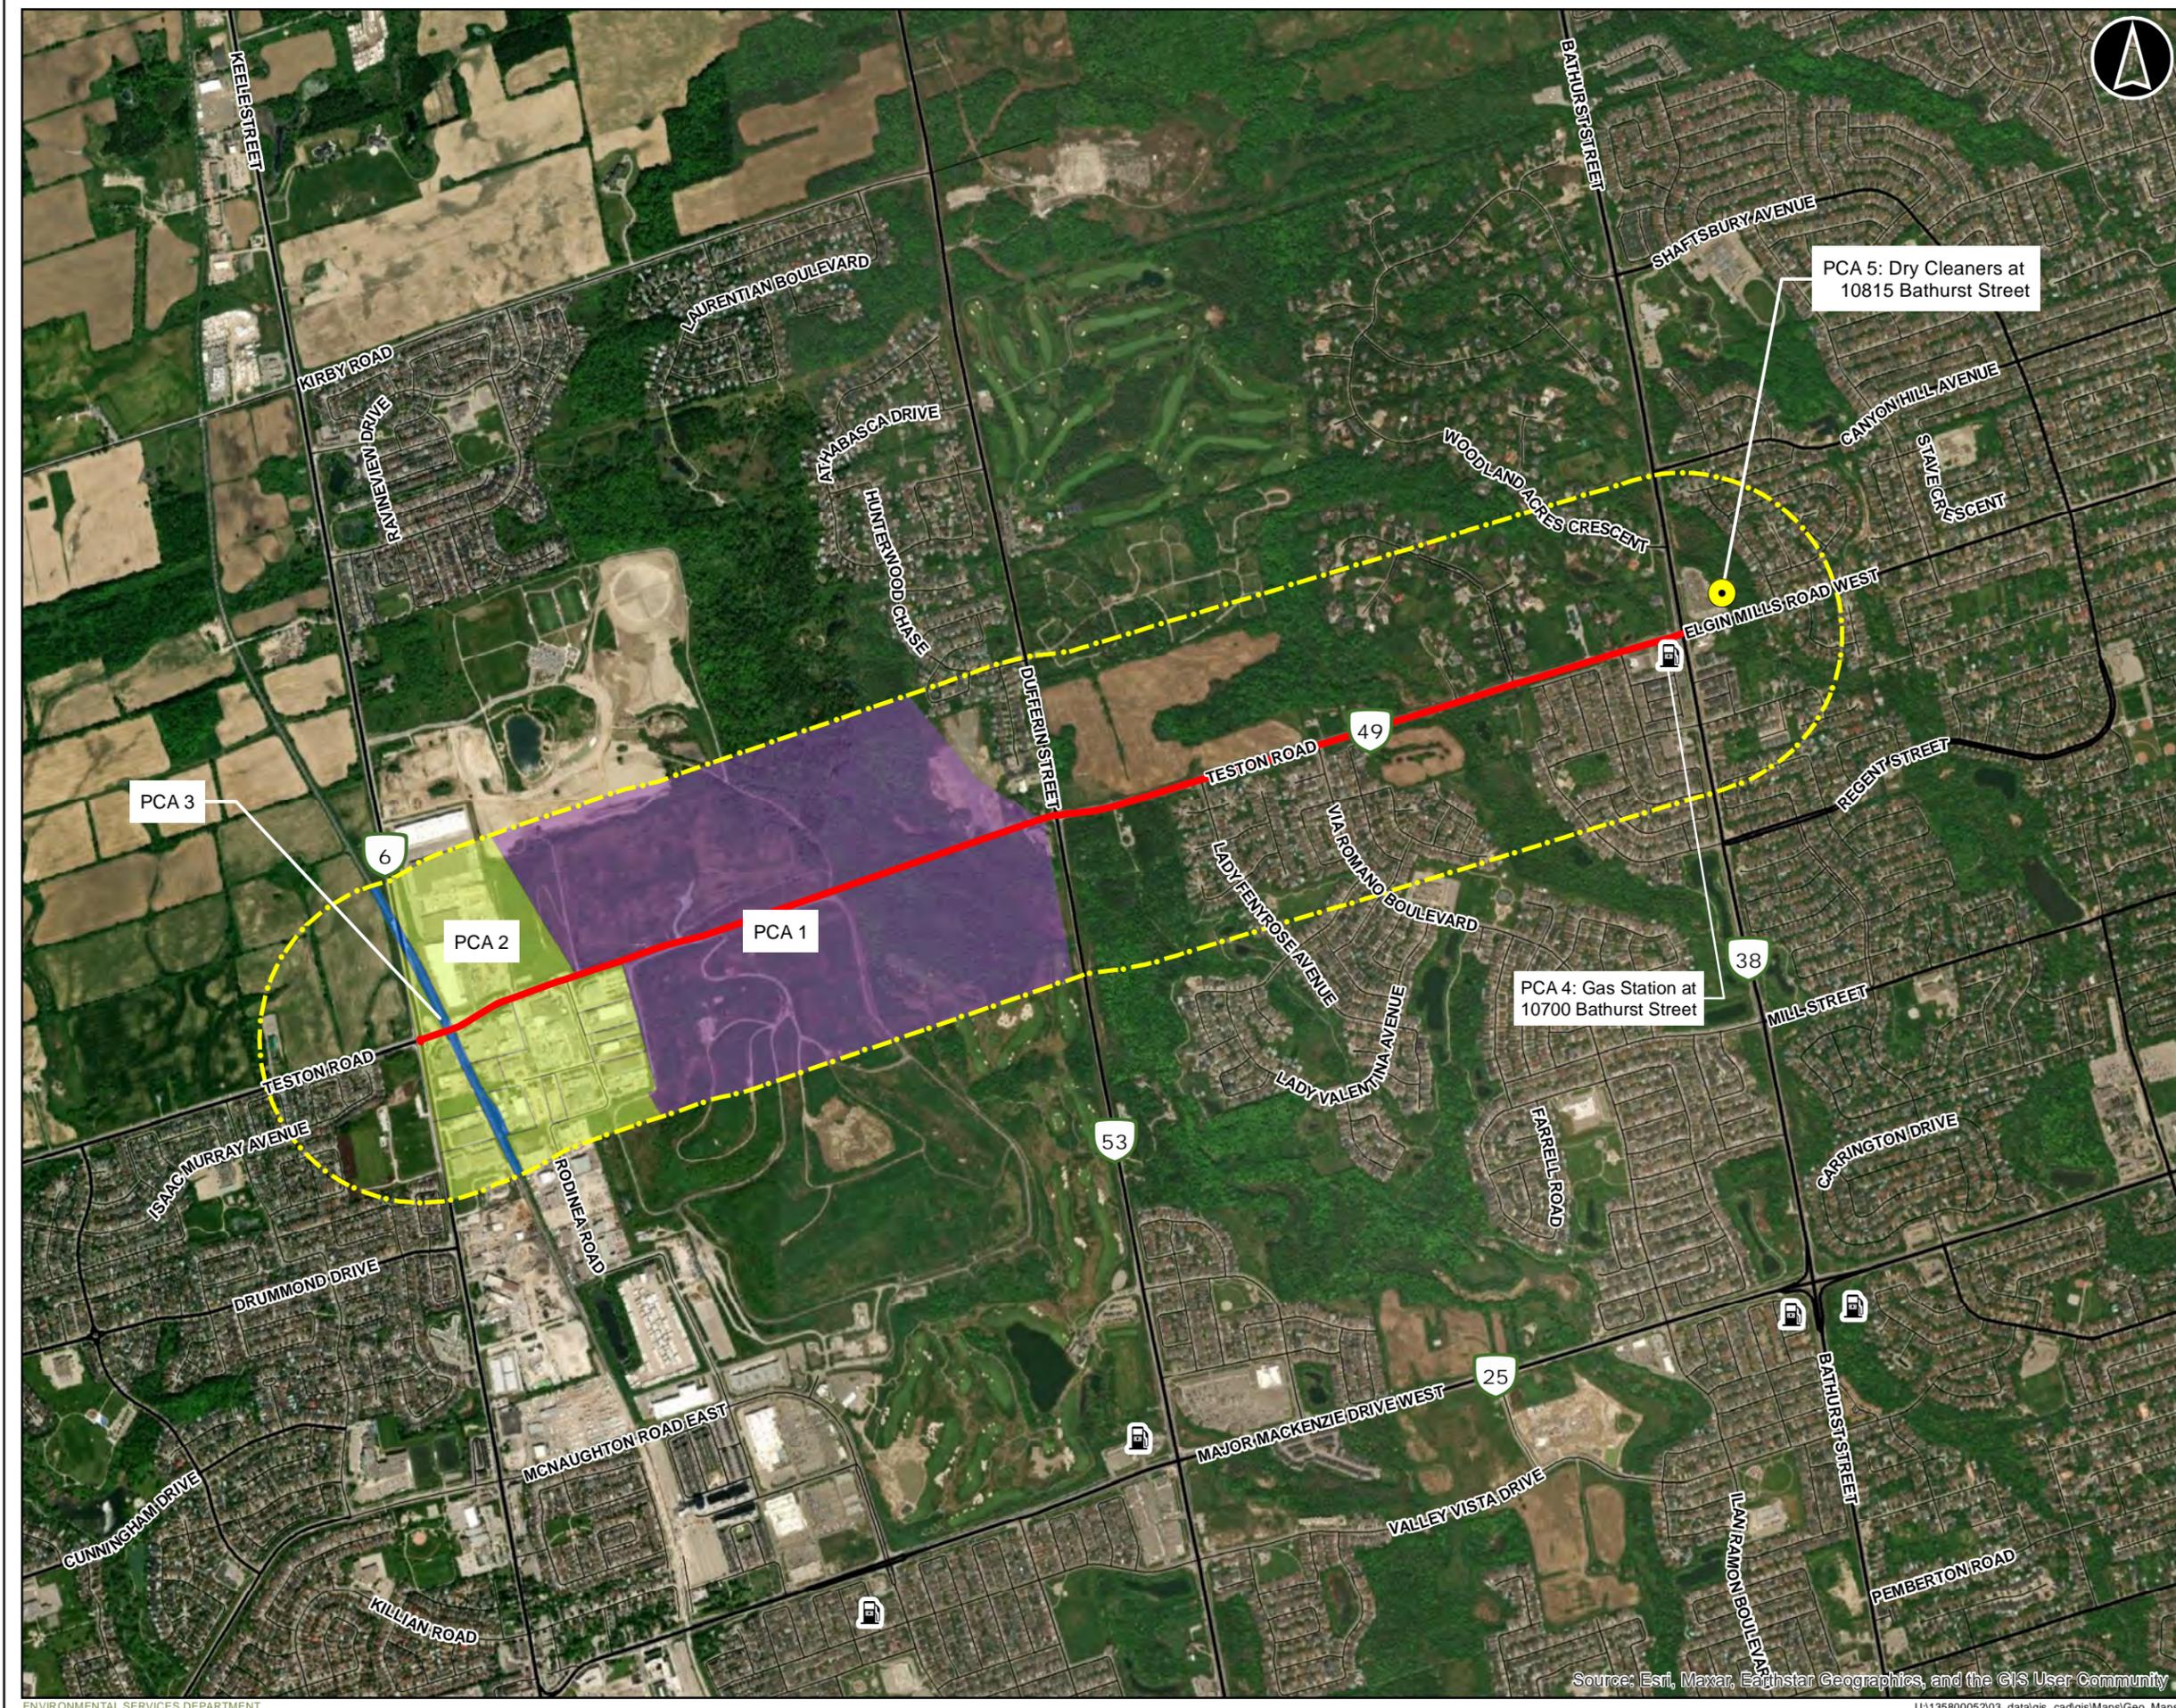
DATE: January 2025 **Figure 4**

PCA 4: Gas Station at 10700 Bathurst Street

PCA 5: Dry Cleaners at 10815 Bathurst Street

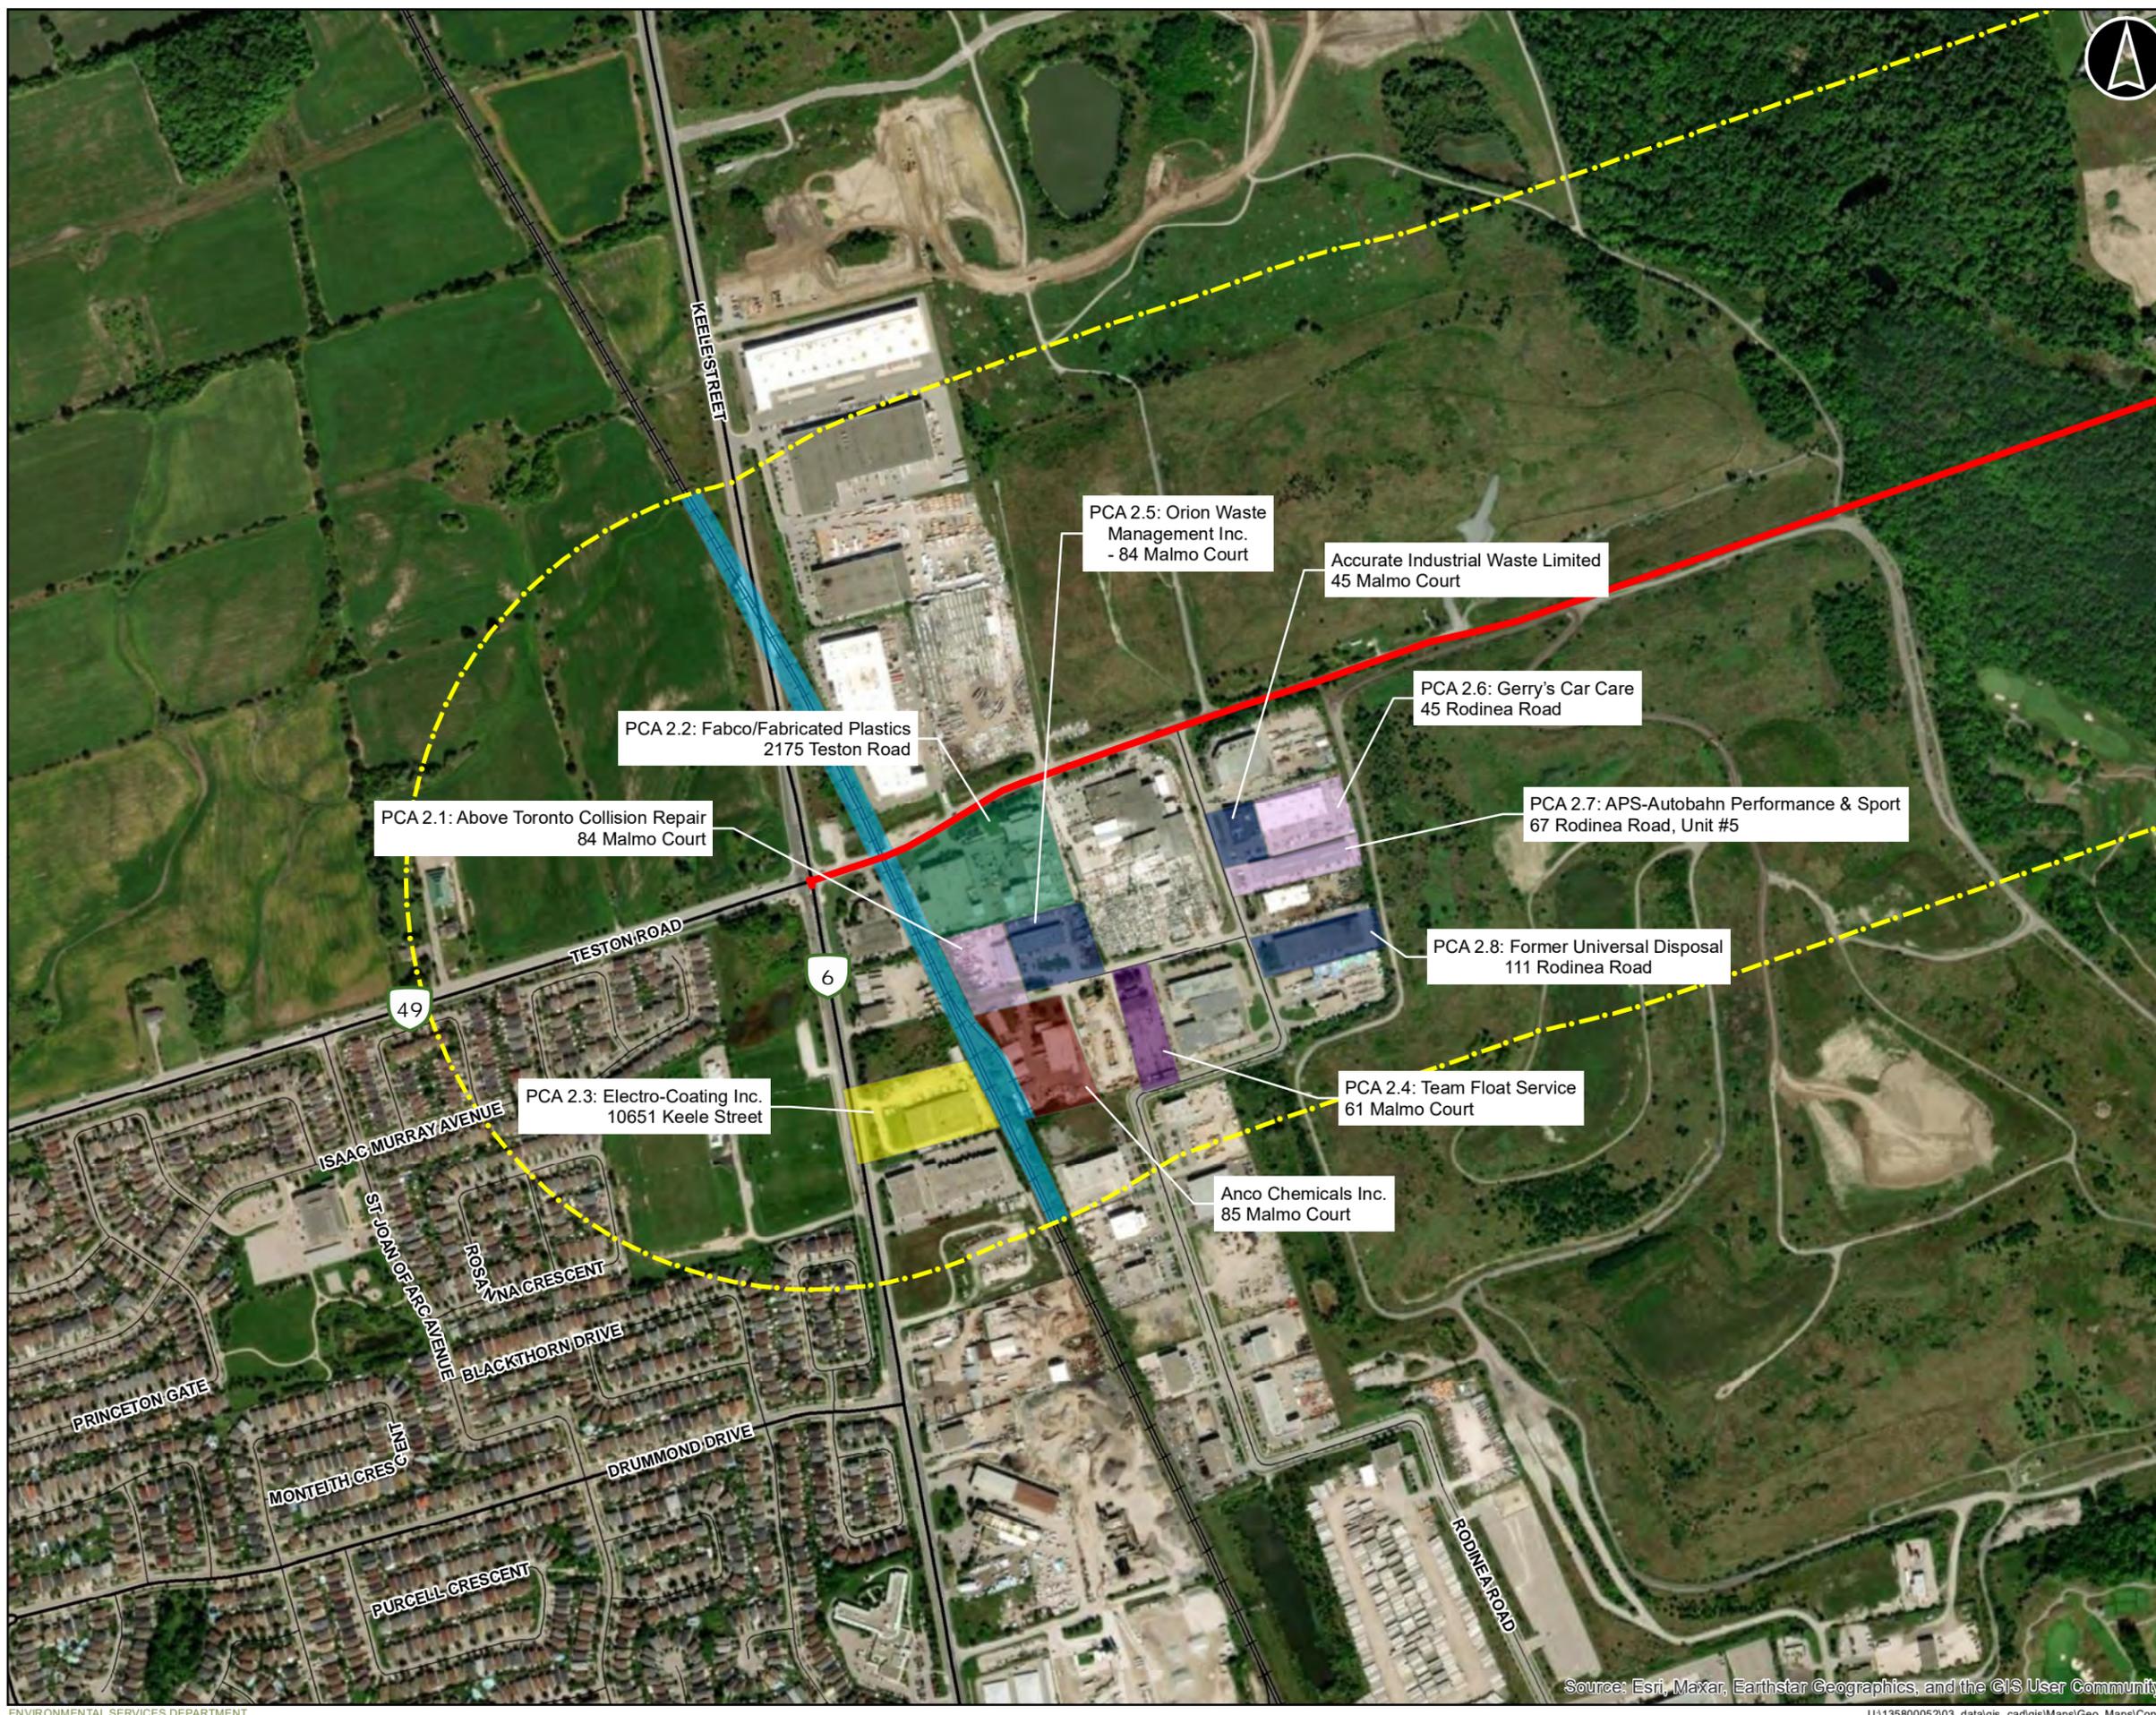
PCA 2.1: Above Toronto Collision Repair
84 Malmo Court

PCA 2.8: Former Universal Disposal
111 Rodinea Road

Anco Chemicals Inc.
85 Malmo Court

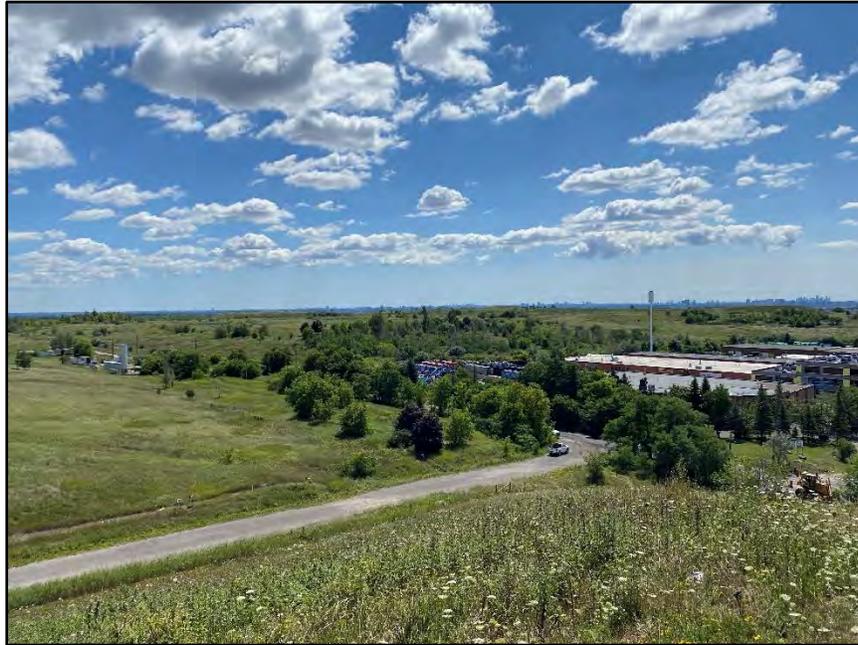
The former landfills were observed to be large grass covered hills. The Vaughan Landfill has been partially transformed into a park complete with walking/bike trails. The Keele Valley Landfill was fenced off and could not be fully inspected.

Photo 1: Keele Valley Landfill, facing southeast.

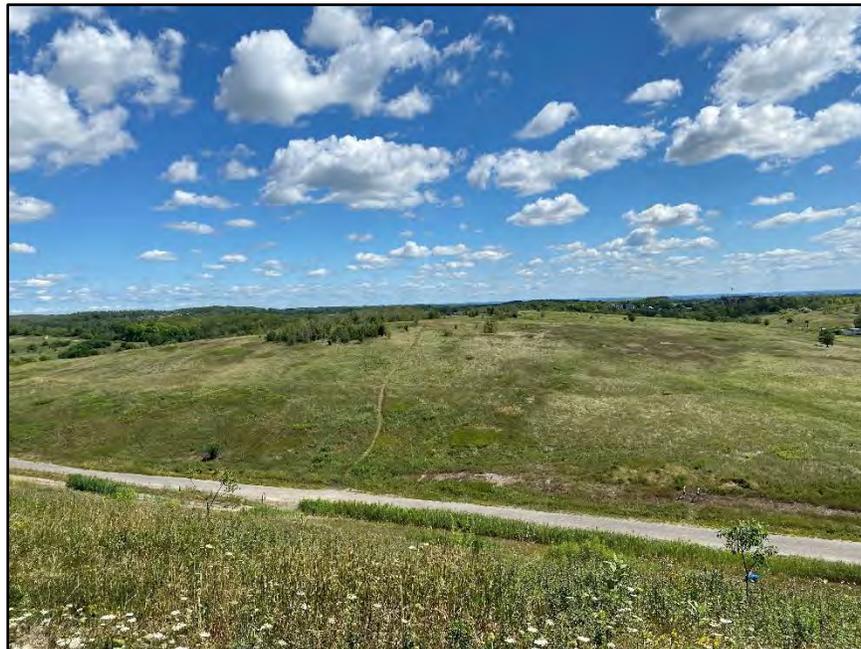
Photo 2: Keele Valley Landfill, facing northeast.

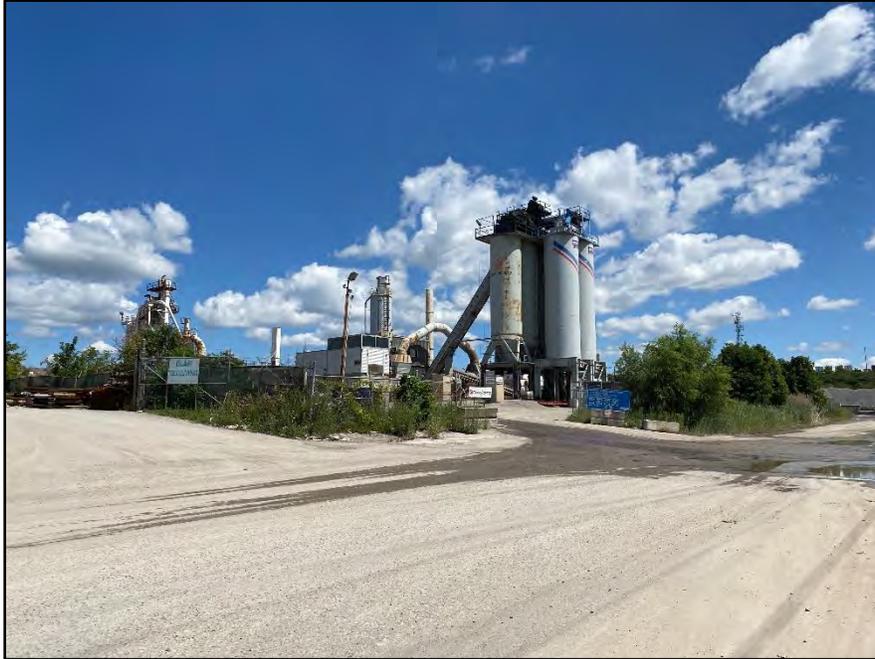
PCA	Address	Company Name	Date of Operation	Risk Level
3) Asphalt and Bitumen Manufacturing	10475 Keele Street	Lafarge Canada Inc./Coco Paving	1983 to Present	High

Photo 3: Coco Paving Maple Asphalt Plant at 10475 Keele Street.

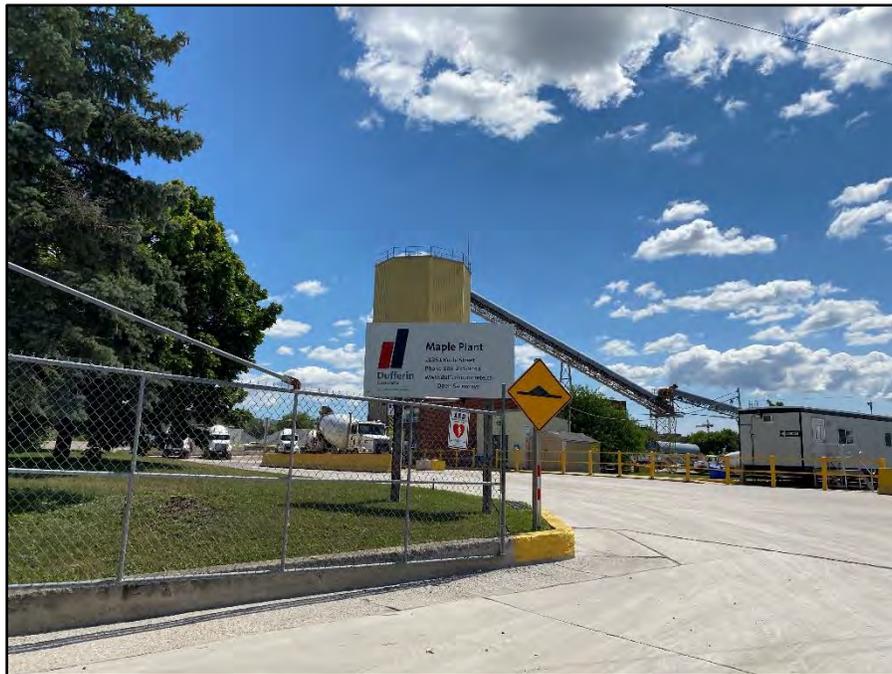
4) Concrete, Cement and Lime Manufacturing	10351 Keele Street	Dufferin Concrete Maple Plant	1989 to Present	High
5) Plastics (including Fibreglass) Manufacturing and Processing	2175 Teston Road	Fabco/Fabricated Plastics Ltd./Kemflo Canada Inc	1962 to Present	High

Photo 4: Dufferin Concrete Maple Plant at 10351 Keele Street.

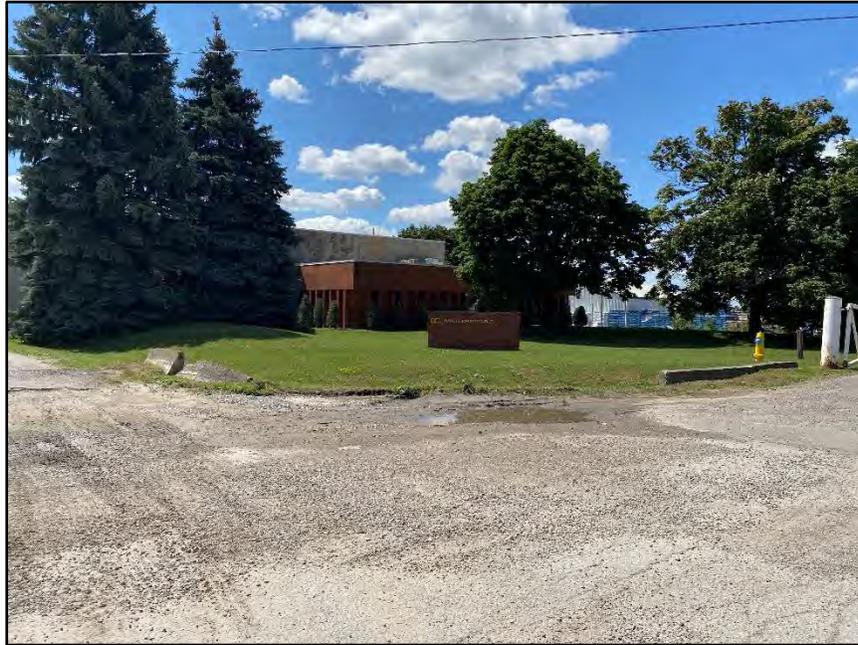
23 Eagle Rock Way	Zetra Waste Systems Ltd.	2011 to unknown	Low	
2) Chemical Manufacturing, Processing and Bulk Storage	85 Malmo Court	ANCO Chemical Ltd./Great North Chemicals	1962 to Present	High

Photo 5: Anco Chemicals at 85 Malmo Court.

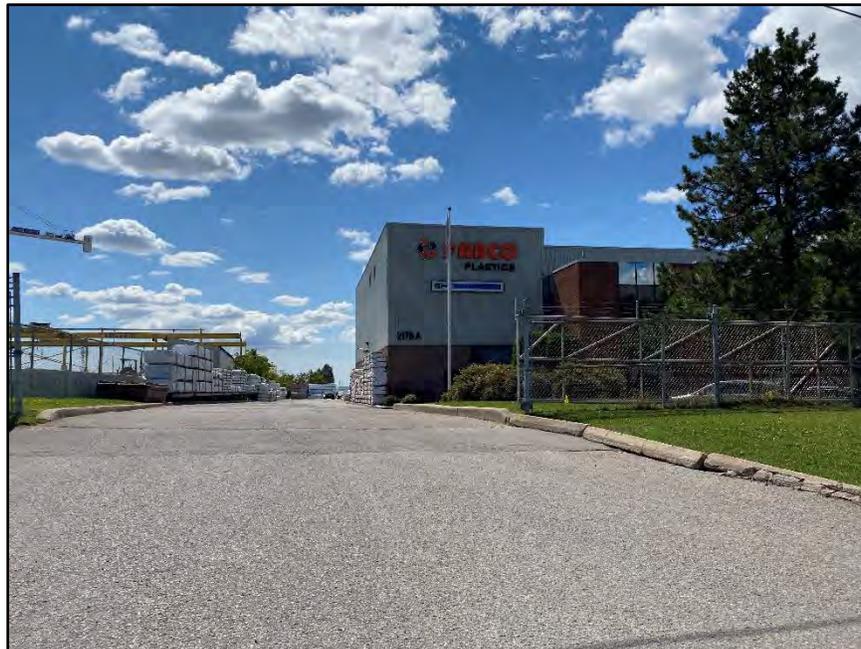
Photo 6: Fabco/Fabricated Plastics at 2175 Teston Road.

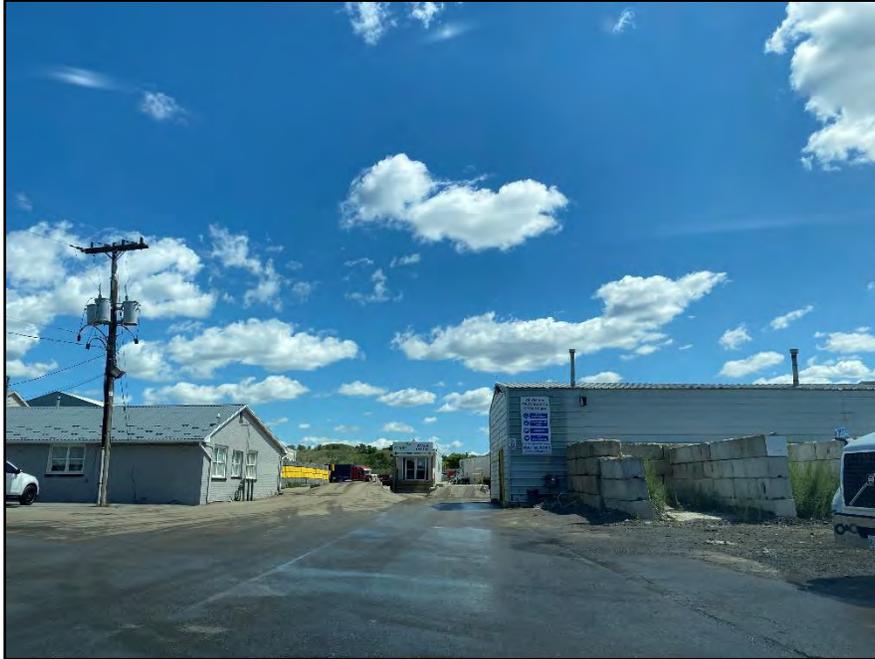
Photo 7: Maple Transfer & Recycling Inc. at 10525 Keele Street.

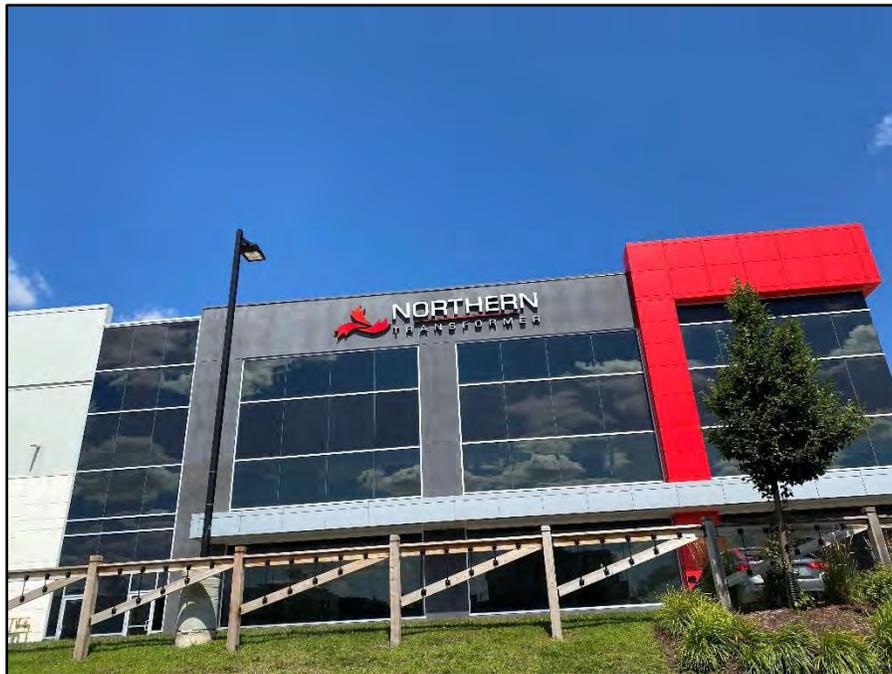
7) Electronic and Computer Equipment Manufacturing	245 McNaughton Road East	Northern Transformer Corporation	2015 to Present	Medium
8) Commercial Trucking and Container Terminals	61 Malmo Court	Team Float Service/Boart Longyear Inc.	1992 to Present	High

Photo 8: Northern Transformer Corporation at 245 McNaughton Road East.

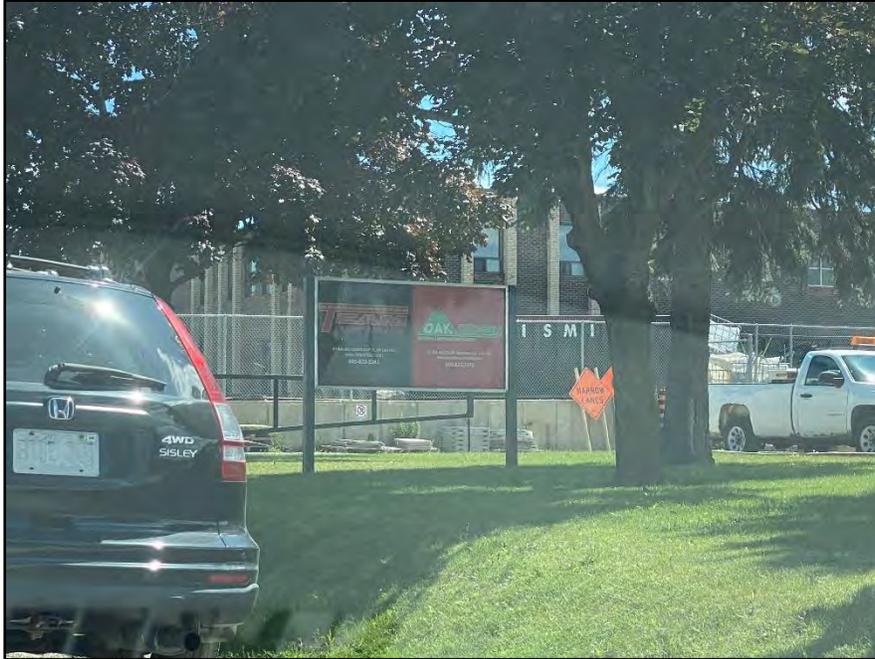
Photo 9: Team Float Service at 61 Malmo Court.

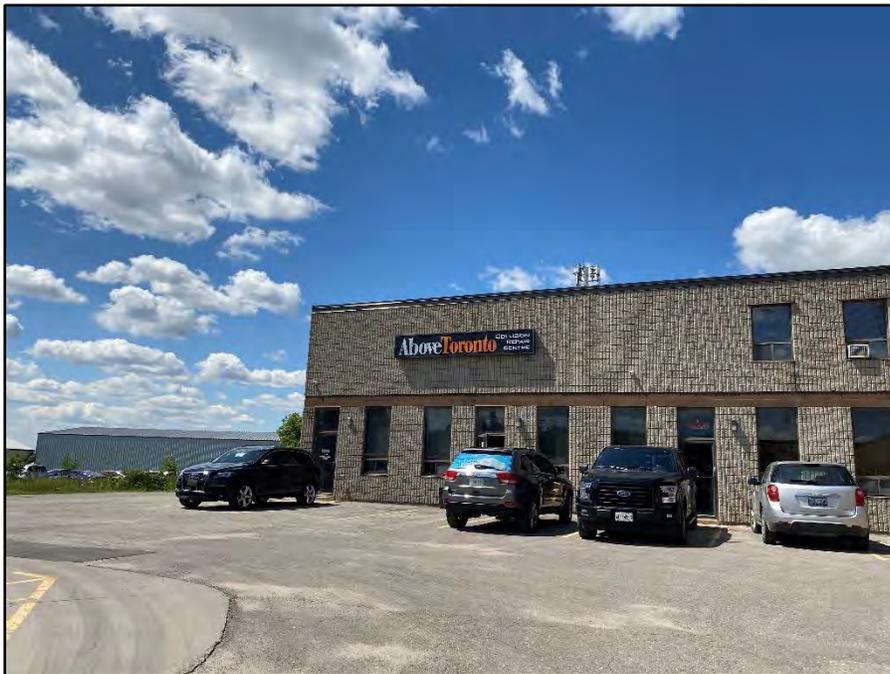
9) Rail Yards, Tracks and Spurs	N/A	Metrolinx Barrie Corridor	Prior to 1956 to Present	High
10) Commercial Autobody Shops	84 Malmo Court	Above Toronto Collision Repair	1986 to Present	High
	45 Rodinea Road	Gerry's Car Care	2008 to Present	High

Photo 10: Above Toronto Collision and Repair at 84 Malmo Court.
