FINAL REPORT

# **Teston Road Area Transportation Improvements Individual Environmental Assessment**

## **Phase One Environmental Site Assessment, Property 1 and Property 2, Teston Road, Maple, Ontario**

Report No. 190261800

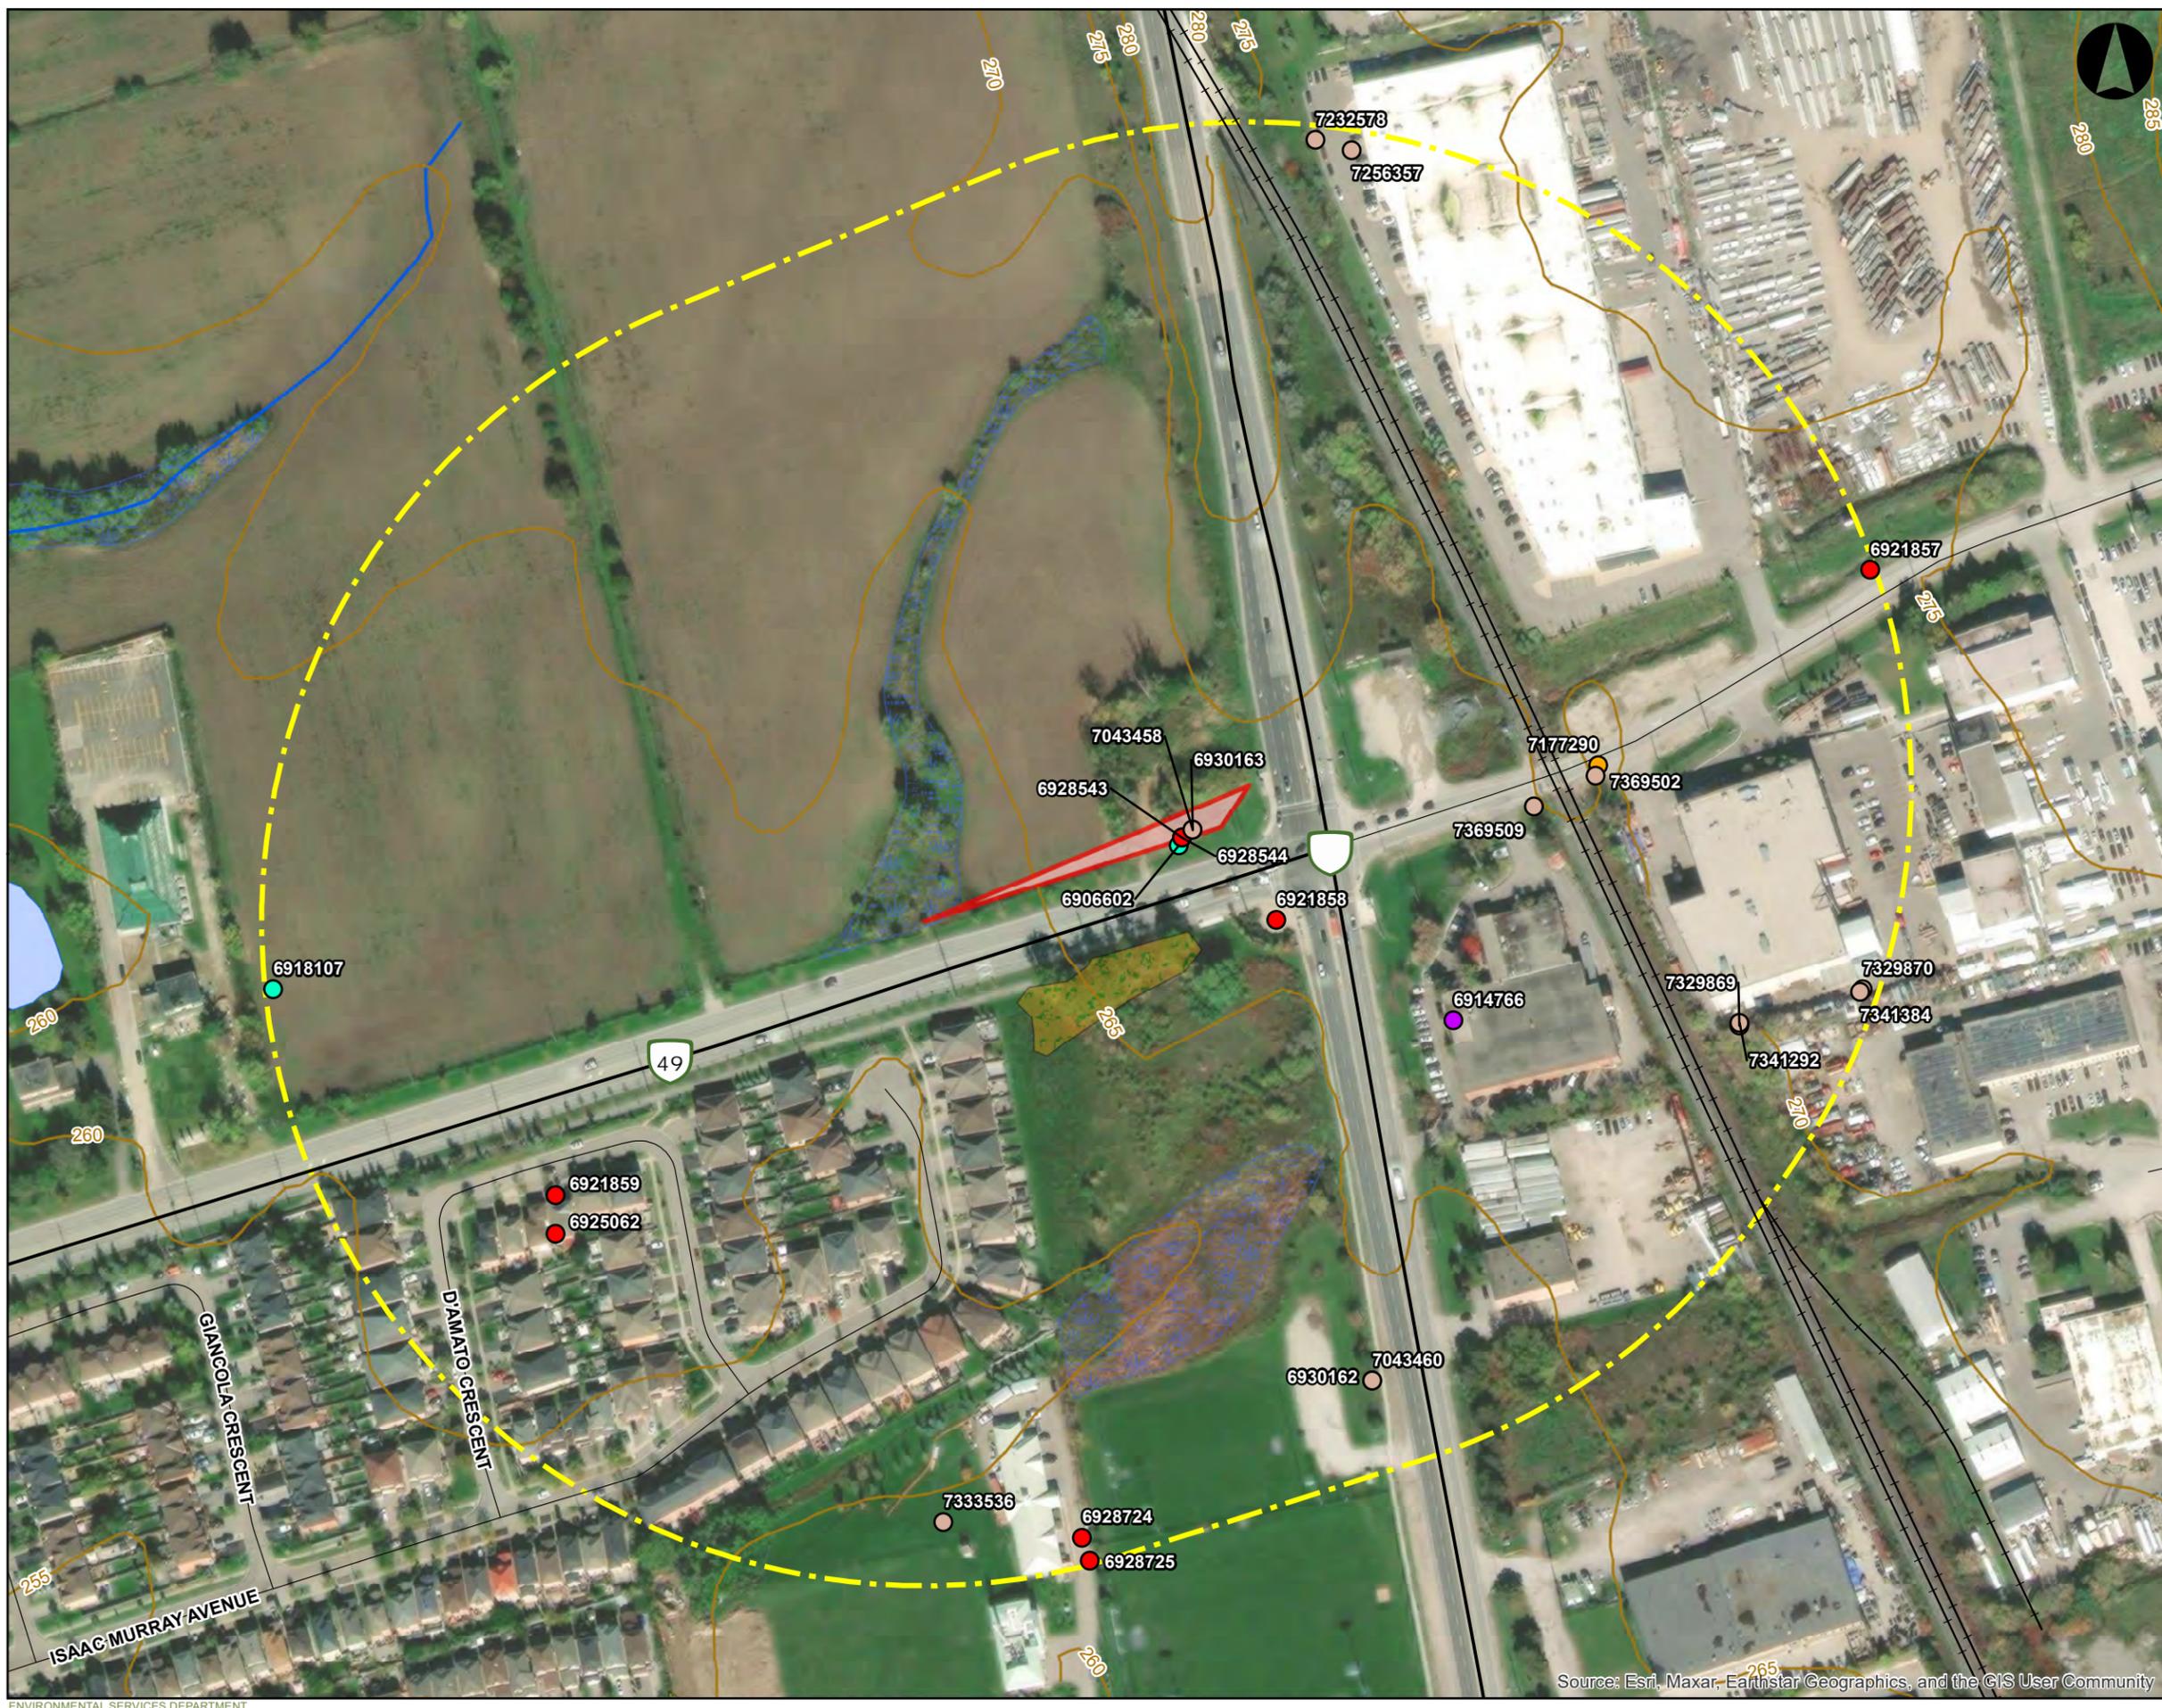
DATE: **March 2023** **Figure 3**

The WWIS locations are shown on **Figure 3 in Appendix A**. It should be noted that the margin of error for the location of these well records ranges from 100 to 300 metres.

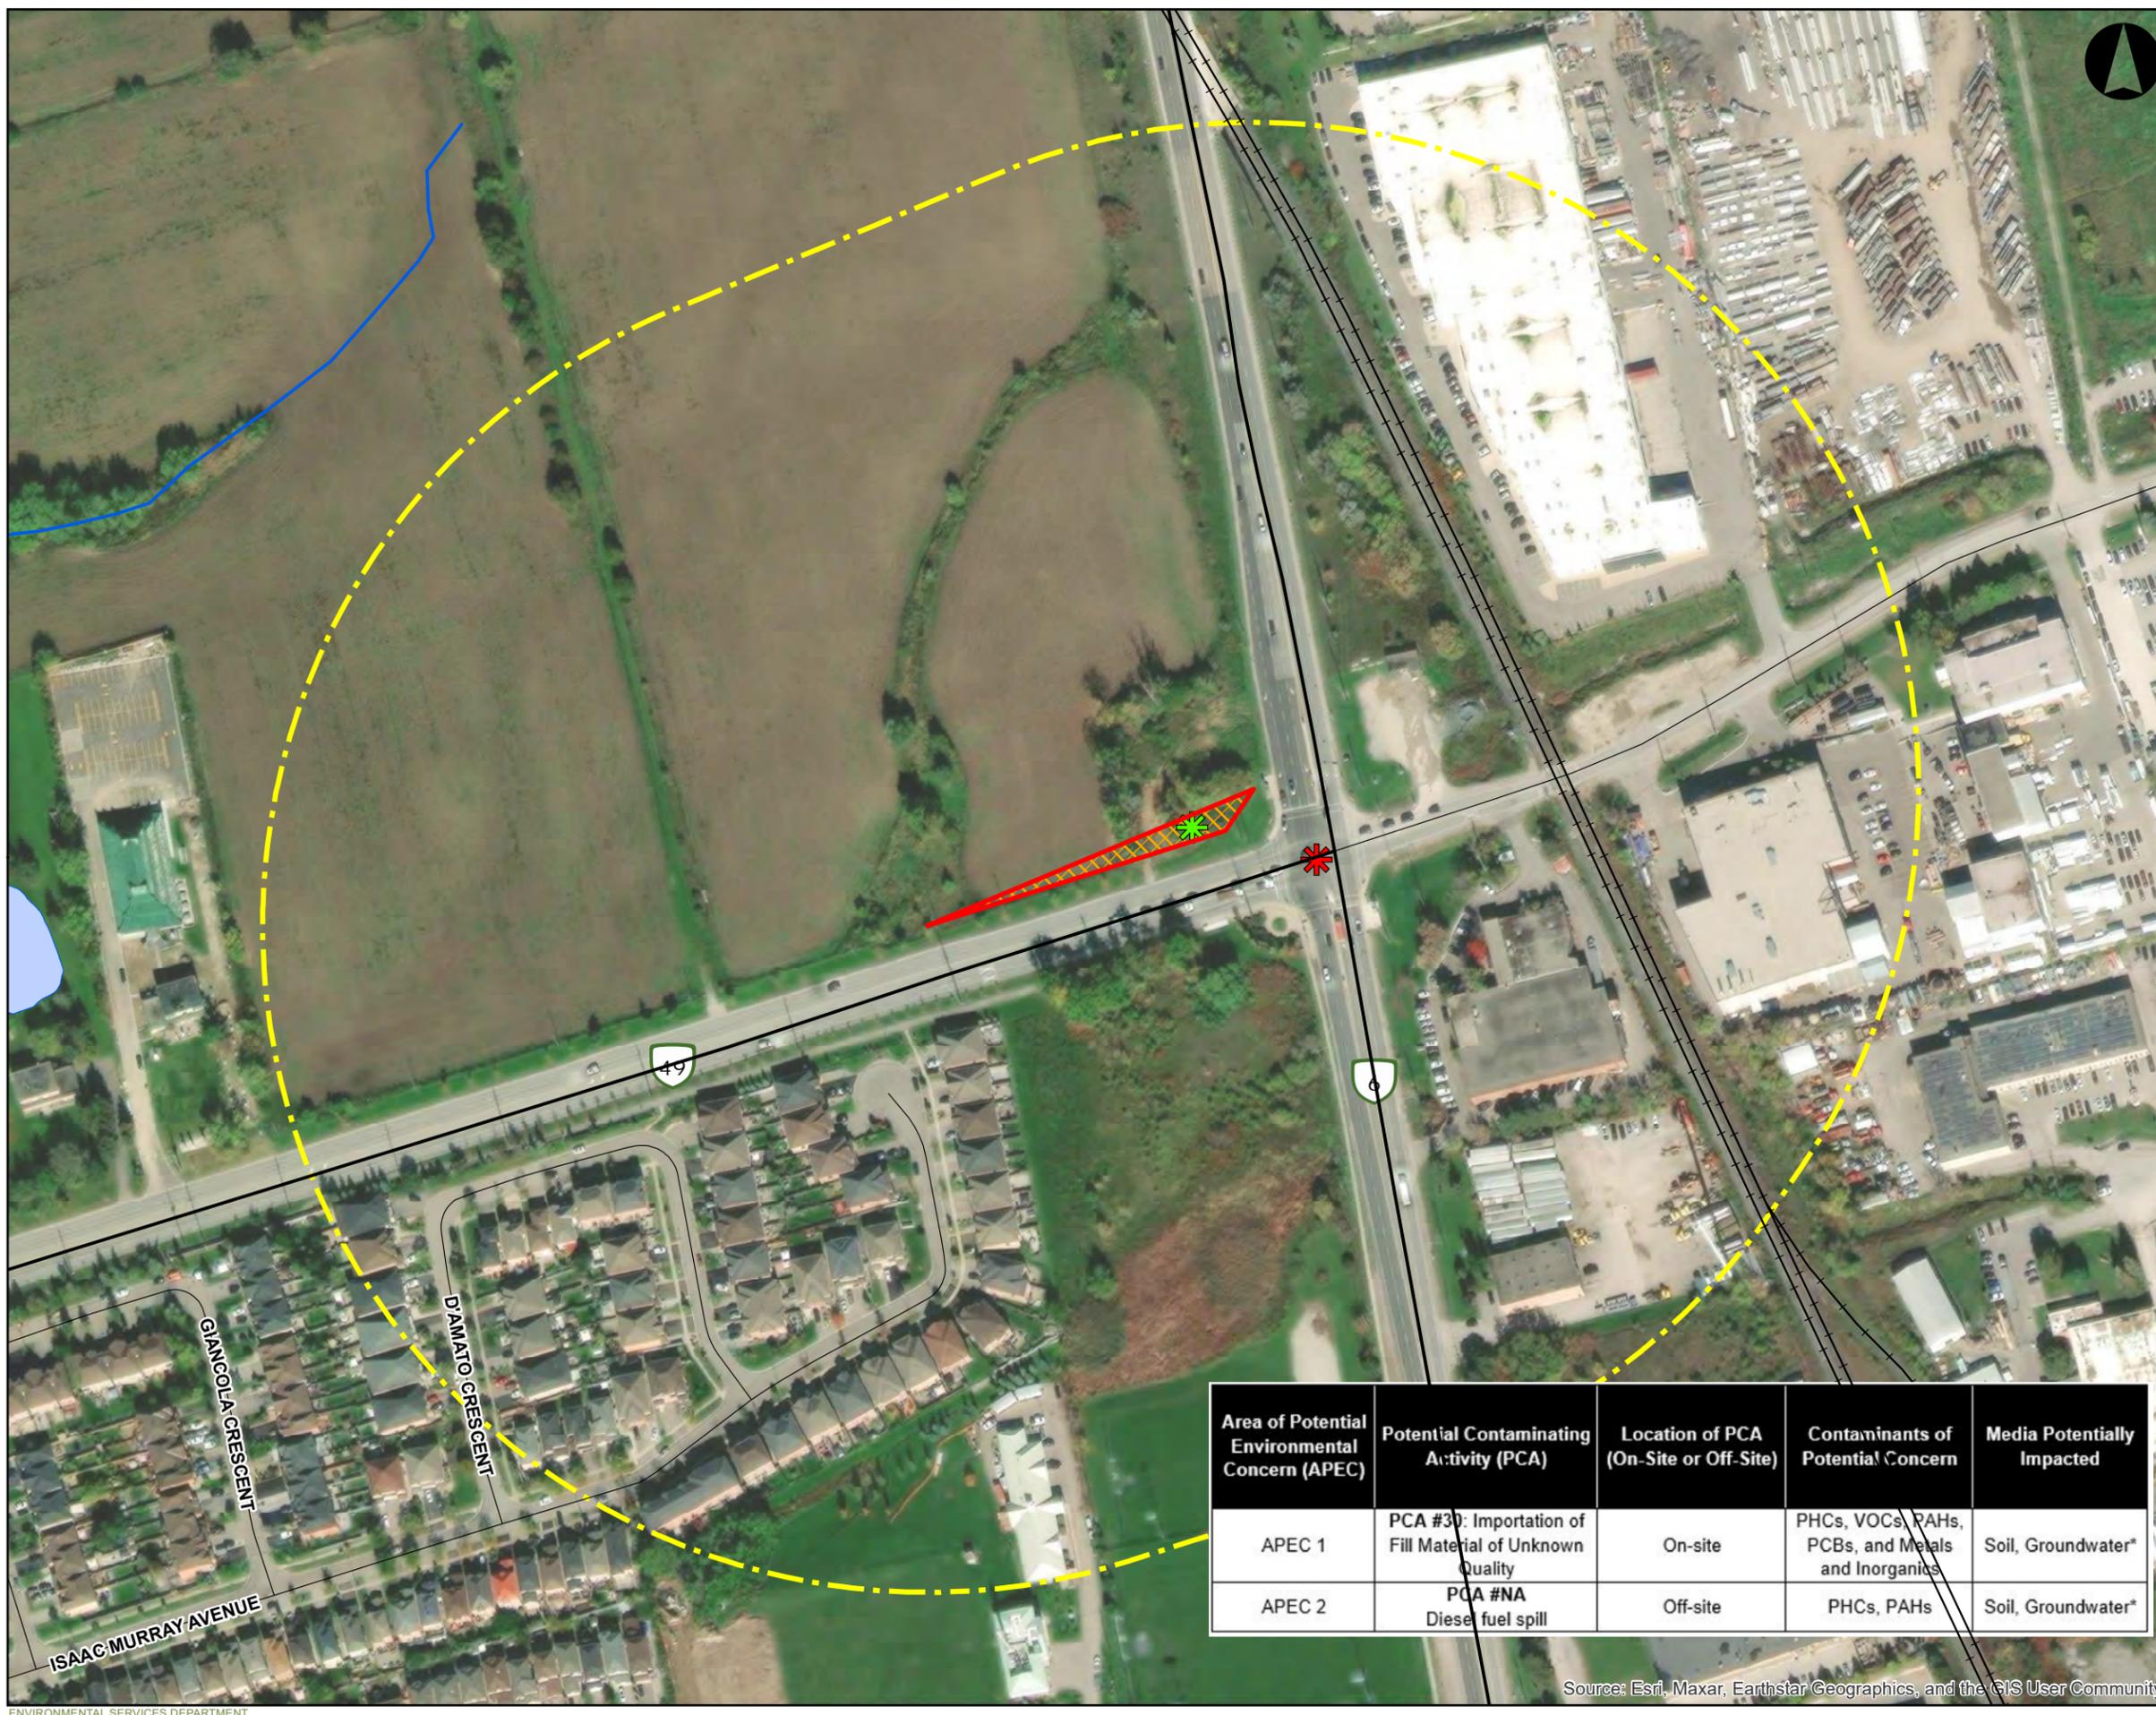
**TITLE:**  
Areas of Potential Contamination Concern (APECs) and Potentially Contaminating Activities (PCAs)

Based on the findings of this Phase One ESA, two areas of potential environmental concern were identified, due to a possible importation of fill material of unknown quality during the development of former residential dwelling at the Phase One Property, and a

spill of diesel fuel at the intersection of Teston Road and Keele Street. The APECs are summarized in the **Table 1** below:

The evaluation of the Phase One Property concludes that there is a possibility that one or more contaminants of potential concern either sourced from the Phase One Property, or from an off-site PCA within the Phase One Study Area, have affected soil or groundwater on, in, or under the Phase One Property. Therefore, a Phase Two ESA is required before an RSC can be submitted for the Phase One Property.

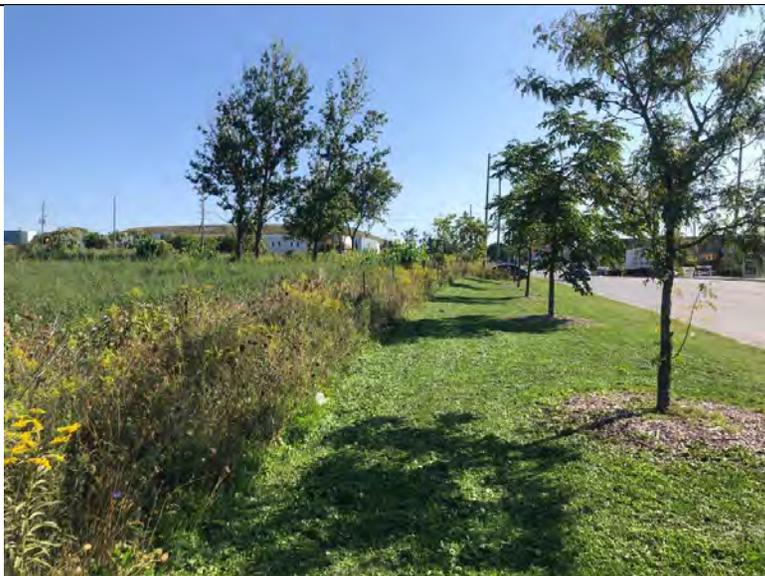
Photo 1: View of the Site facing east

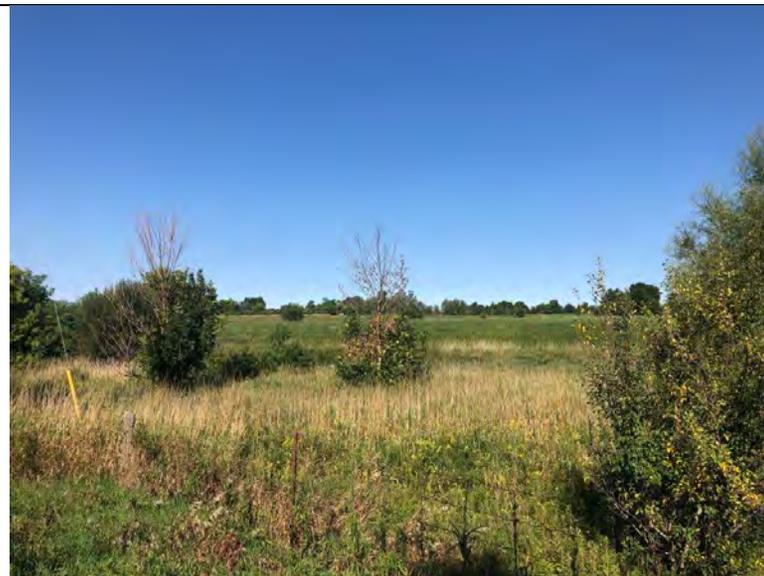
Photo 2: View of the Site facing northwest

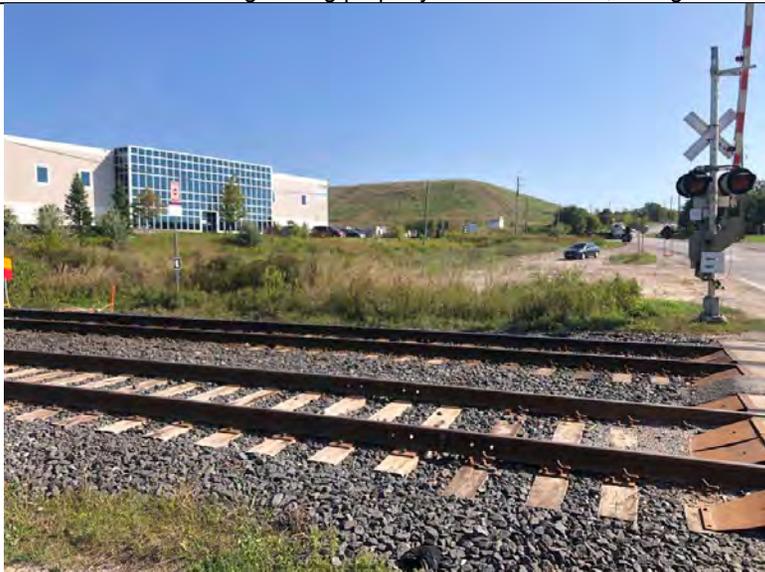
present at the Phase One Property. Railway lines were observed 100 m east of the Phase One Property, running from north to southeast.

Photo 7: View of properties farther east of the railway tracks, facing east
