# YORK REGION TRATION REDUCTION **STRATEGY**

## **ANNUAL REPORT**

### MARCH 31, 2018

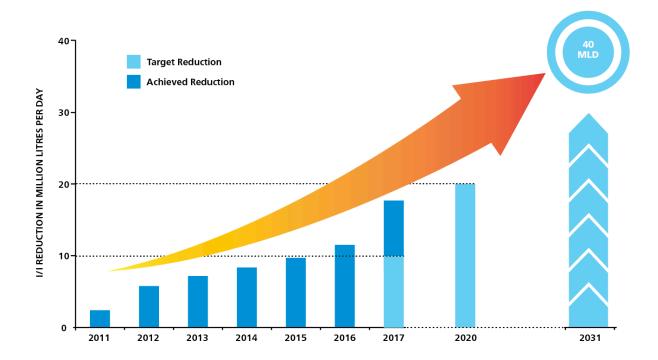
Since implementing York Region's 2011 Inflow and Infiltration Reduction Strategy, regular reporting of successes and challenges of the program has been necessary to build on lessons learned and to establish whether targets and goals have been met. The Strategy is meeting all interim goals and is on track toward reaching the overall reduction of 40 MLD by 2031 (Figure 1)

Figure 1: Target and Achieved Inflow and Infiltration Reduction

To date, the Region and local municipalities reduced inflow and infiltration by 17.59 MLD in the York Durham Sewage System (YDSS), representing 44 per cent of the 2031 target reduction of 40 MLD. This achievement exceeds the interim reduction target of 25 per cent (10 MLD) as set in the Strategy for end of 2017. Reduction targets set in the 2016 Strategy Update are shown in Table 2 below.

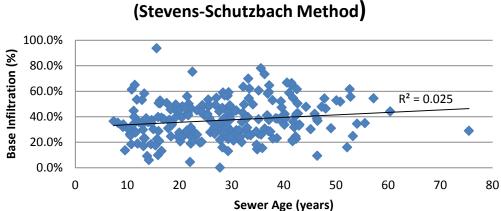
Base Infiltration vs. Sewer Age (Stevens-Schutzbach Method)

#### Figure 2: Base Infiltration versus Sewer Age

The trend line indicates higher base infiltration with increasing sewer age, which is what one might expect. However, the correlation coefficient indicates a correlation in the weak to none range and the R-squared value is low. The results are similar for peak RDII plotted against sewer age in Figure 3 below.

Another interesting observation from Figures 2 and 3 is that inflow and infiltration is a significant problem even in development areas as young as ten years old. Base infiltration above 40 per cent of ADDF is considered elevated and peak RDII above 0.26 L/s/ha is also considered elevated. For this reason the Region has begun a new project to examine the new development design, construction, inspection, and testing and acceptance practices of the nine local municipalities to make recommendations for improvement. More details are provided in Section 4.8.

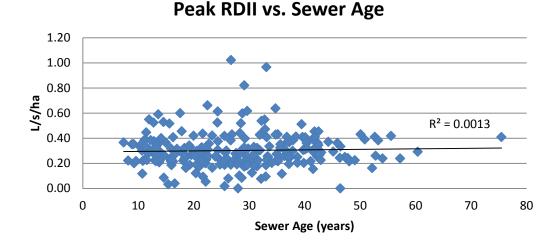
#### Figure 3: Peak RDII versus Sewer Age

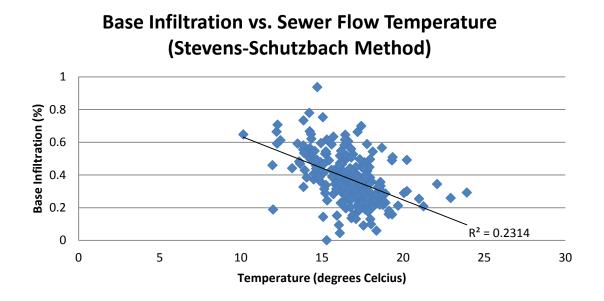
#### Figure 4: BI versus Average Sewer Flow Temperature in Each Meter Basin

The trend line indicates lower sewage flow temperatures in meter basins with more base infiltration. The correlation coefficient for the data in Figure 4 indicates a correlation in the moderate to weak range.

A correlation was also sought between the sewer flow temperature and the amount of base infiltration in York Region. Since the groundwater temperature is typically colder than the sewer flow temperature, one would expect to see lower sewage flow temperatures in meter basins with more base infiltration. The average sewer flow temperature in York Region is 16.7°C, whereas the groundwater temperatures near the sewer pipes are generally in the seven to ten Celsius range. Figure 4 below plots base infiltration versus sewer flow temperature.

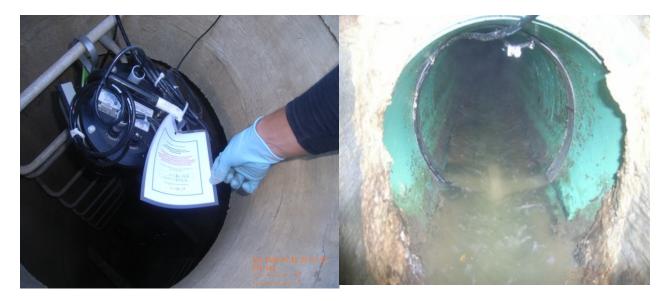
Figure 5: Pictures showing Area Velocity Meter and Sensor installed as part of the Flow Monitoring Program

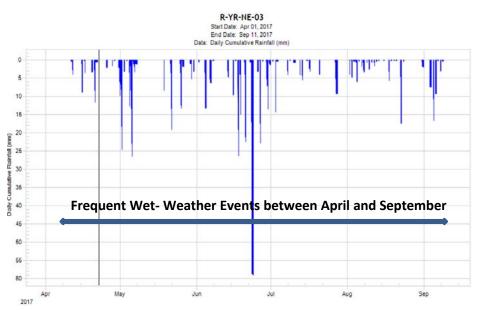
Figure 6 shows the daily cumulative rainfall that fell on one catchment in the Town of Newmarket between April and September demonstrating the high frequency of wet weather events in 2017. Specifically of interest was the impact in the Town of Newmarket, where 53 mm of rain fell within a six hour period. Catchments within the Town of Newmarket were already under saturated soil moisture conditions due to the high frequency of wet weather events present for the previous months.

Figure 6: Newmarket Rain Gauge Showing Wet Weather Conditions between April and September of 2017

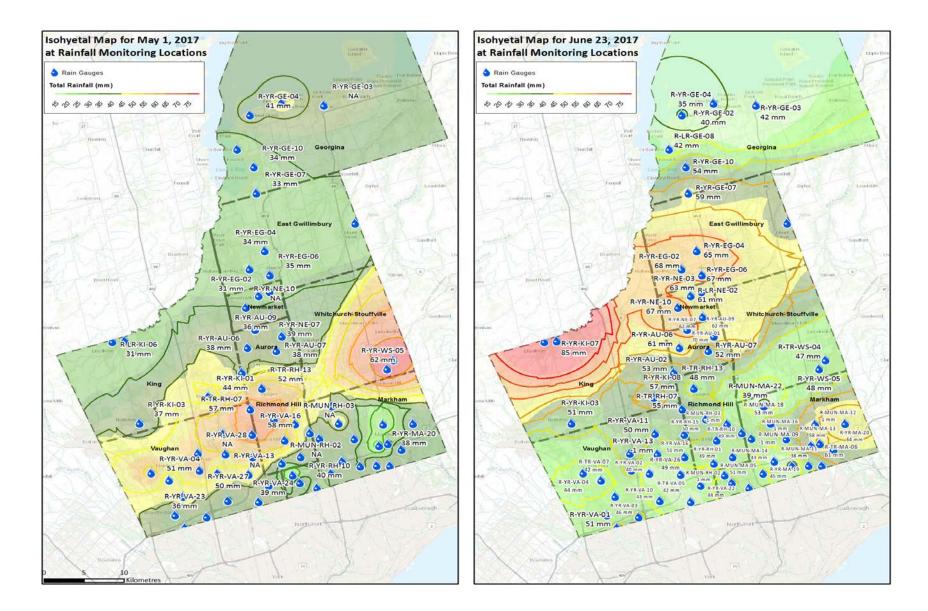
**Figure 7: Isohyetal Maps for May 1st (left) and June 23rd (right), 2017 Rainfall Events showing different localized events** The Regional Municipality of York | 20

Figures 7 and 8 show different maps produced as part of the monitoring program following a major rainfall and based on the real-time data collected from rain gauges installed throughout the Region. These figures illustrate localized events that affected different parts of the Region in 2017.

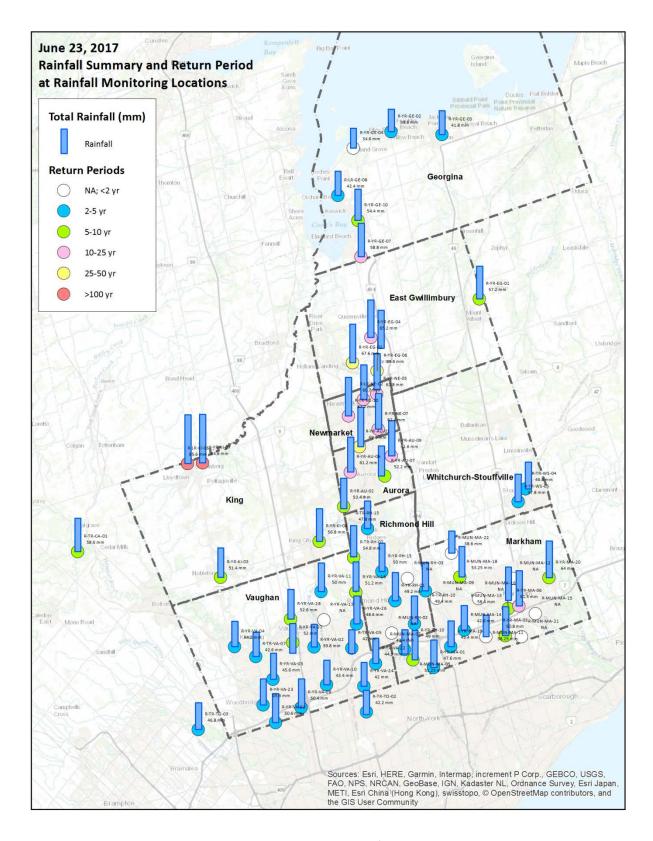
Figure 8: Rainfall Summary Return Periods on June 23<sup>rd</sup>, 2017 Event

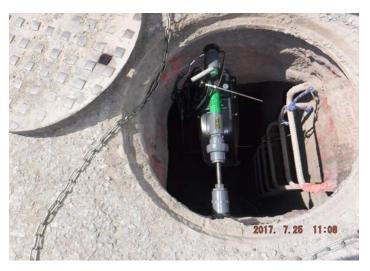
Figure 13: Level-only Flow Meter installed in the Town of Georgina

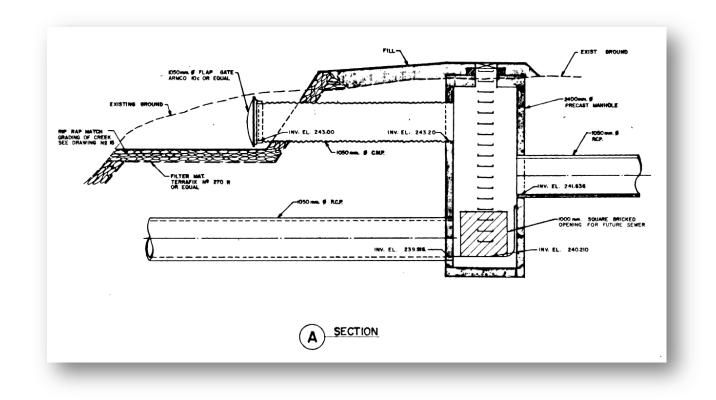
## Figure 14 – Pipe Section and Elevations of the Outfall Pipe and Flap Gate at the Aurora Sewage Pumping Station Outfall (see drawing provided in Appendix B)

York Region Operations suspected a problem at the Aurora Sewage Pump Station overflow outfall flap gate in the summer of 2016. Extremely high flows at the pumping station during storm events led operations staff to believe that creek water may be entering the station through the overflow pipe, as the golf course was prone to flooding during large storms. See Figure 14 below, detailing a cross section of the overflow pipe and flap gate.

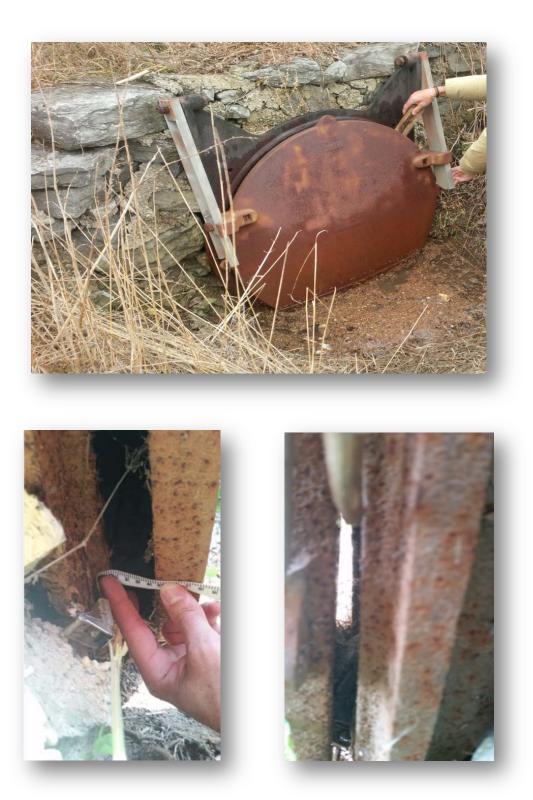
Further investigation revealed that the gate could not completely close due to accumulation of vegetation and debris. The opening ranged from approximately 45 mm at the bottom (Figure 15 – lower left picture) and 2 mm at the top (Figure 15- lower right picture).

Figure 15 – Aurora Sewage Pumping Station Flap Gate Opening and Field Measurements

Service (SCS) storm, the LSRCA model estimates the flood plain elevation at 246.31 m. The invert for the outfall flap gate was listed as 243.0 m in the Region's GIS records. With 3 m of hydrostatic pressure over an opening with a cross sectional area larger than a 200 mm pipe, it was clear that the flap gate could be an extremely large source of inflow and required immediate remediation.

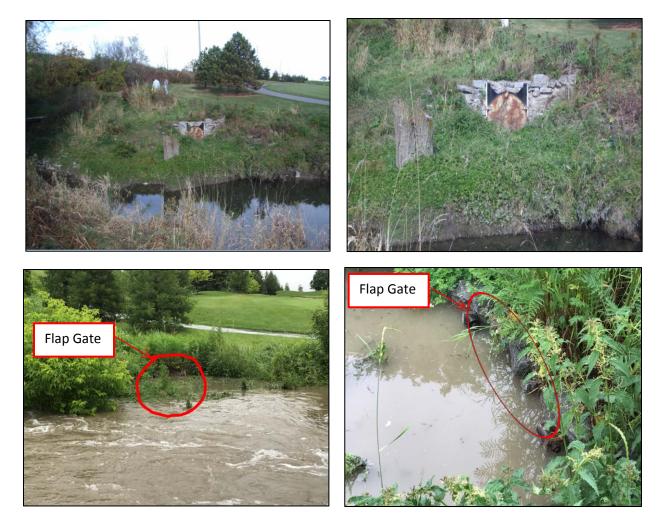
Figure 16 –Aurora Sewage Pumping Station Overflow Outfall Flap Gate location in comparison to the creek levels during dry and submerged conditions (During Jun 22-23, 2017 rainfall event)

An ultrasonic sensor was installed in May of 2017 to measure the rise and fall of the river in response to rainfall. The purpose was to verify operations staff sightings of golf course flooding, use the data to predict a 25-year storm response and confirm the results provided by the LSRCA flood model. The relative elevations of the outfall invert, river bank, monitoring point and surface of water in dry (top row), and flooded (bottom row) conditions are shown below in Figures 16-18.

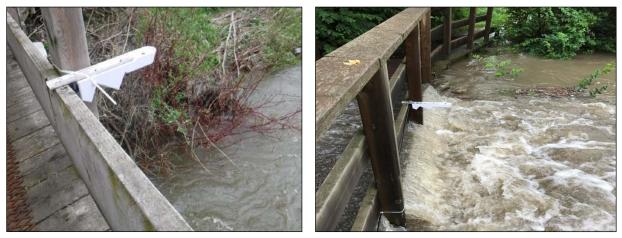
Figure 17 – Down-looking Ultrasonic Level Sensor Monitoring Creek Levels at Aurora Sewage Pumping Station in May (left) and June 23 (right) of 2017

Using level data for the creek (Figure 17), and the benchmarks shown in Figure 18, a reduction figure for the repair of this problem was generated from the June 23, 2017 storm event creek rise.

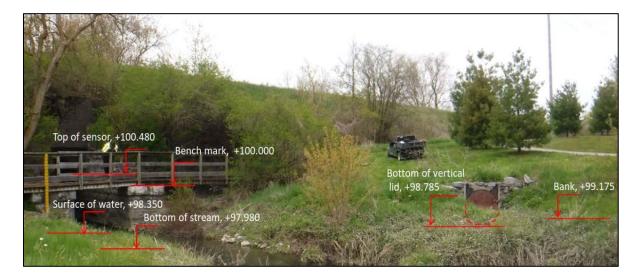
#### Figure 18 – Aurora Sewage Pump Station Stream Level (in meters)

The reduction of inflow is estimated to be 5.6 MLD, using weir and orifice equation calculations in InfoWorks modelling software and excel. See Appendix B for a detailed description of the problem and quantification method/calculations. A 36" Series 35-1 Tideflex Duckbill Check Valve and new concrete headwall was installed, along with the necessary regrading and restoration (Figure 19). This work will ensure creek water is isolated from the sewer system during high flow events.

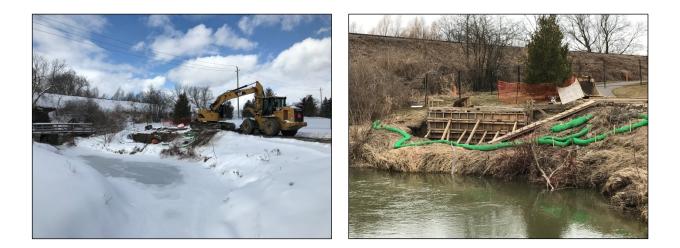
## Figure 19 – Construction Zone after Removing the Old Headwall (Left) and Formation of the New Headwall (Right)

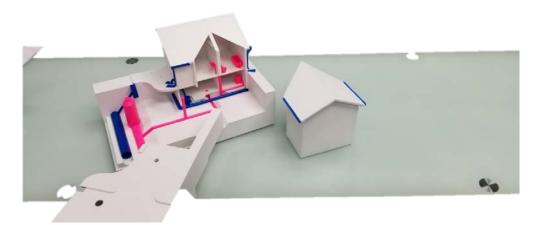
Figure 21 – 3D Printed Model used to Demonstrate Proper Pipe Connections

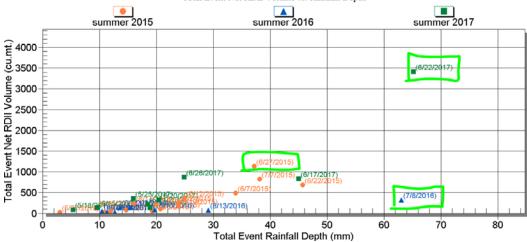
Figure A1 – Antecedant Rainfall vs Return Period on RDII

The trend of antecedant rainfall importance over return period is not as extreme in every basin in the Region, but there are many with similar results – especially in basins that are high volume I/I responders. The observed trend leads to a caution in using results in one basin to compare to another in different years of monitoring with significant differences in rainfall/moisture conditions. However, when this basin is sorted into groups of < 12.5 mm rain (dry), 12.5-38.1 mm rain (average wet) and > 38.1 mm of rain (very wet), the groupings have a very good correlation (r2 = 0.96, 0.89, 0.90). See Figure A2 for illustration. It can then be said with some certainty that the basin responds in certain ways in dry conditions, and in other ways in wet conditions. This will perhaps make for better comparisons across basins over varying seasons.

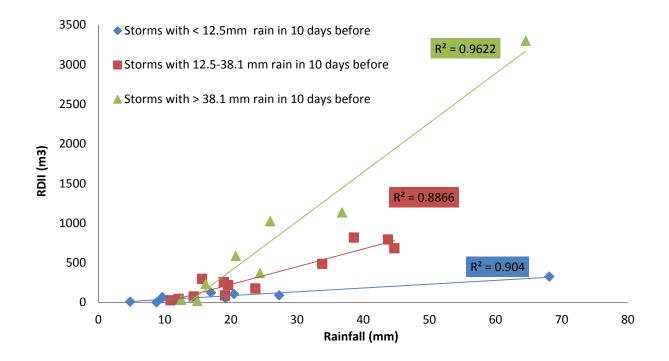
Figure A2 – Storm Trends by Antecedant Rainfall Volumes

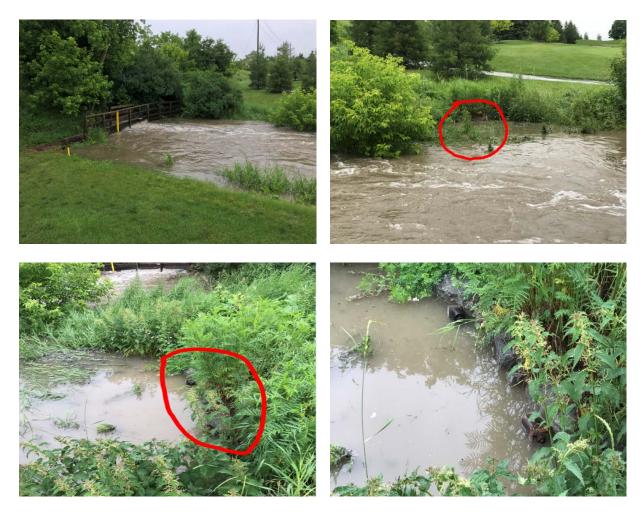
At the time of the storm, the vegetation had been cleared and the debris removed while a more permanent fix of the problem was planned. When alarms sounded for creek levels rising over the river bank, the following images were taken. The oufall flap gate is circled in red in some of the images provided in Figure B1 (The fourth picture shows the top of the flap gate hinges, and confirms the submerged condition). While the storm result doesn't come close to the Lake Simcoe Region Conservation Authority predicted flood level, the flooding is significant. These pictures were taken at 9:50 am on June 23, 2017.

Figure B1 – Images of Submerged Condition of the Aurora Sewage Pumping Station Outfall Flap Gate – June 23, 2017

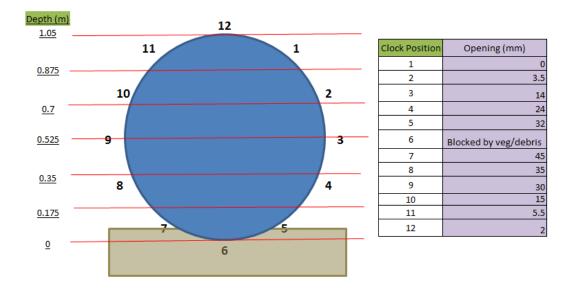
### Figure B2 – Measured Opening Widths at Various Clock Positions Around The Flap Gate

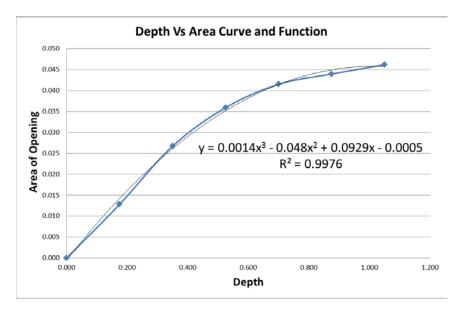
### Figure B4 – Depth vs Area Curve for Equivalent Weir and Orifice Calculations

From Table B2, the depth vs equivalent area curve was resolved in Figure B4.

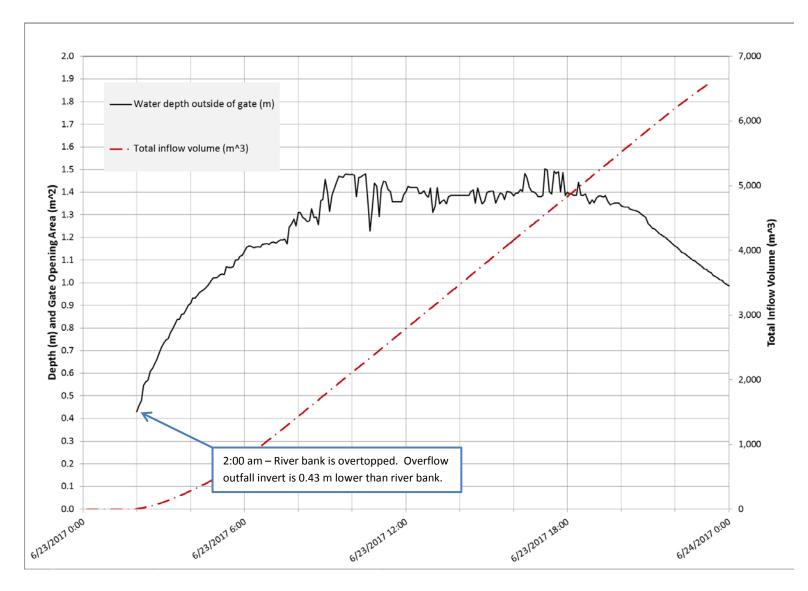
Figure B5 – River depth above outfall and cumulative inflow at Aurora Sewage Pumping Station Overflow Outfall

For 24 hours, from the start of the storm at 11:00 pm on June 22, 2017, the total inflow estimated by this method is 6.557 MLD. A calculation worksheet can be provided upon request for review. Figure B5 on the following page charts the depth of the creek over the overflow outfall invertand the total cumulative inflow volume.

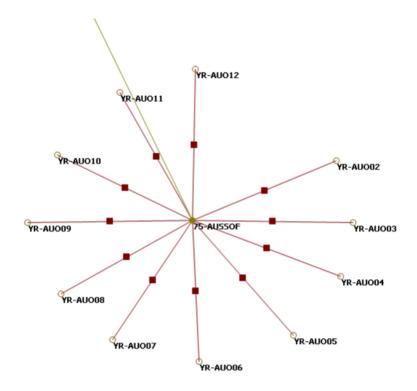
### Figure B6 – InfoWorks Weir Arrangement to Approximate Flap Gate Openings

The second method used to quantify the flow through the overflow outfall flapgate, employed a similar approach, in the InfoWorks integrated modeling platform. Twelve weir shapes were aranged at depth positions similar to the measurements taken at clock positions around the circular flap gate (See Figure B6). Each weir operated with 1/12 of the circumference used either as the roof height or width of the weir, depending on the position. Since the opening was 0 mm at the 1 o'clock position, and 2 mm at the 12 o'clock position – which was rounded to 0 mm by the software - there were essentially only ten weirs used in the calculation.

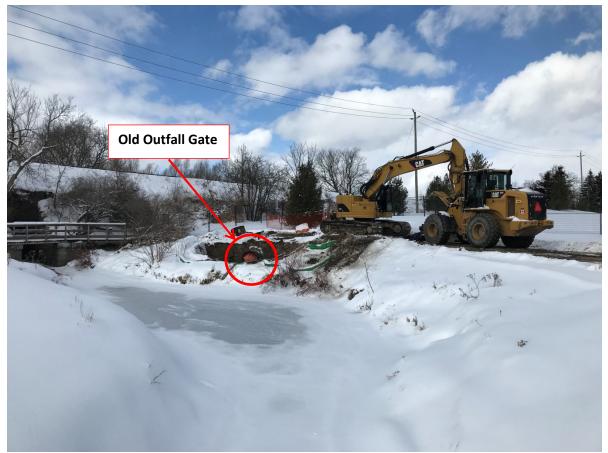
Figure B7 – Construction Zone after Removing the Old Headwall

Images of the repair are shown in Figures B7 and B8

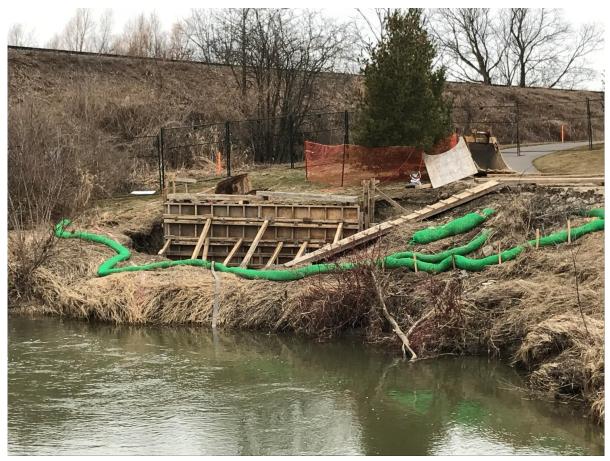
Figure B8 – Formation of the New Headwall

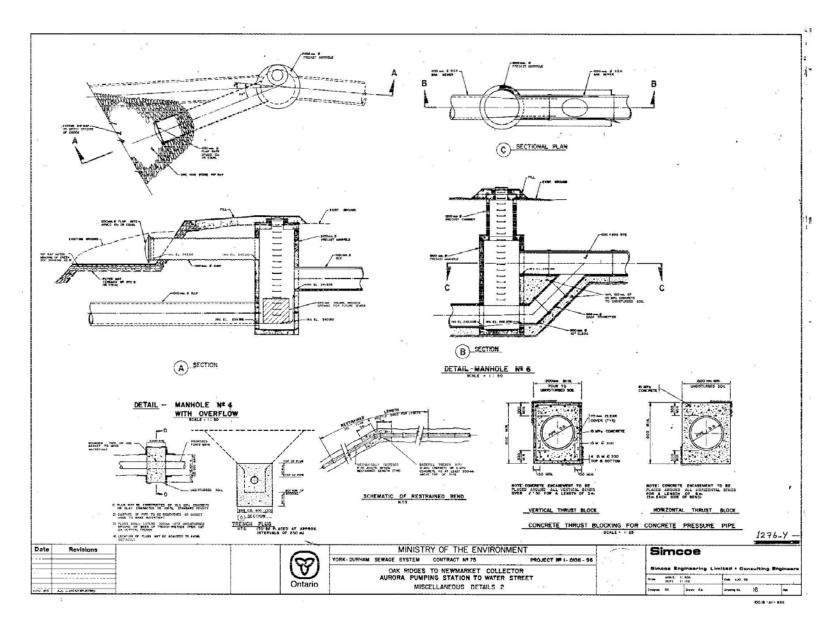
Figure B9 – Contract 75 (Aurora Pumping Station to Water Street) – Cross Sections Drawing
