Bridge Inspection Form

Struct. ID 03-06 B0400

York Region

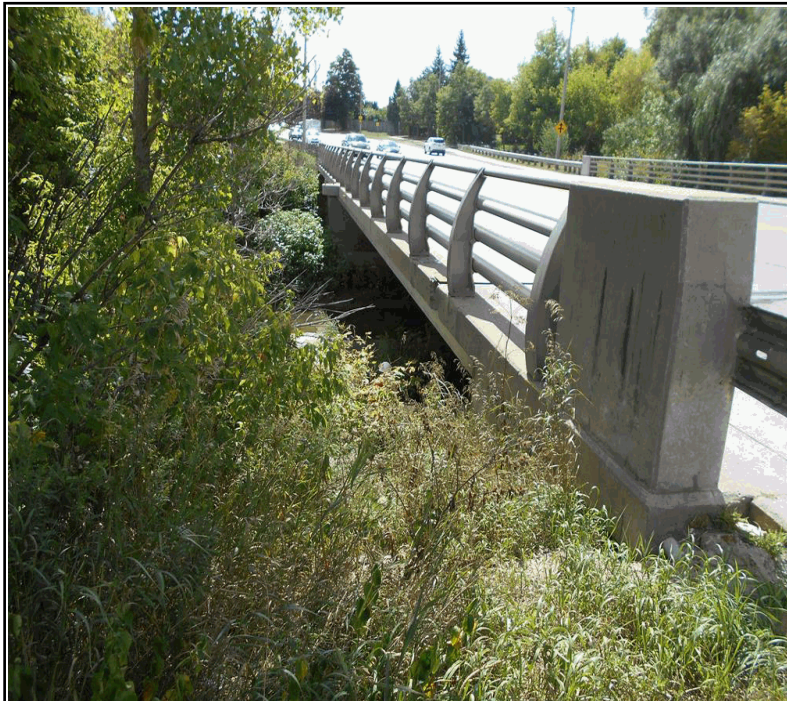
File Name DSCN4170.JPG

East elevation, general photo

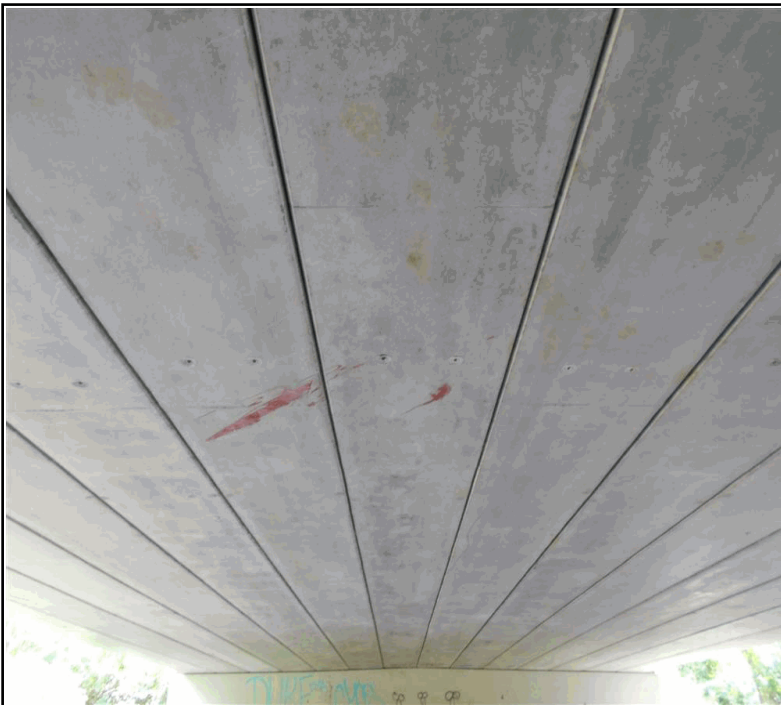
File Name DSCN4182.JPG

Soffit general photo

Elem Grp/Class	Beams/ML'E's/Girders
Elem Type	Box/trapezoidal
Sub Element	Middle
Material Type	Precast concrete
Locator	
Defect Descript1	
Defect Descript2	
Defect	
Other

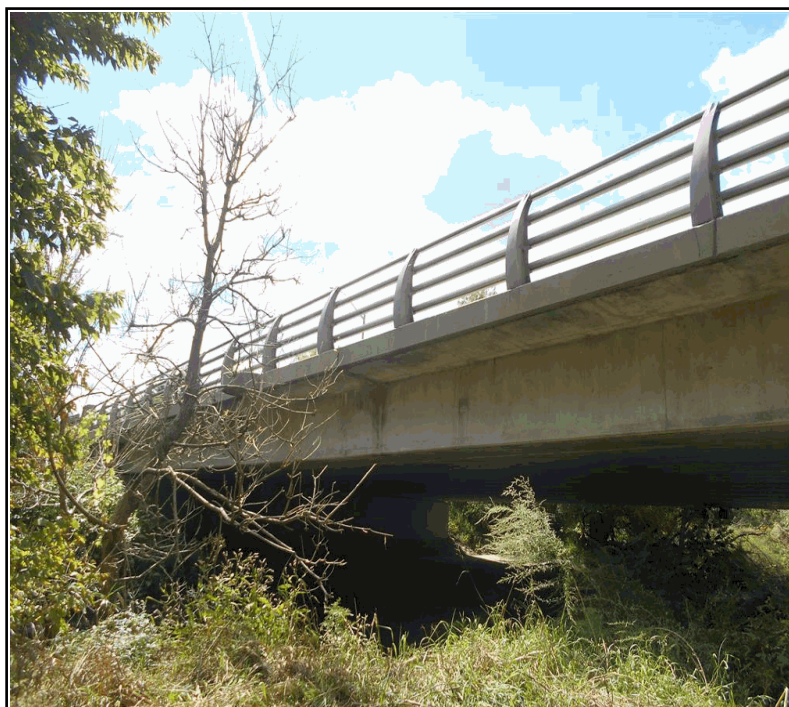
East elevation, general photo

Elem Grp/Class	
Elem Type	
Sub Element	
Material Type	
Locator	East
Defect Descript1	
Defect Descript2	
Defect	
Other
