SUBSURFACE UTILITY ENGINEERING (SUE) QUALITY LEVEL B INVESTIGATION

Project #46726 (Warden Ave, Markham, ON)

Subsurface Utility Engineering Report for York Region, ON

The Regional Municipality of York

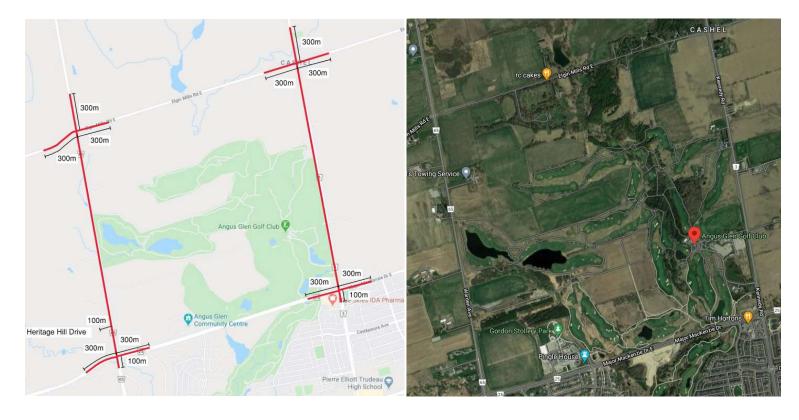
Figure 1-1: Aerial View of the Project Area at Warden Avenue and Kennedy Road, Markham. ON

multiVIEW Locates Inc. has performed the SUE investigation; fieldwork Quality level B (QL-B) and completed the desktop investigation for the project area of the Warden Ave; from Elgin Mills Rd to Mackenzie Drive East, Markham, ON and Kennedy Road; from Elgin Mills Rd to Mackenzie Drive East, Markham, ON . That is defined in the map and scope of work, shown in Figure 1-1 and Figure 2-1.

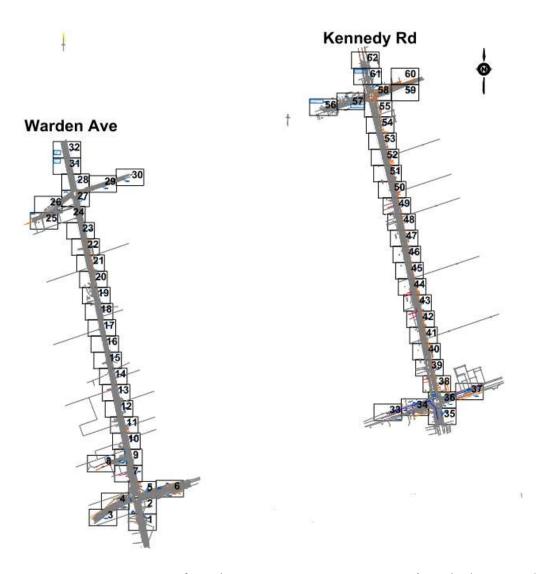
Figure 2-1: Key Map from the Composite SUE QL-B Drawing (Attached in Appendix A)

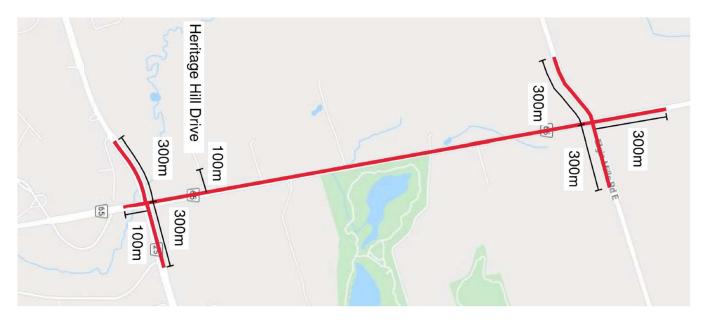
Figure 3-1: Sketch Map of the SUE Investigation & Scope of Work on Warden Avenue

Project includes the investigation area as per Figure 3-1 and Figure 3-2.

The project limits defined as follows and shown in Figure 3-1 and Figure 3-2.

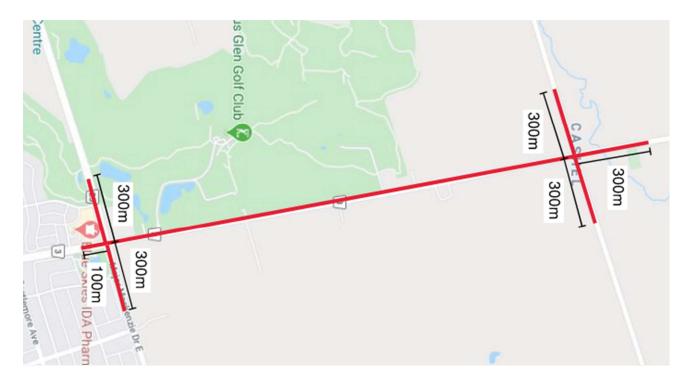
Figure 3-2: Sketch Map of the SUE Investigation & Scope of Work on Kennedy Road

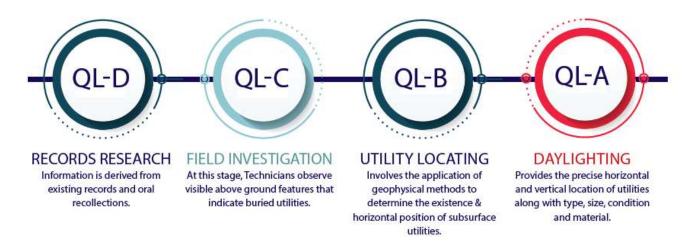
Figure 5-1: Quality Levels for SUE Investigation

A SUE investigation involves the collection of utility data through four (4) Quality Levels, or activities, as per Figure 6-1 below. Comparing and analyzing data makes it possible to achieve a complete and accurate composite data set for making informed decisions within a project or impact area.

In this study, the first three SUE Quality Levels; QL-D, QL-C and QL-B have been requested and performed accordingly.

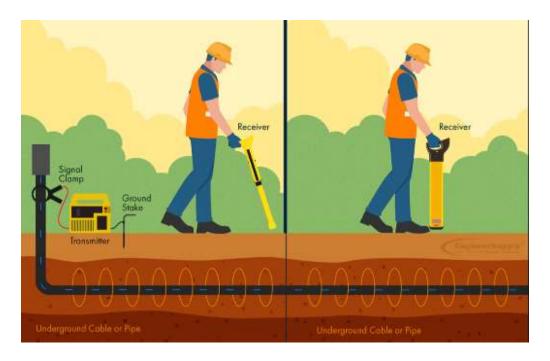
Figure 6-1: Electromagnetic (EM) Induction Process (Pipe and cable Locating)

Electromagnetic (EM) Induction tools (RD4000 PL Radio-detection type), otherwise known as pipe and cable locating, were leveraged to carry out the Quality Level B component of the SUE program and accurately locating buried infrastructure utilities.

This technique is extremely effective for locating utilities comprised of electrically conductive material or those that contain an intact tracer wire.
