Subsurface Utility Engineering Investigation Report

SUBSURFACE UTILITY ENGINEERING (SUE) QUALITY LEVEL B INVESTIGATION

Project #46726 (Warden Ave, Markham, ON)

Subsurface Utility Engineering Report for York Region, ON

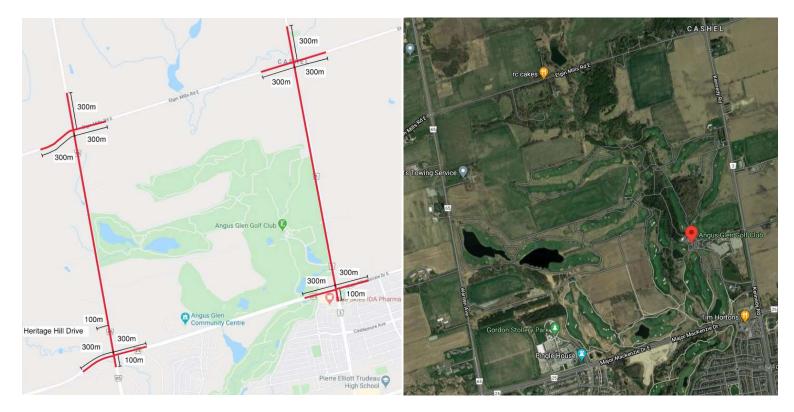
Figure 1-1: Aerial View of the Project Area at Warden Avenue and Kennedy Road, Markham. ON

multiVIEW Locates Inc. has performed the SUE investigation; fieldwork Quality level B (QL-B) and completed the desktop investigation for the project area of the Warden Ave; from Elgin Mills Rd to Mackenzie Drive East, Markham, ON and Kennedy Road; from Elgin Mills Rd to Mackenzie Drive East, Markham, ON . That is defined in the map and scope of work, shown in Figure 1-1 and Figure 2-1.

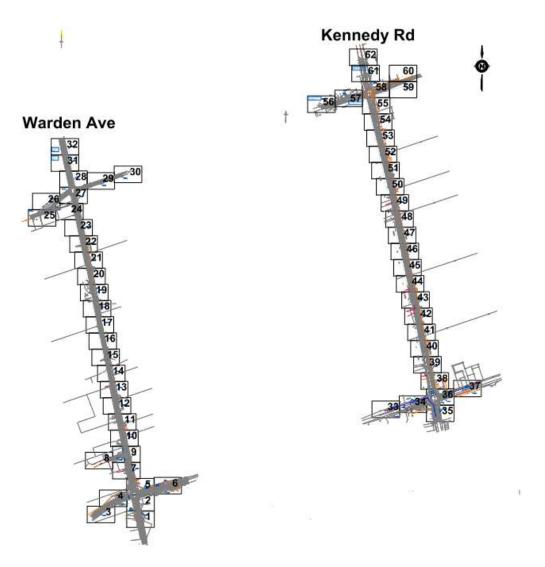
Figure 2-1: Key Map from the Composite SUE QL-B Drawing (Attached in Appendix A)

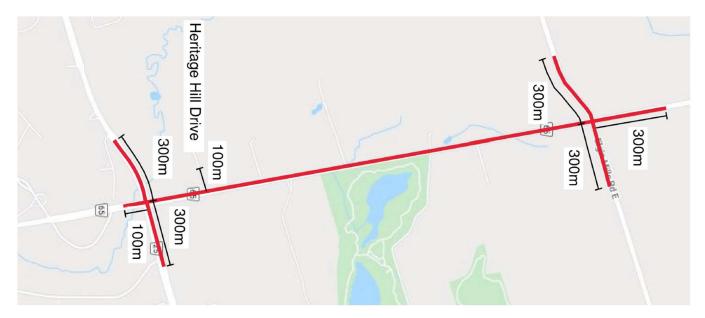
Figure 3-1: Sketch Map of the SUE Investigation & Scope of Work on Warden Avenue

Project includes the investigation area as per Figure 3-1 and Figure 3-2.

The project limits defined as follows and shown in Figure 3-1 and Figure 3-2.

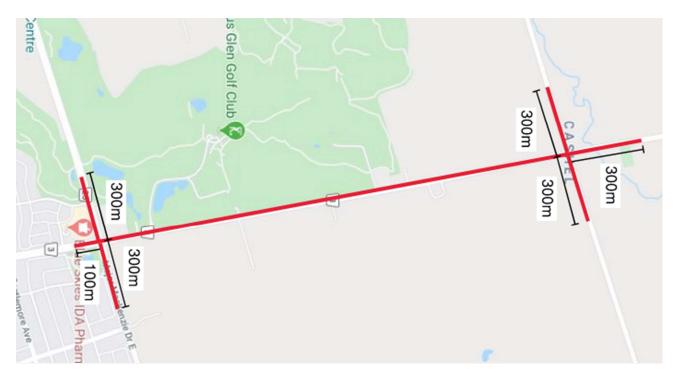
Figure 3-2: Sketch Map of the SUE Investigation & Scope of Work on Kennedy Road

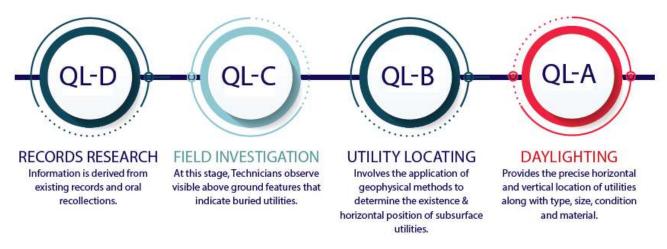
Figure 5-1: Quality Levels for SUE Investigation

A SUE investigation involves the collection of utility data through four (4) Quality Levels, or activities, as per Figure 6-1 below. Comparing and analyzing data makes it possible to achieve a complete and accurate composite data set for making informed decisions within a project or impact area.

In this study, the first three SUE Quality Levels; QL-D, QL-C and QL-B have been requested and performed accordingly.

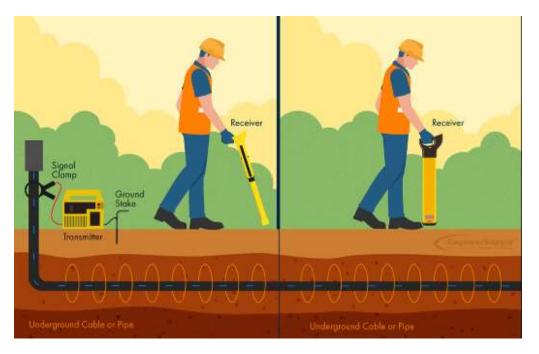
Figure 6-1: Electromagnetic (EM) Induction Process (Pipe and cable Locating)

Electromagnetic (EM) Induction tools (RD4000 PL Radio-detection type), otherwise known as pipe and cable locating, were leveraged to carry out the Quality Level B component of the SUE program and accurately locating buried infrastructure utilities.

This technique is extremely effective for locating utilities comprised of electrically conductive material or those that contain an intact tracer wire.
