YORK REGION

CLASS ENVIRONMENTAL ASSESSMENT STUDY FOR IMPROVEMENTS TO LANGSTAFF ROAD FROM WESTON ROAD TO HIGHWAY 7

PRELIMINARY STRUCTURAL DESIGN REPORT BOWES BRIDGE (WEST DON RIVER CROSSING)

NOVEMBER 26, 2021

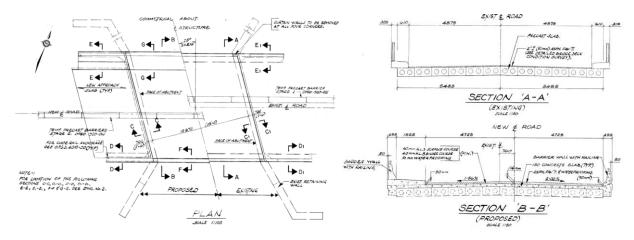
Figure 1: Plan and Sections from 1993 Contract Drawings

See Figure 1 below for the plan and sections of the structure from the 1993 contract drawings.

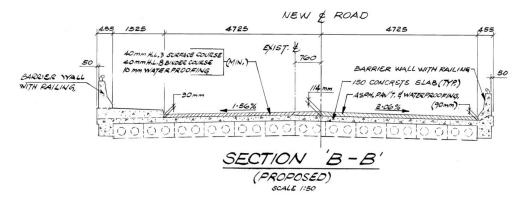
Figure 2: Existing Cross-Section

- 0.455 m north barrier wall
- 1.525 m north sidewalk
- 4.275 m shoulder and westbound lane
- 4.275 m eastbound lane and shoulder
- 0.455 m south barrier wall

Figure 2 shows a cross-section of the existing bridge from the 1993 contract drawings.

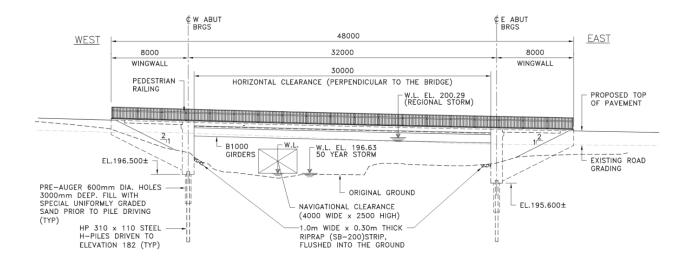
Figure 3: Proposed Elevation

Based on the project correspondence with Navigation Protection Program (NPP), it was confirmed that West Don River would be considered as a navigable waterway. The proposed crossing structure can accommodate a navigational clearance of 4 m (Horizontal) x 2.5 m (Vertical), required for motorized boats up to 8.0 m in length; however, it will not be able to accommodate motorized boats larger than 8.0 m in length. Based on high level observation, the West Don River crossings upstream at Rutherford Road and downstream at Rivermede Road are not considered navigable as they are culvert crossings. Therefore, it is highly unlikely to have motorized boats larger than 8.0 m using this portion of the West Don River. NPP has subsequently confirmed that it is generally acceptable to provide a navigational clearance no less than the structures immediately upstream and downstream from the proposed new structure. An absolute determination can only be provided after the NPP has had an opportunity to review the submission, which is to be confirmed in detail design.

A preliminary General Arrangement drawing of the proposed work is included in Appendix A.

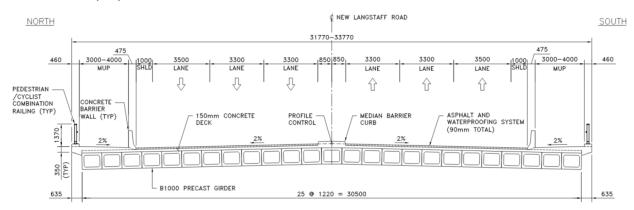
Figure 4: Proposed Cross Section

- 3.000 m ~ 4.000m south multi-use path
- 0.460 m south pedestrian/cyclist railing

The proposed roadway cross-section has a normal crown with a 2% cross-fall.. See Figure 4 below for the proposed cross-section.
