Pavement Design Report

Teston Road from Keele Street to Bathurst Street, Regional Municipality of York,
Ontario

WSP Canada Inc.

September 25, 2023

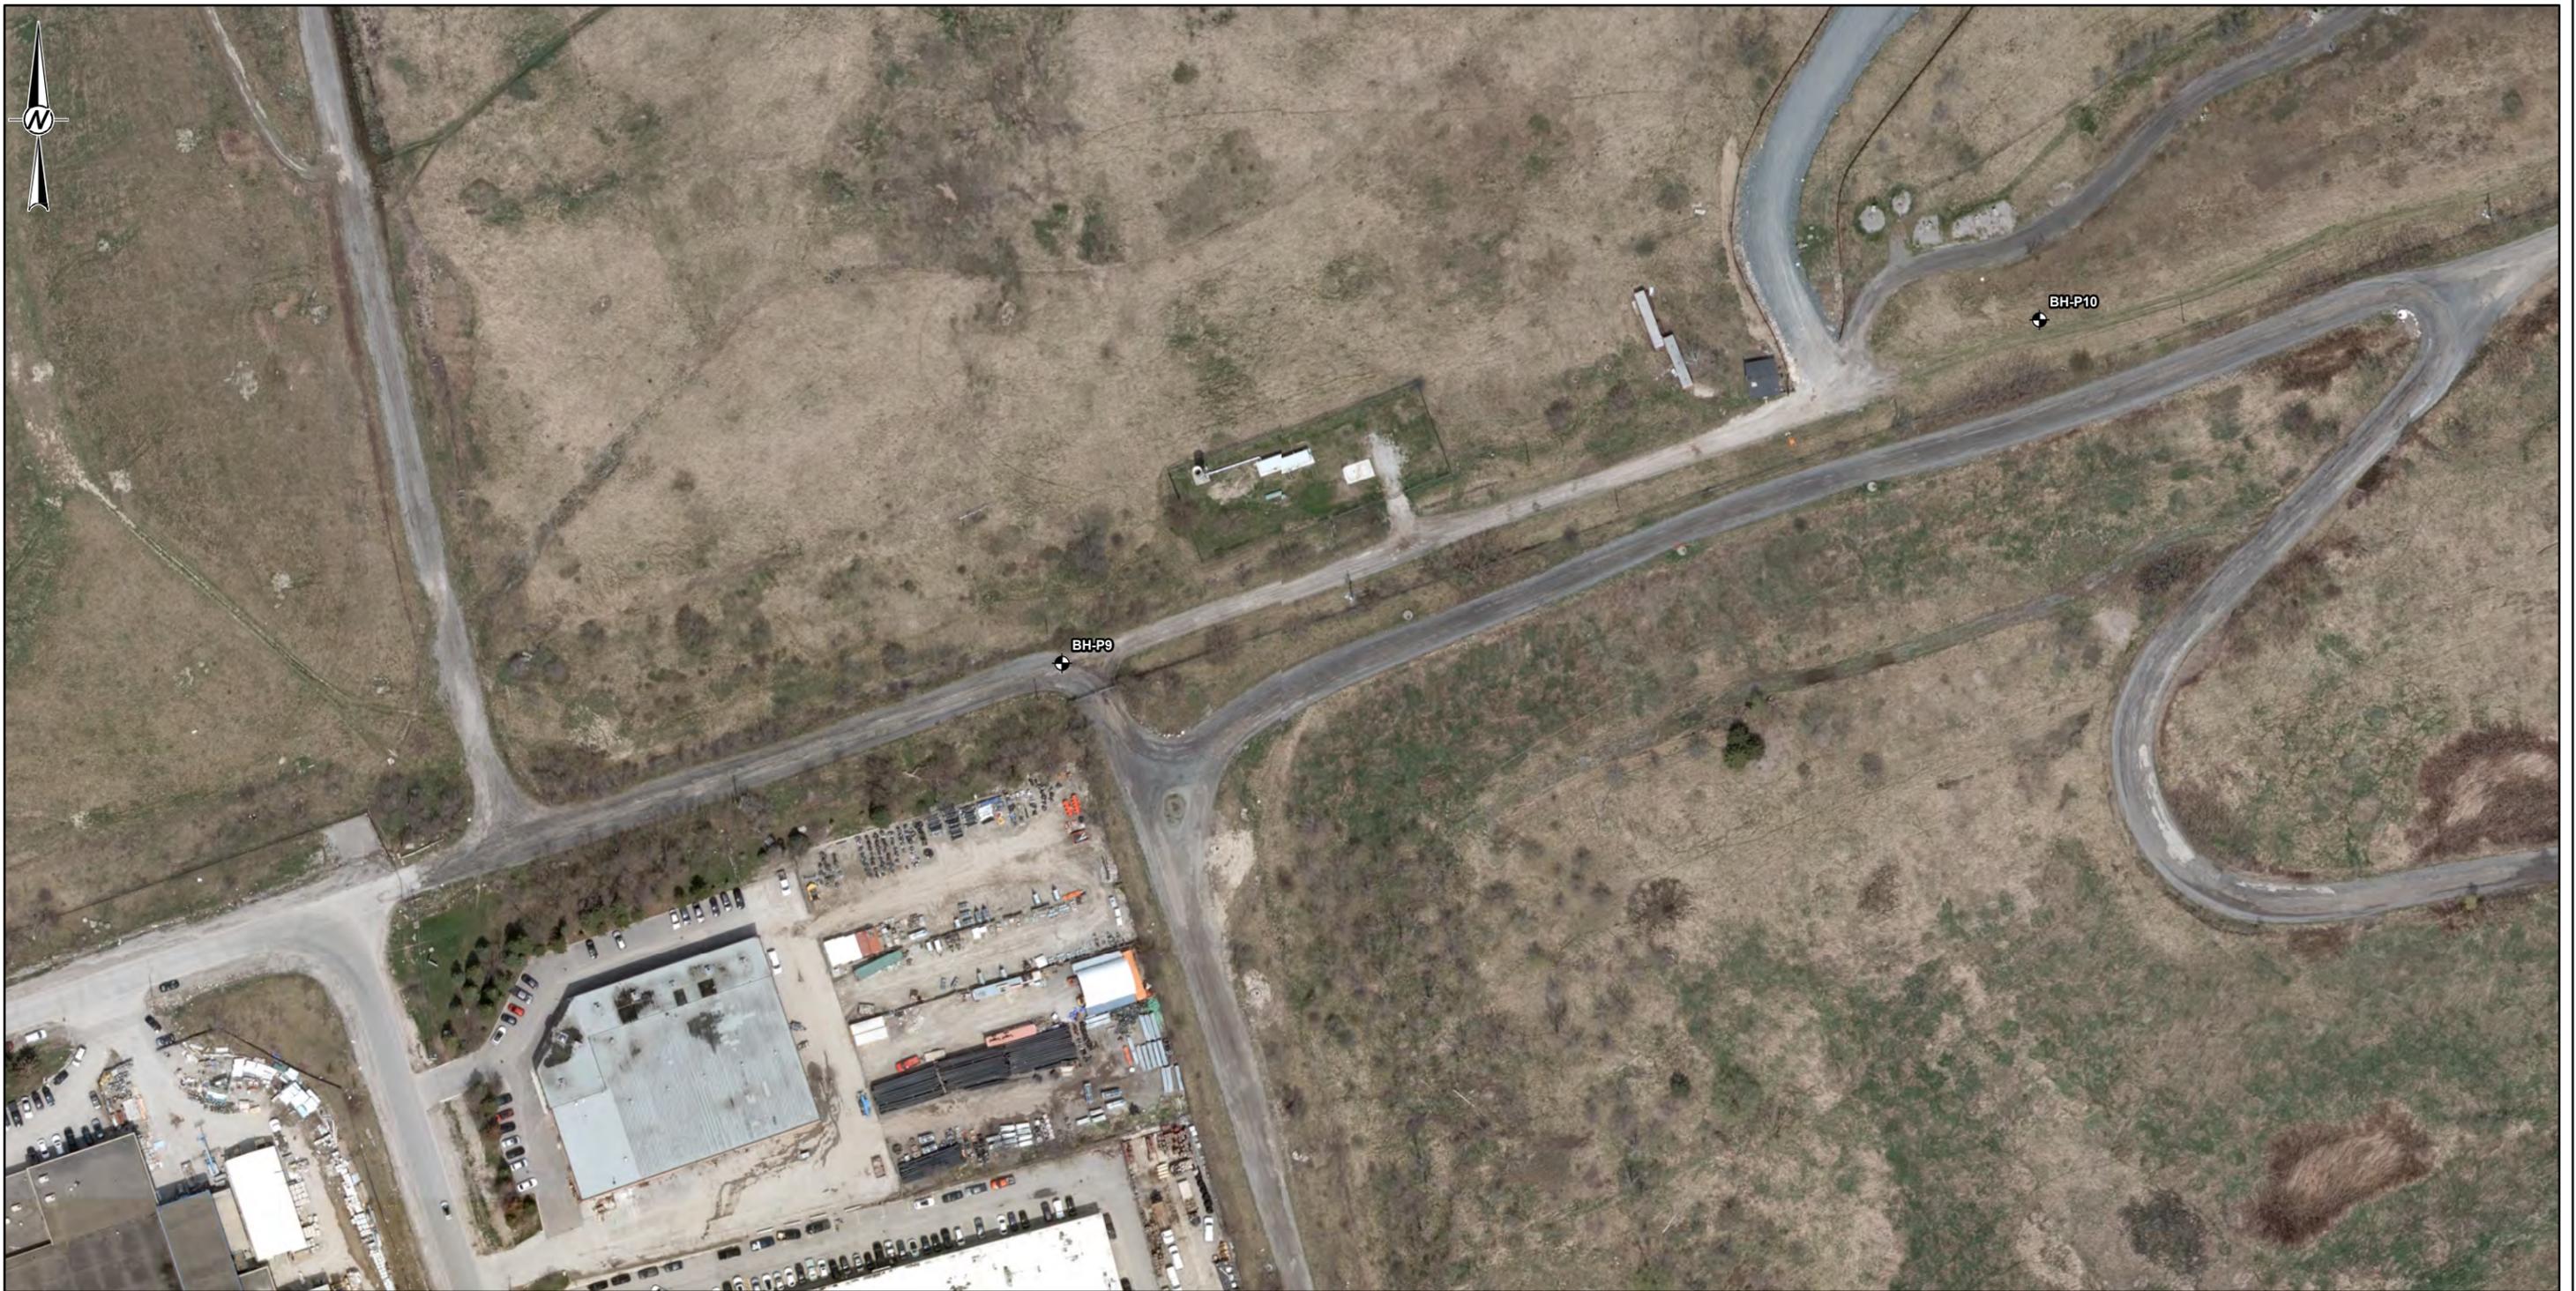
LEGEND
 ✚ BOREHOLE LOCATION

The field work was carried out in January of 2023, at which time 36 boreholes were advanced to a depth of about 1.5 mbgs and 2 full depth hot-mix asphalt (HMA) cores were obtained from the locations shown on the Borehole/Core Location Plan (see Figure 1, attached). The boreholes were drilled using solid stem augers advanced by a truck mounted drill rig supplied and operated by a specialist drilling contractor, subcontracted to WSP. The off-road boreholes were advanced using hand augering equipment operated by WSP. The groundwater conditions were noted in the open boreholes during drilling. The soil samples obtained during the site investigation were brought to our Whitby laboratory where further examination and classification testing (i.e. water contents, grain size distributions and Atterberg Limits) were carried out on selected samples. At the two locations where full depth asphalt core samples were obtained, the boreholes could not be advanced due to utility conflicts.

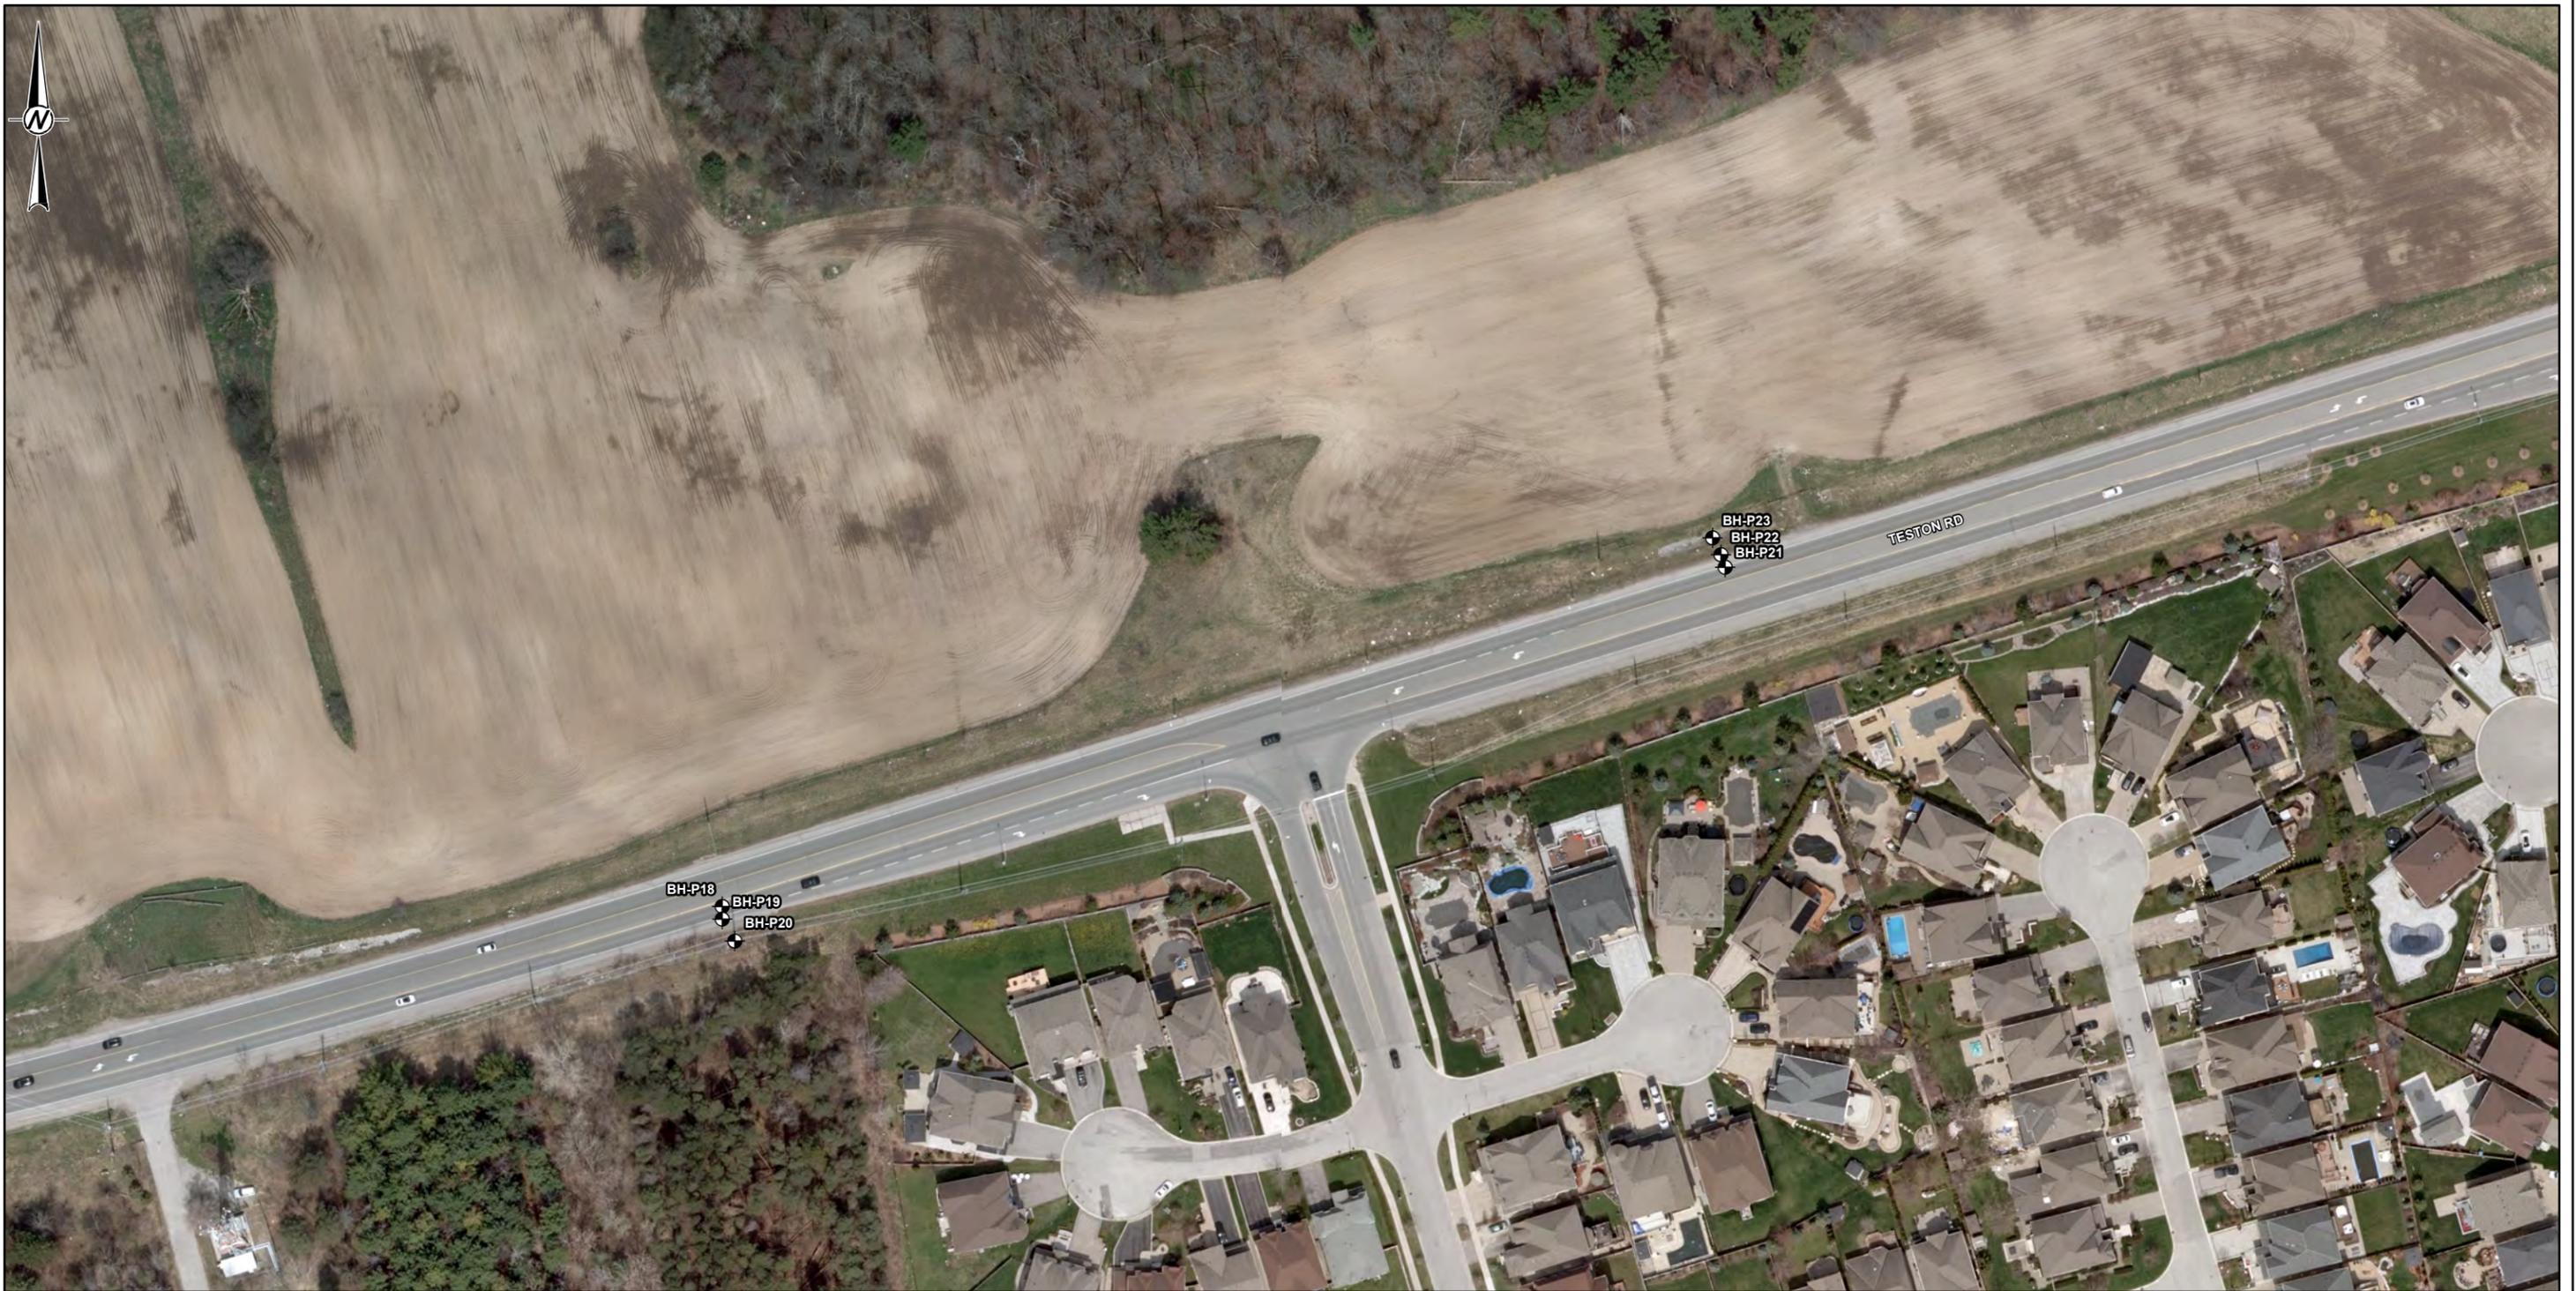
PROJECT NO. 21496759 CONTROL 0001 REV. A FIGURE 1E

LEGEND
 ◻ BOREHOLE LOCATION

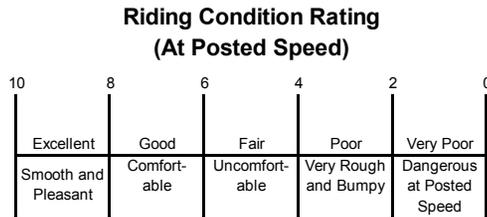
FLEXIBLE PAVEMENT CONDITION EVALUATION FORM (MUNICIPALITIES)

Road No. (Street) Teston Road **Location From** Dufferin Road **To** Bathurst Street
Section Length 2.0 (KM) **Survey Date** January 16, 2023 **Traffic Direction** B B: Both Directions, N: North Bound
 S: South Bound, E: East Bound, W: West Bound
Contract No. _____ **Work Project No.** _____ **Class** A F: Freeway, C: Connecting Link, A: Major Arterial
 M: Minor Arterial, R: Residential
Pavement Condition Rating (PCR) 75 **Riding Condition Rating (RCR)** 7 **Evaluated by** TSD

Severity of Distress			Density of Distress % <small>Extent of Occurrence</small>		
	Slight	Moderate	Severe	Intermittent	Frequent	Extensive
Pavement Distress Manifestation	1	2	3	< 20 1	20-50 2	> 50 3
Surface Defects	Ravelling	X			X	
	Flushing					
	Potholes	X			X	
	Pavement Edge Breaks	X			X	
	Manholes and Catchbasins	X			X	
Surface Deformation	Rippling and Shoving					
	Wheel Track Rutting	X			X	
	Distortion	X			X	
Cracking	Utility Trenches	X			X	
	Longitudinal		X		X	
	Transverse		X		X	
	Pavement Edge	X			X	
	Map	X			X	
Alligator	X			X

The following surface distresses were documented in Section 2:

- Frequent, slight ravelling;
- Intermittent, slight potholes;
- Intermittent, slight pavement edge breaks;
- Frequent, slight wheel track rutting;
- Intermittent, slight distortions;
- Intermittent, slight utility trench patches
- Intermittent, moderate longitudinal cracking;
- Intermittent, moderate transverse cracking;

- Intermittent, slight pavement edge cracking;
- Intermittent, slight map cracking; and
- Intermittent, slight alligator cracking.

The RCR is 7 in Section 2.

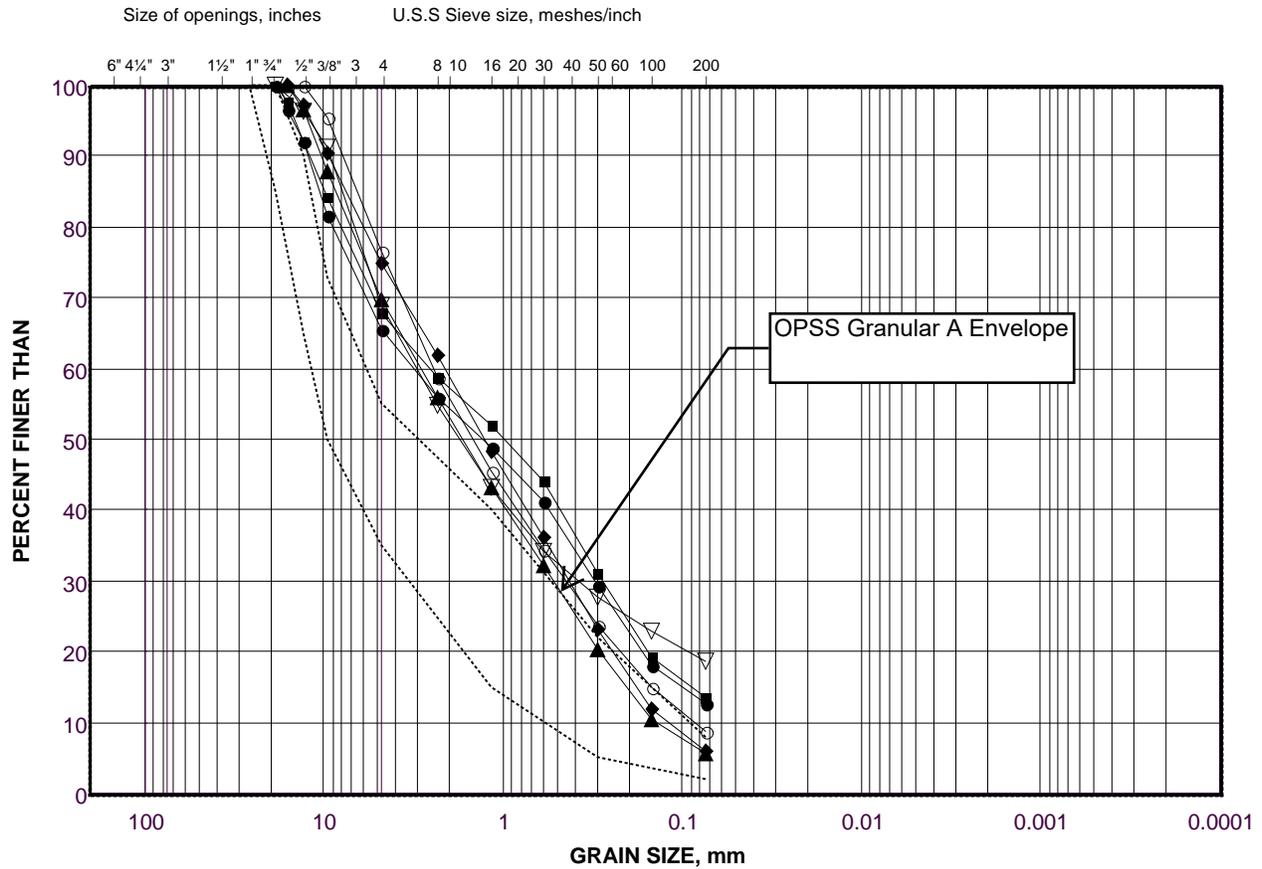
FIGURE C-1

Typical Granular Base Material

GRAIN SIZE DISTRIBUTION

Gradation testing was carried out on six (6) granular base samples. The results indicated that none of the samples tested satisfied the current OPSS.PROV 1010 gradation requirements for Granular A. In most cases, the samples were too fine on most of the sieve sizes, as shown on Figure C1 in Appendix C. The water content of the granular base samples ranged from 3 to 8 percent.

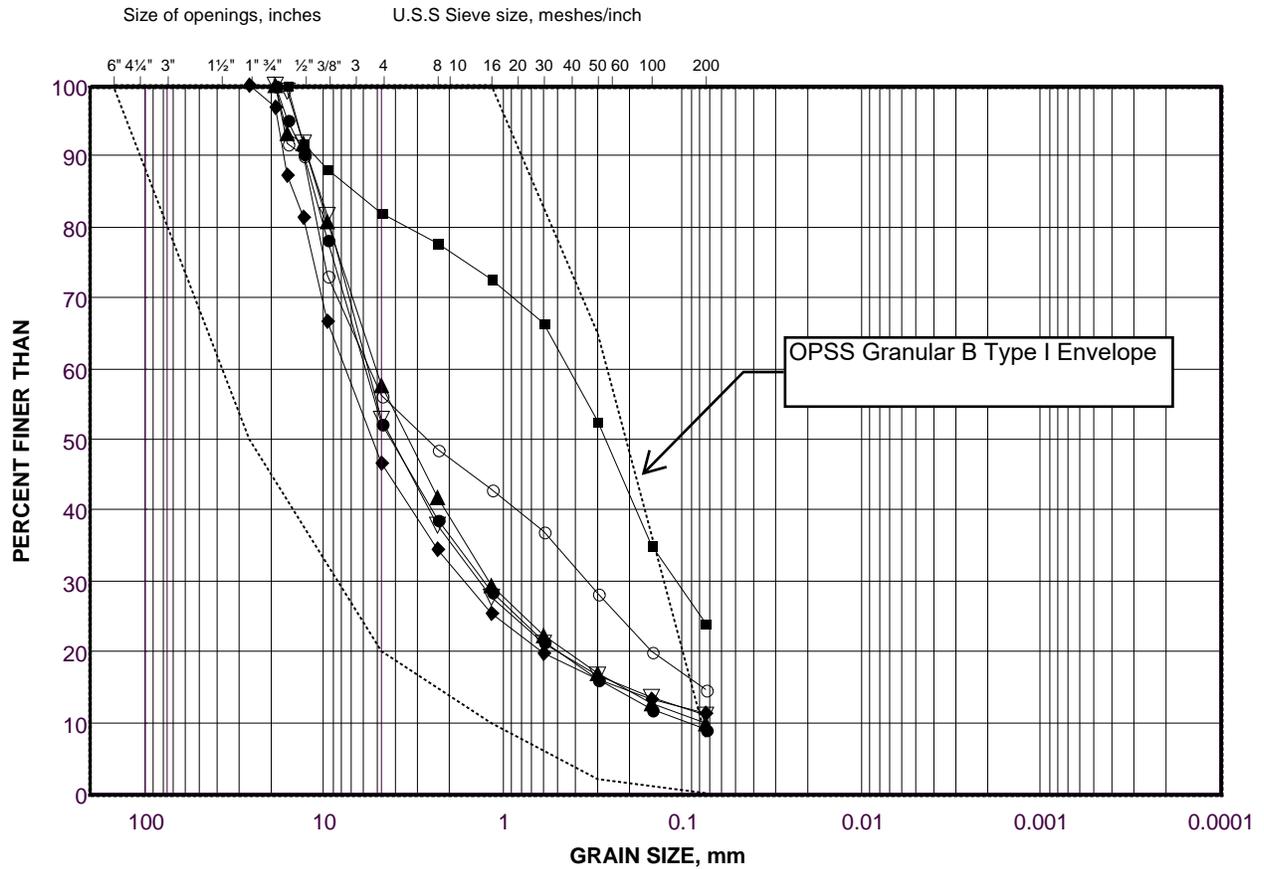
FIGURE C-2

Typical Granular Subbase Material

Gradation testing was carried out on six (6) granular subbase samples. None of the granular subbase samples satisfied the current OPSS.PROV 1010 gradation requirements for Granular B, Type I, generally due to excessive material passing the 75 µm sieve, as shown on Figure C2 in Appendix C. The water content of the subbase samples tested ranged from 2 to 7 percent.

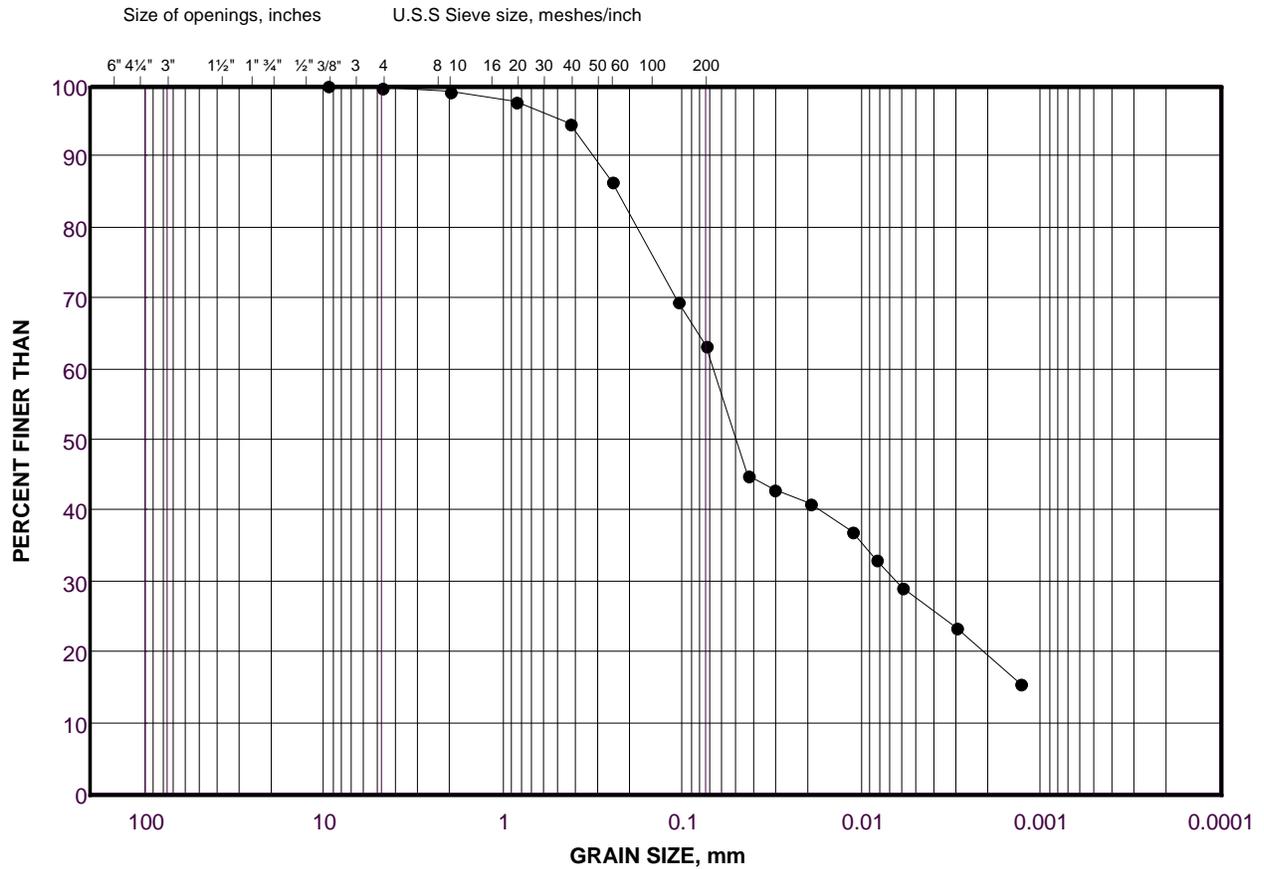
FIGURE C-5

Sandy Silt Subgrade

Laboratory testing was carried out on selected samples of the subgrade materials. The subgrade soils were generally in a moist condition, with two samples in a wet condition encountered in the ditch boreholes. The in-situ water contents of the silty clay/clayey silt subgrade materials generally were 15 percent, and the moisture content of the silty sand, sand and sandy silt materials was 8 to 21 percent. The results of particle size distribution testing carried out on the subgrade soil samples are shown on Figures C3 – C5, in Appendix C.
