# Appendix H.5 – Heritage Impact Assessment Report – George Hunter House

**George Hunter House, 9286 Kennedy Road,  
City of Markham, Ontario**  
*Heritage Impact Assessment*

1664178-13000-R02

August 9, 2019

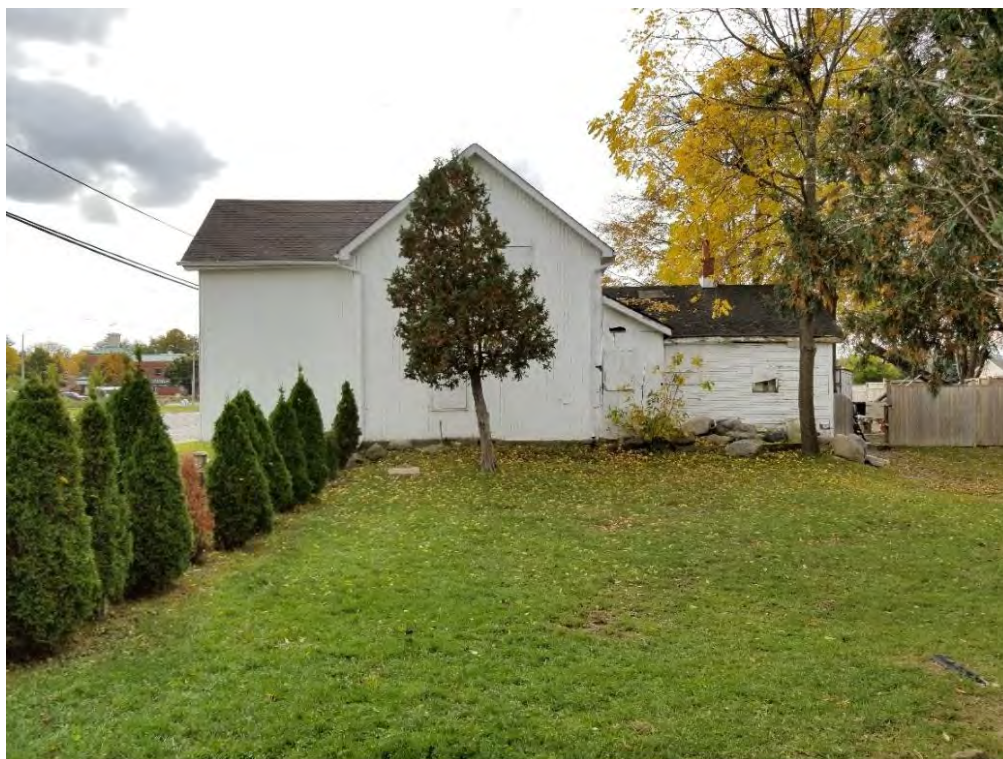
Figure 8: North façade of George Hunter House.

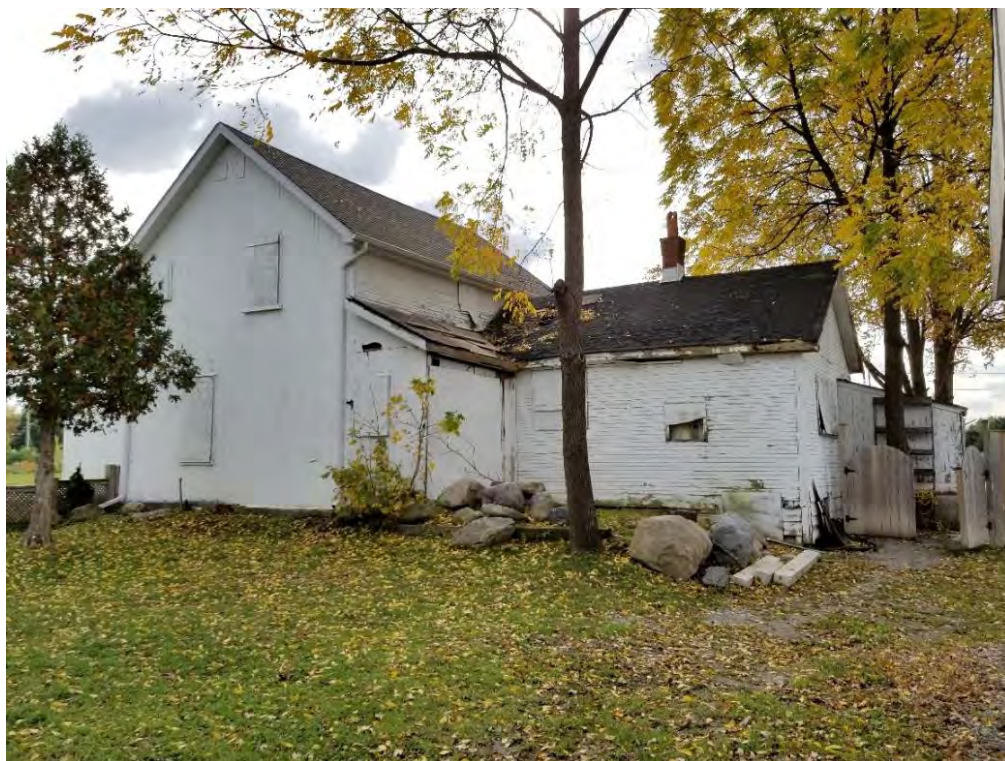
**Figure 9: North and west façades.**

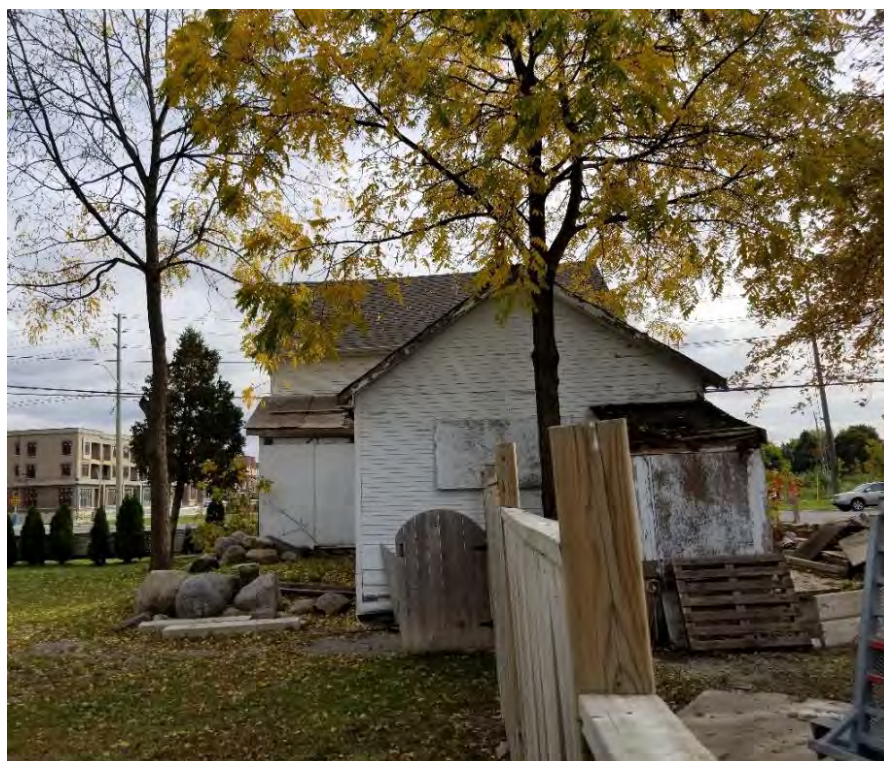
**Figure 10: West façade.**

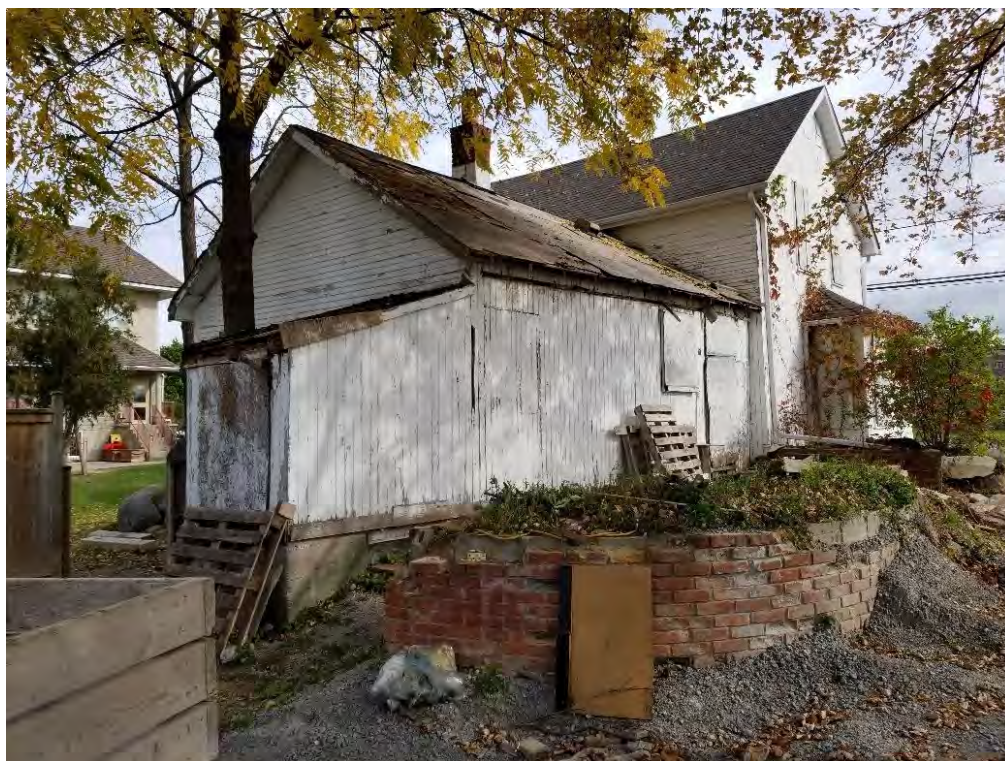
**Figure 11: West and south façades.**

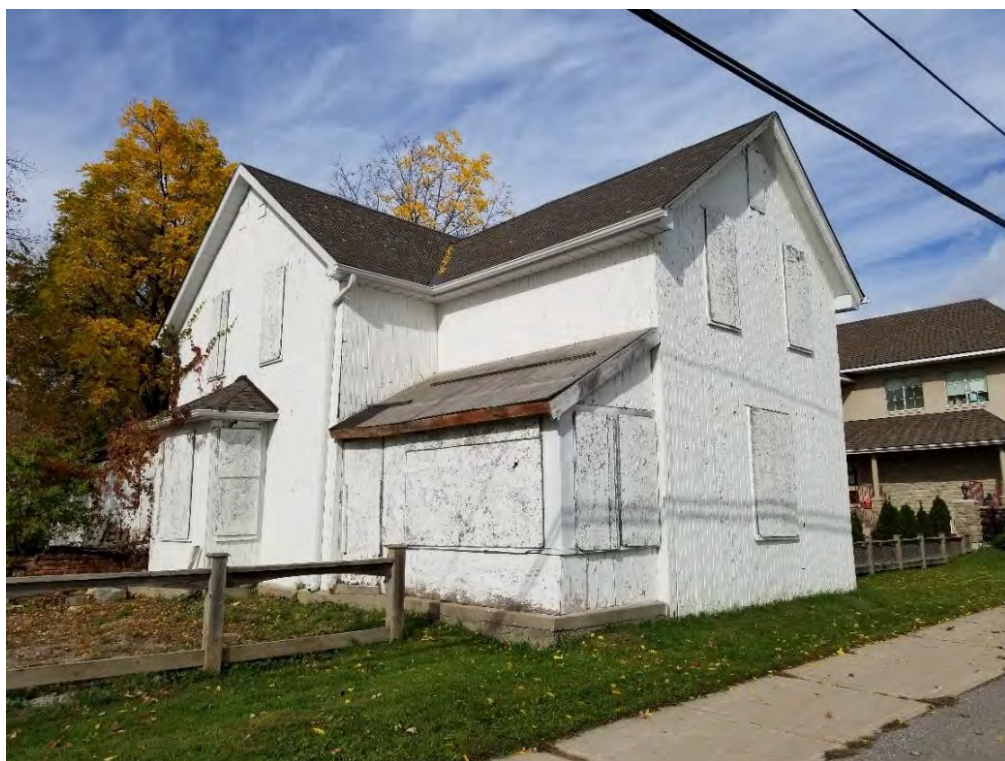
**Figure 12: South and east façades.**

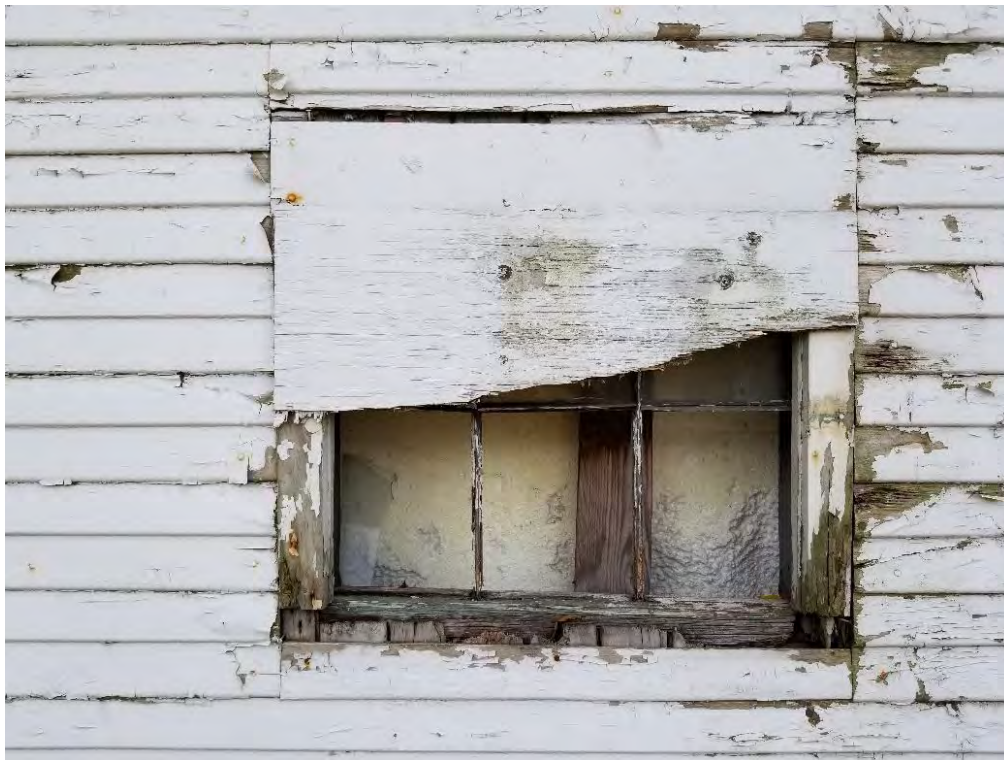
The fenestration is asymmetrical with all windows being tall, flat headed, and lacking a sill and decorative features. All openings have been blinded with plywood sheet, although one is partially uncovered, revealing a three-over-six fixed sash wood window (Figure 13). On the south end wall the Main Block has a three-sided, hip-roof bay (Figure 14).

Figure 13: Fixed sash three-over-six wood window revealed underneath the plywood hoarding.

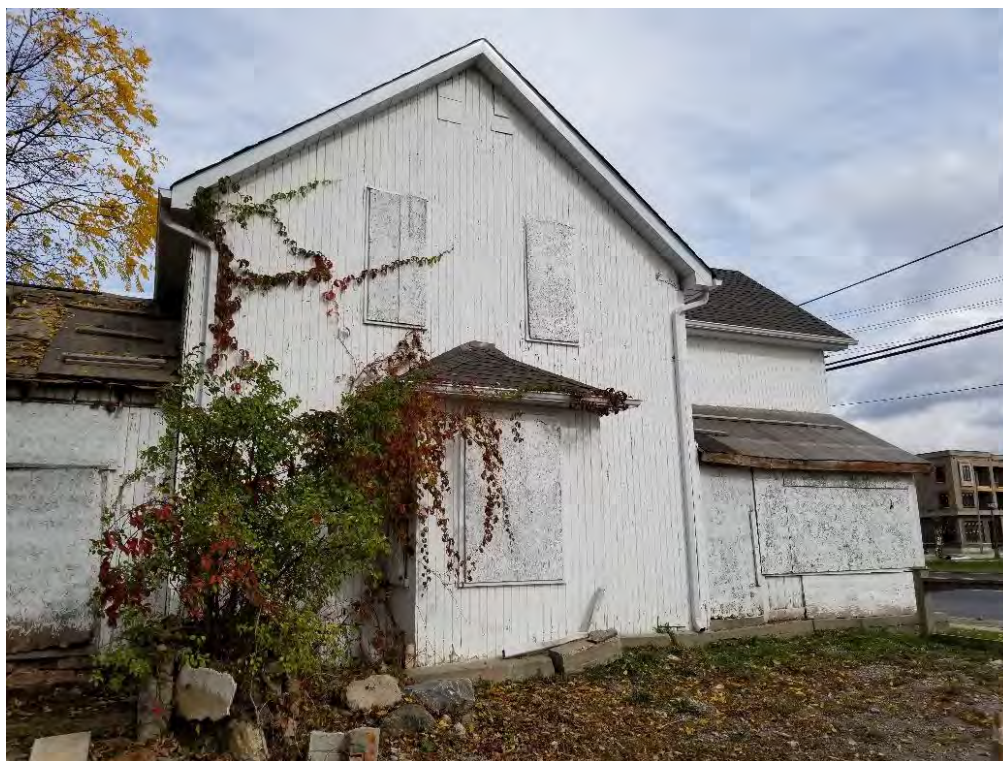
**Figure 14: Three-sided, hip-roof bay on the south end wall.**

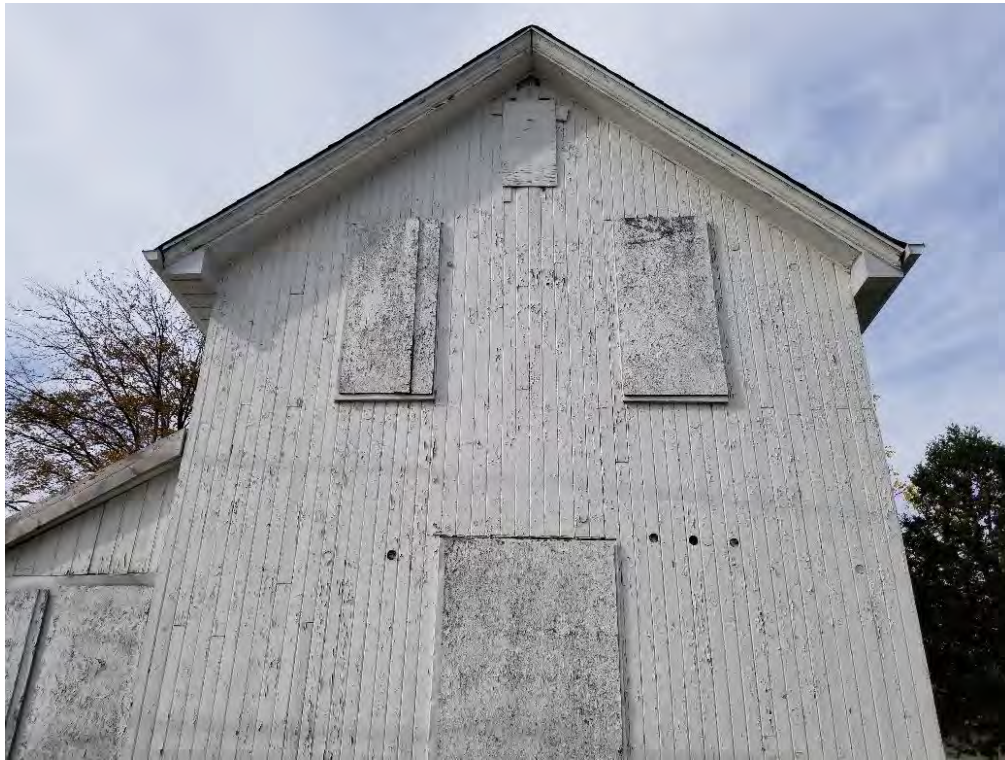
The East Wing has the same vertical wood plank siding of the Main Block. The medium gable roof has asphalt shingles with boxed eaves, metal projecting eaves and verges, moulded fascia and a plain soffit (Figure 15). The fenestration, which is asymmetrically placed, is blind.

Figure 15: East end wall and gable of the East Wing.

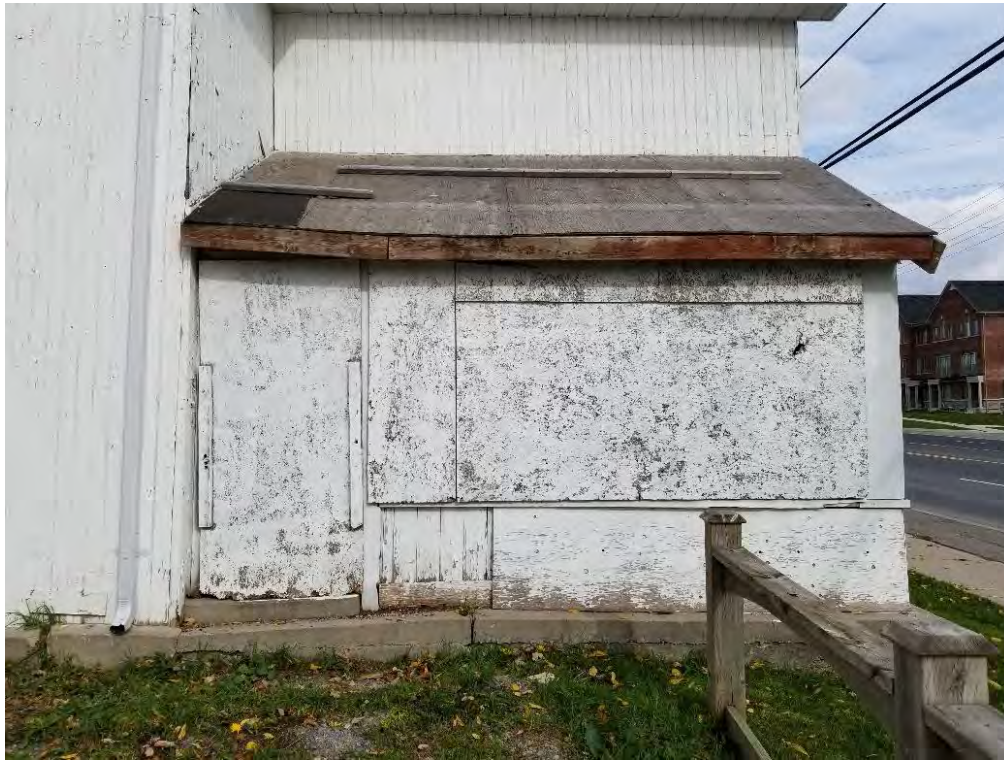
The siding of the Southeast Porch is also vertical wood plank, although most of it has been covered with white plywood. The main entrance on the south façade has been blinded but is single-leaf with a set of straight concrete steps (Figure 16).

Figure 16: South façade of the Southwest Porch.

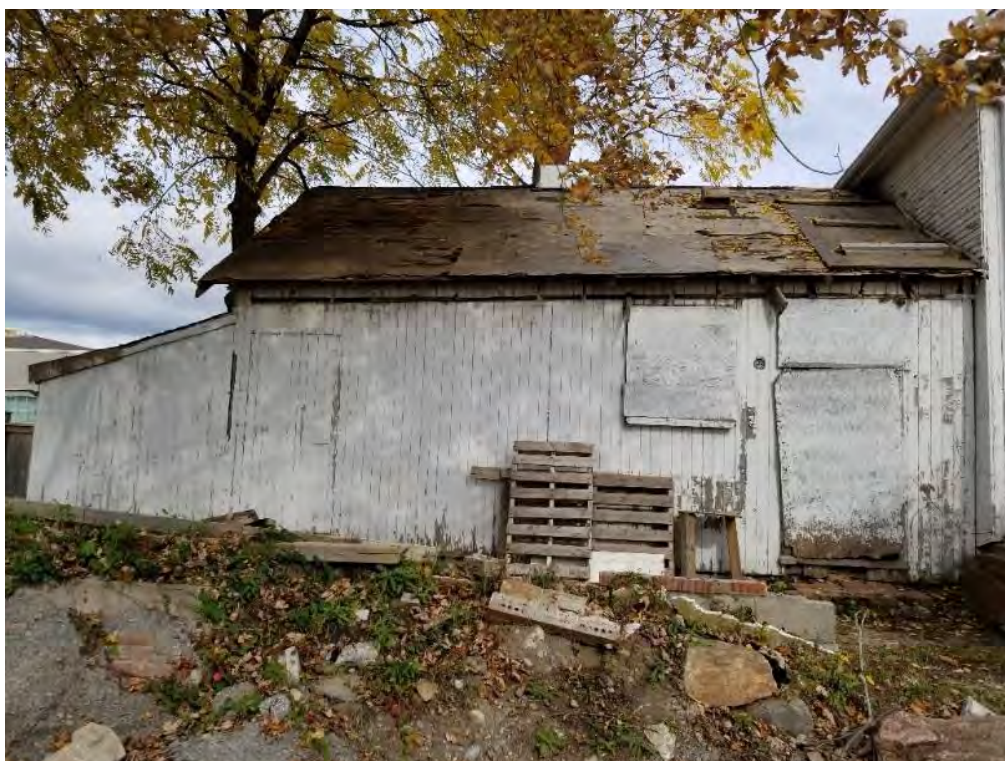
The West Wing stands on a concrete or concrete-parged stone foundation (Figure 17). It has a medium gable roof with asphalt shingles and projecting eaves and verges, as well as a small section at the southwest corner with a shed roof. A single-leaf, wood-plank door is on the south façade (Figure 18), but otherwise all openings have been blinded with plywood.

**Figure 18: South façade of the West Wing.**

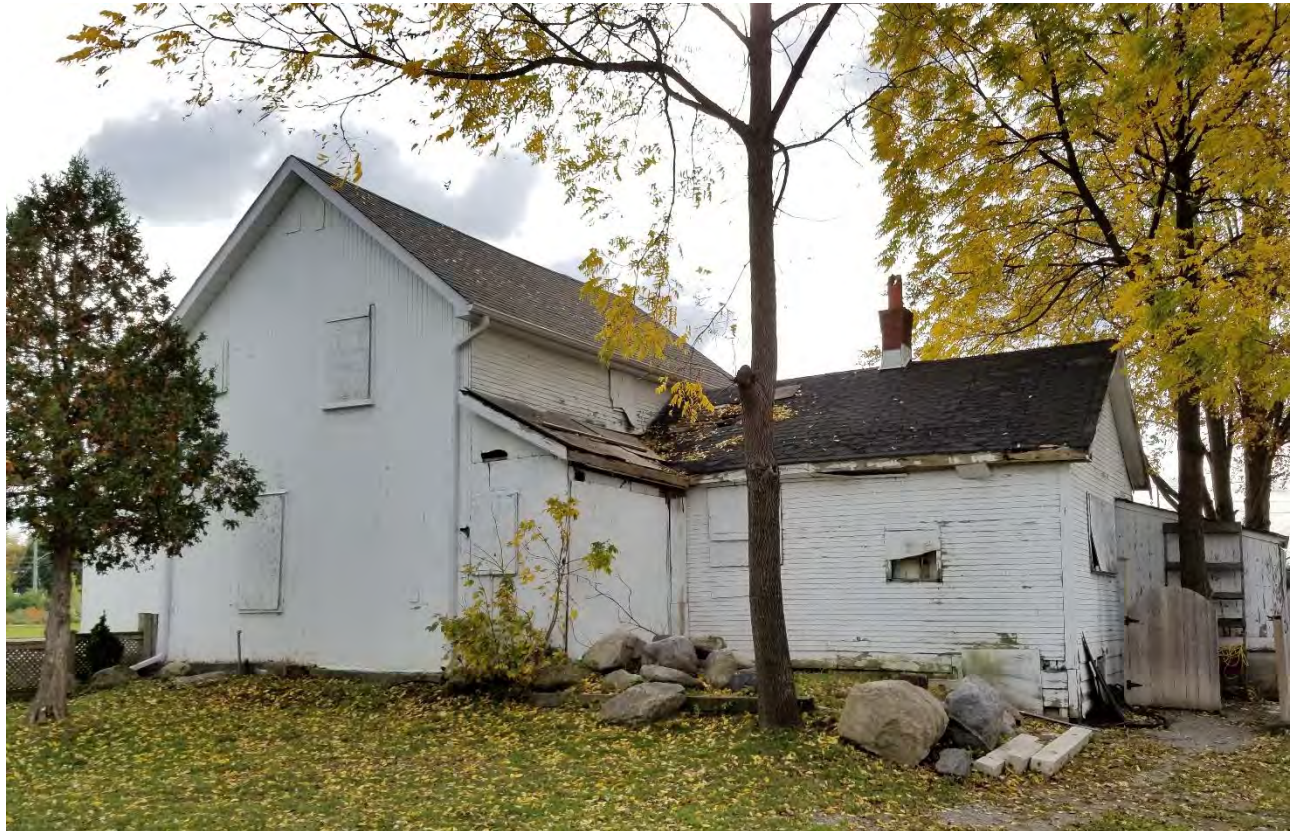
A small porch with shed roof covers the north connection of the Main Block and West Wing. It has a small window on the north façade and is largely covered with plywood (Figure 19).

Figure 19: North and west walls of the Northwest Porch (centre).

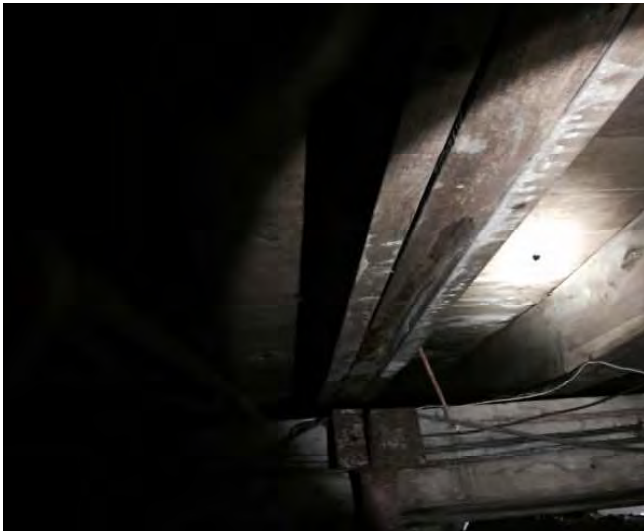
Original beam supported by 2" beams on each side

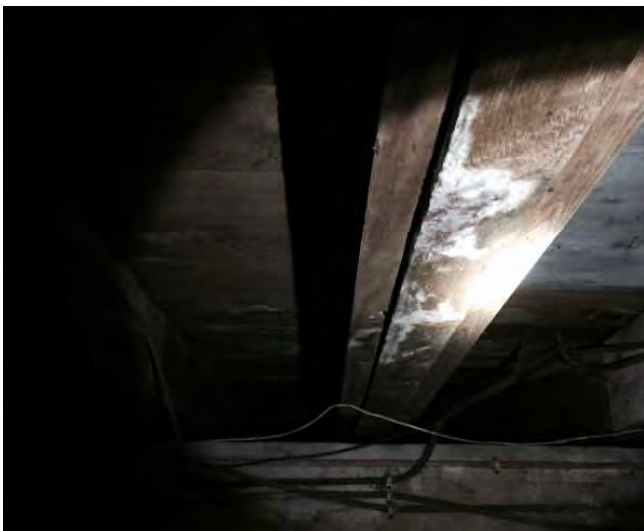
Beams with mould growth

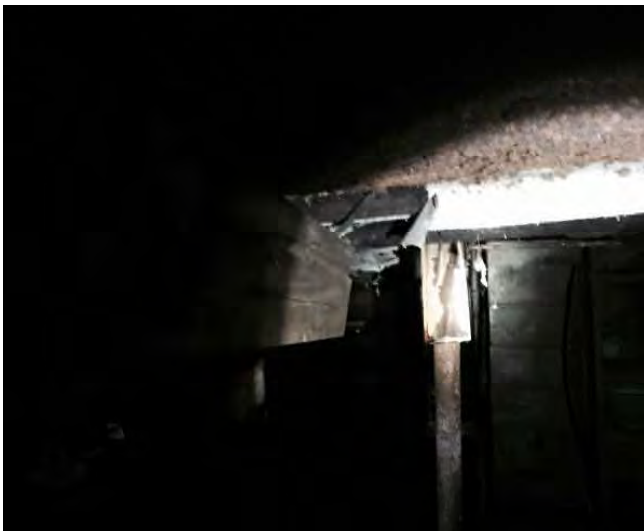
Beam supported by pipe

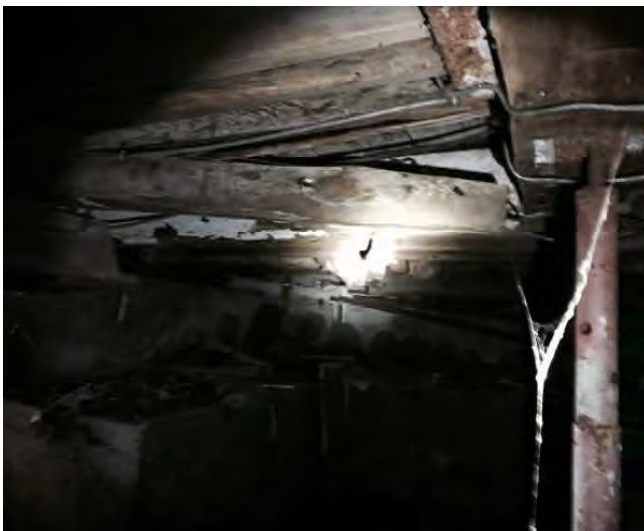
Beam supported by pipe

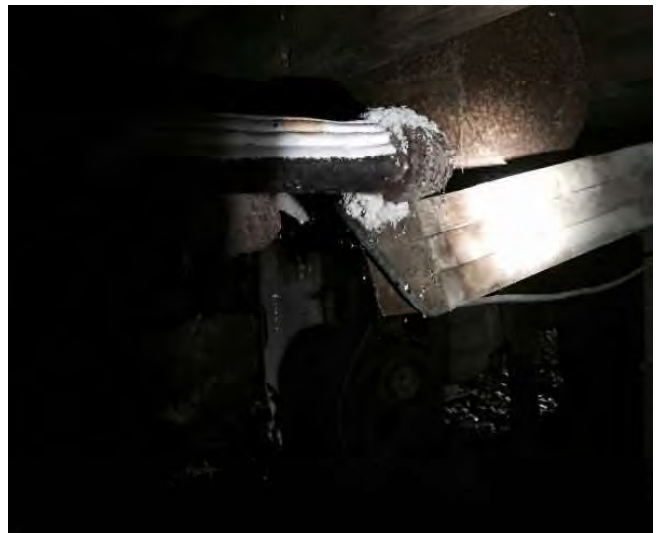
Asbestos detail

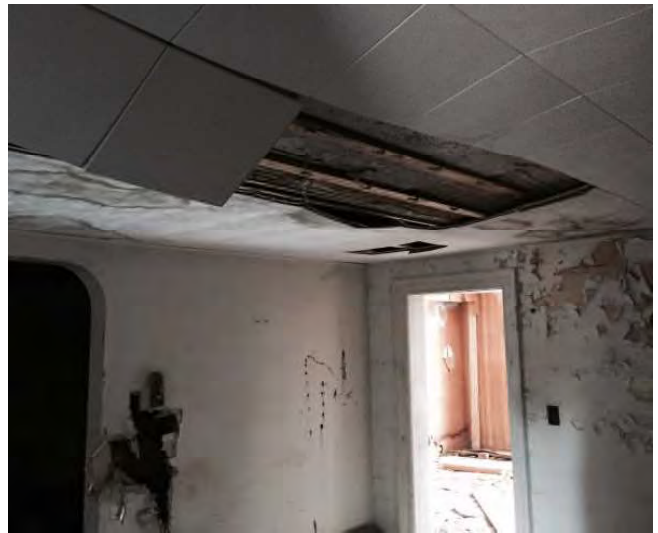
Main floor ceiling

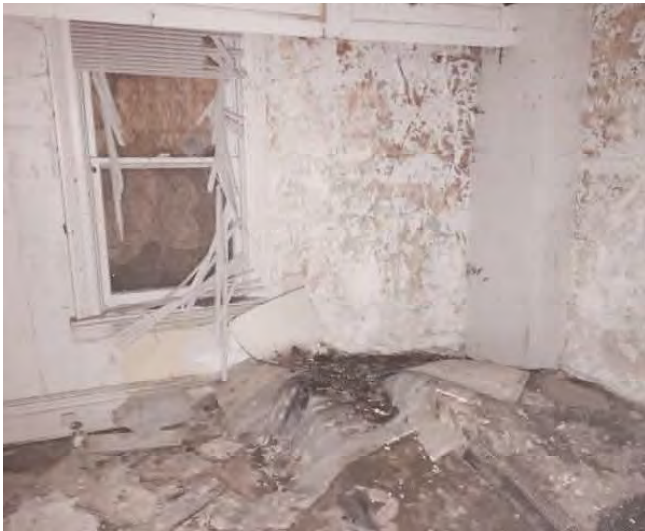
Main floor room

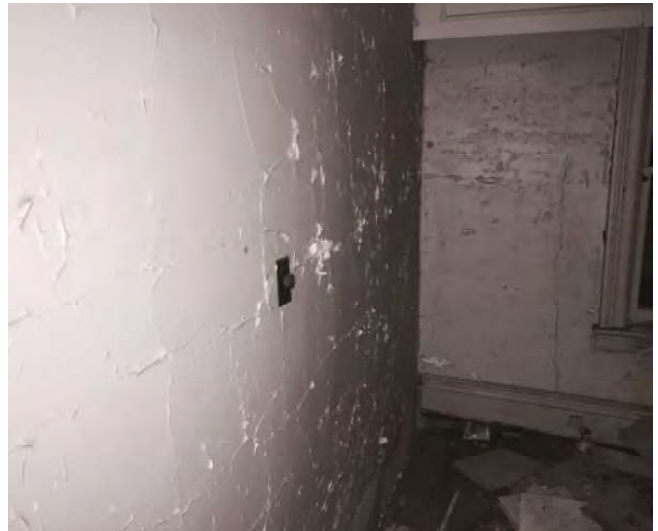
Main floor room

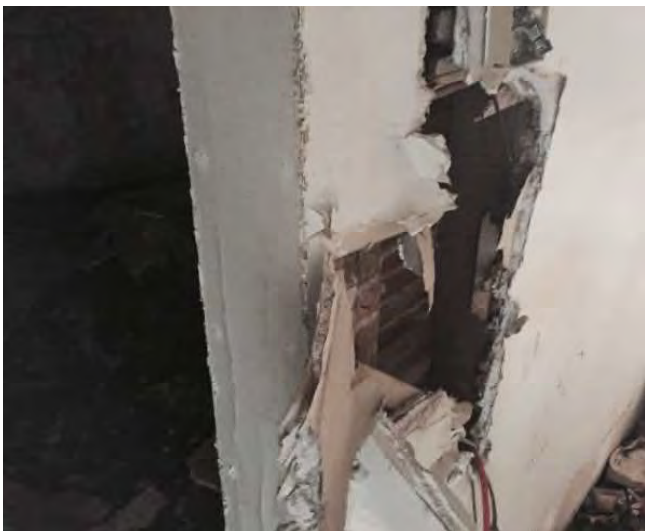
Plaster wall on main floor

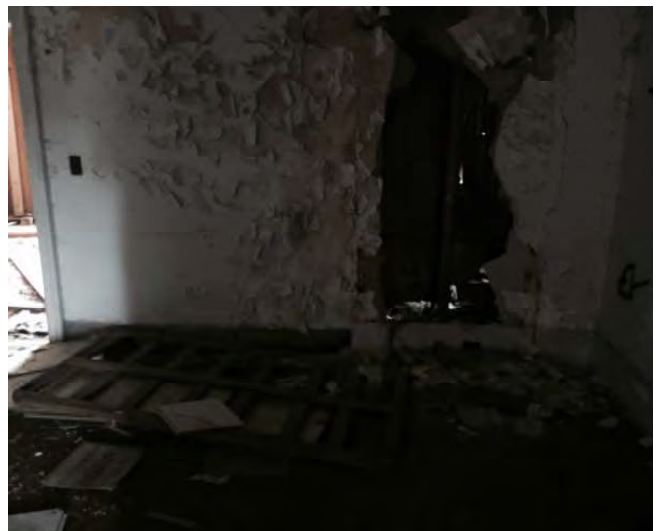
Main floor wall

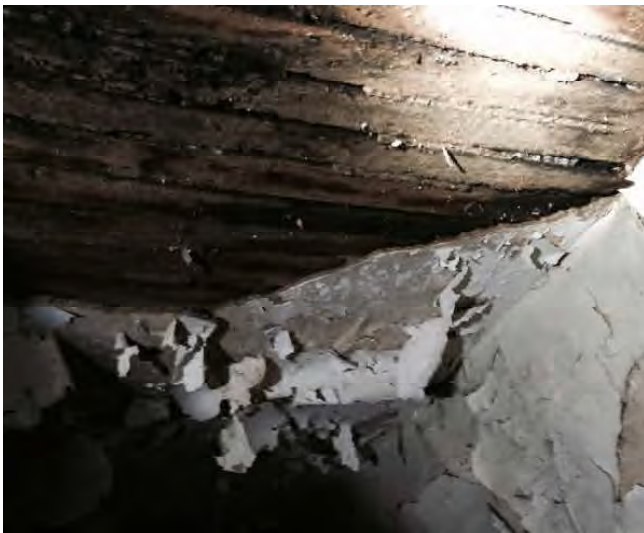
Main floor ceiling detail

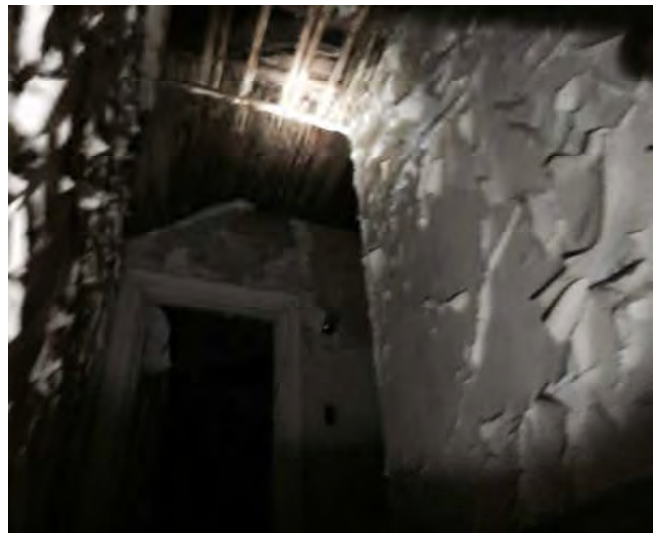
Main floor ceiling detail

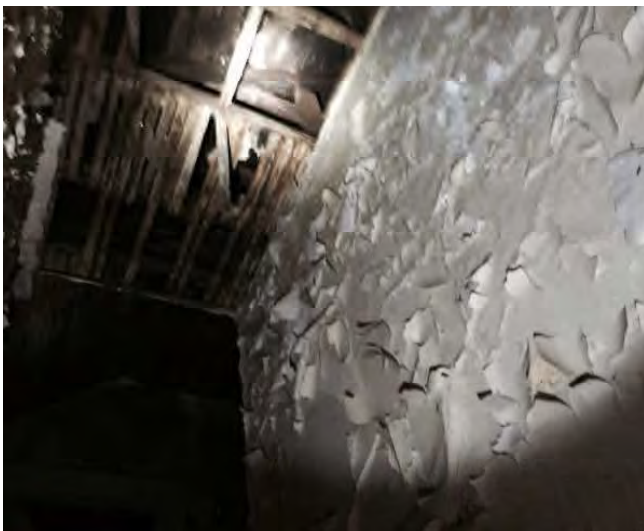
Main floor ceiling detail

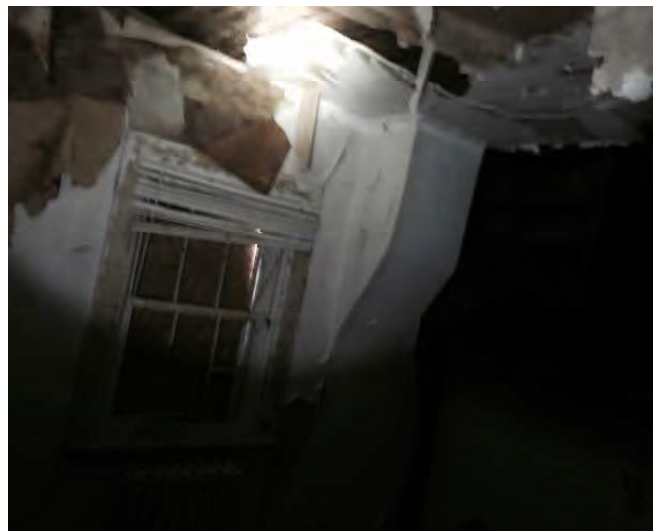
Main floor wall detail

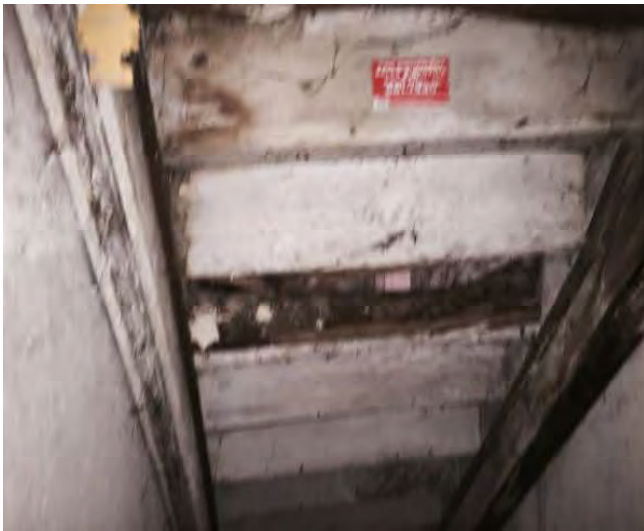
Main floor stairs

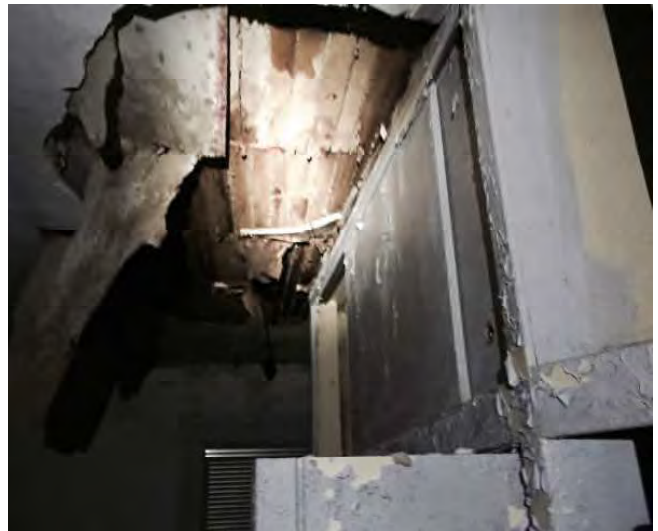
Second floor ceiling detail

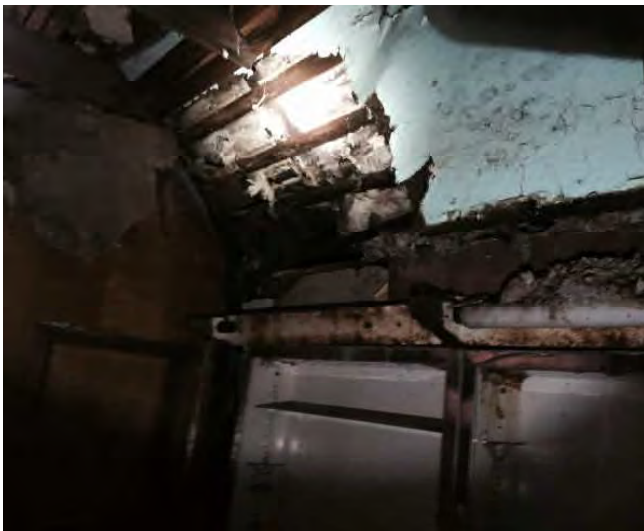
Second floor detail

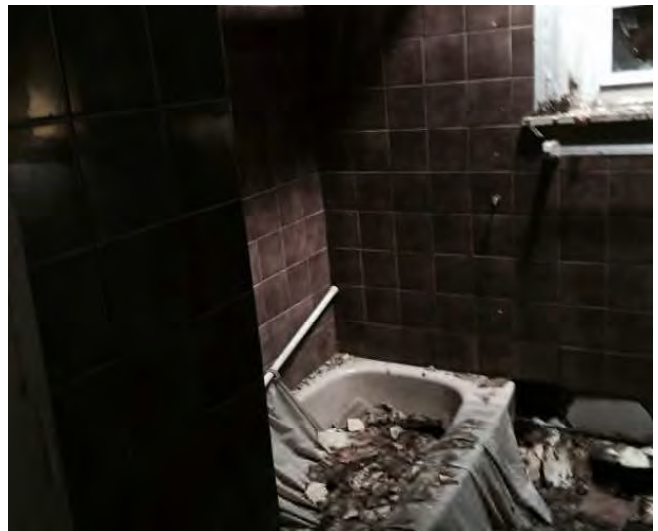
Second floor detail

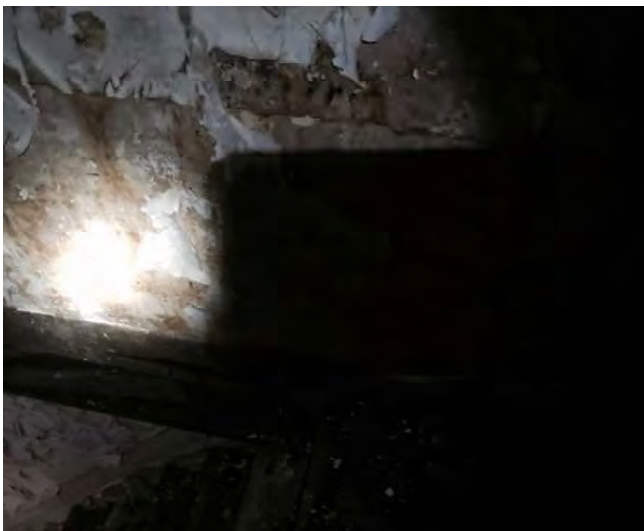
Second floor wall detail

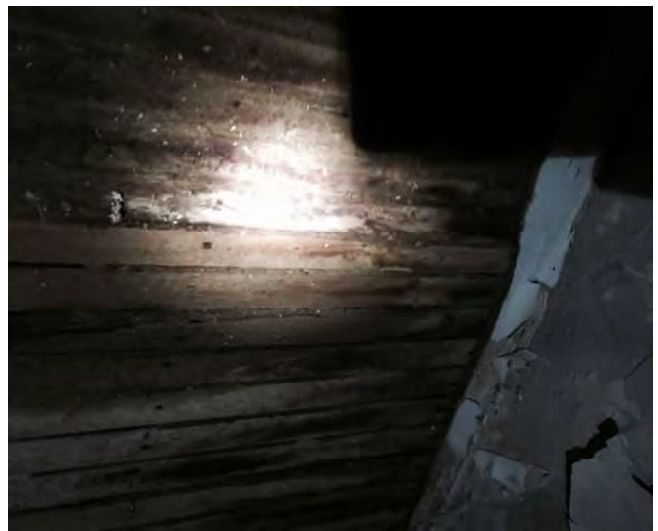
Second floor wall detail

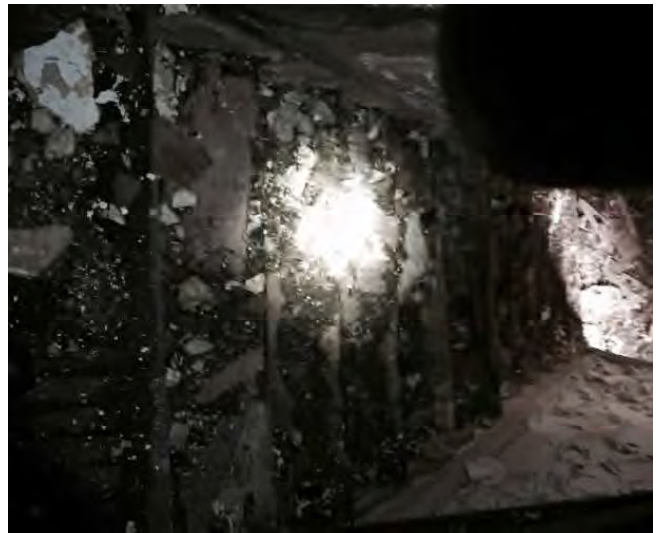
Second floor - west extension

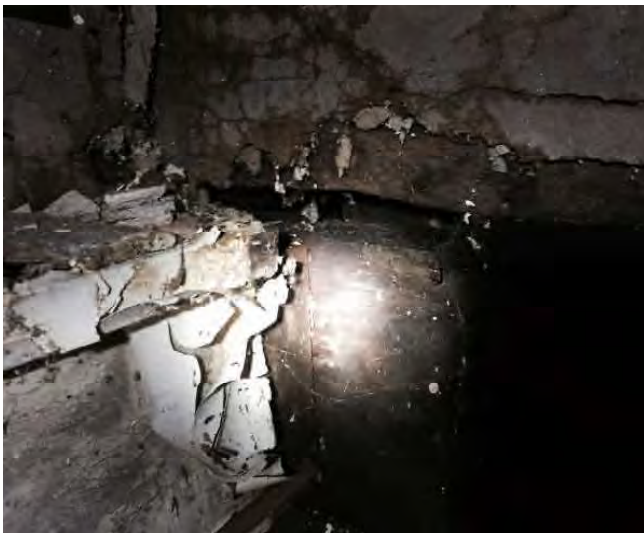
Second floor - west extension

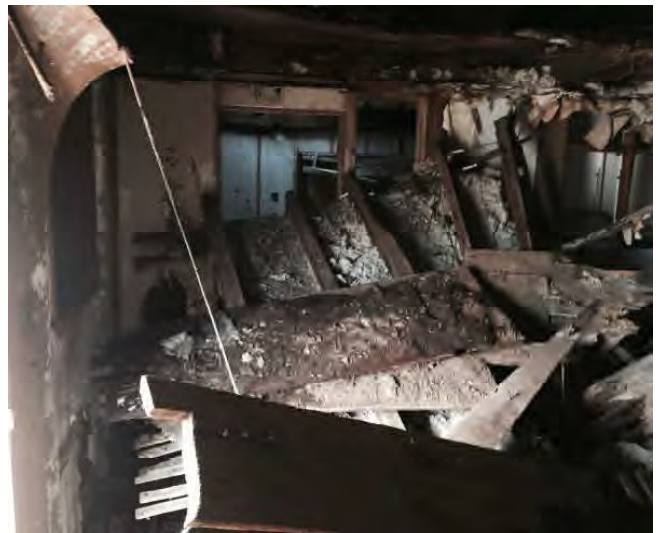
Second floor - west extension

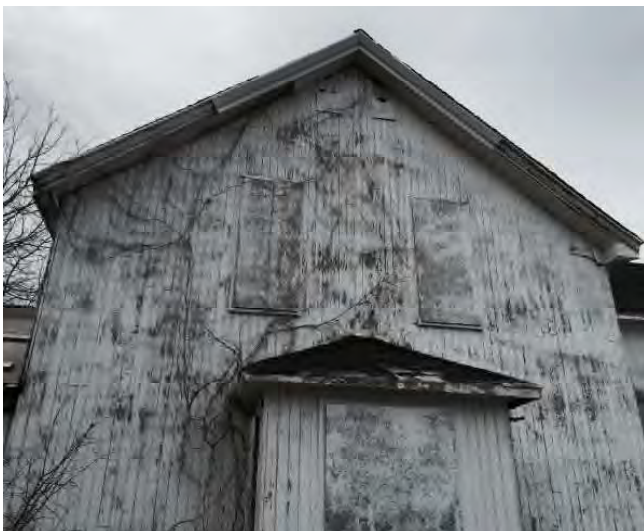
Eastern view of the house

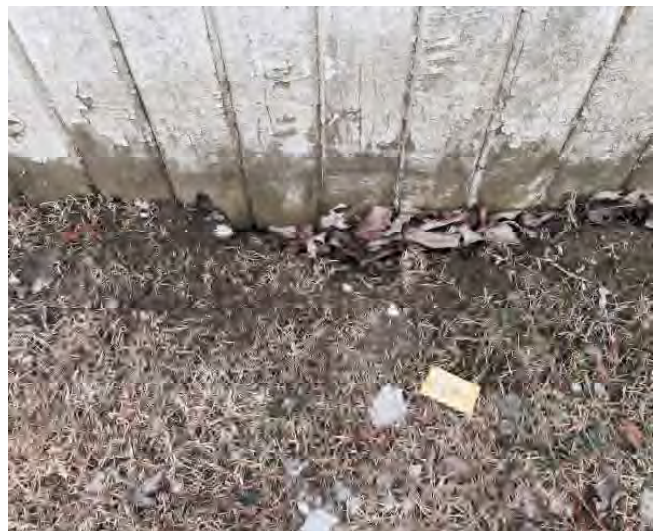
Fascia boards detail

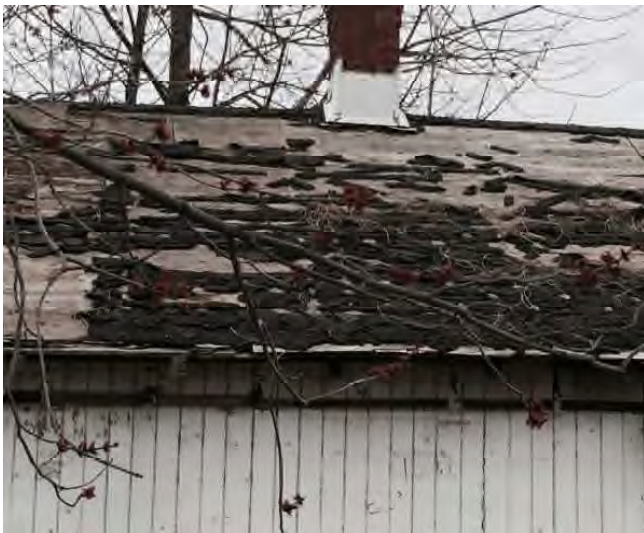
Roof detail

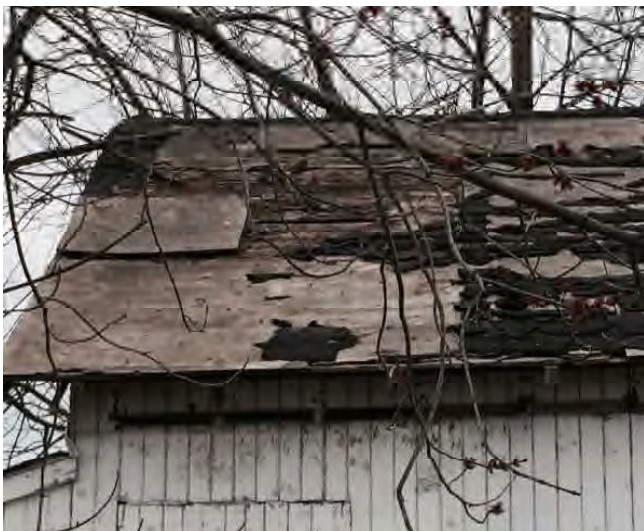
Roof detail
