Appendix N.1 – Structural Inspection Report

*Kennedy Road Environmental Assessment between
Steeles Avenue and Major Mackenzie Drive*

Structural Inspection Report

Class Environmental Assessment for Kennedy
Road from Steeles Avenue to Major Mackenzie
Drive

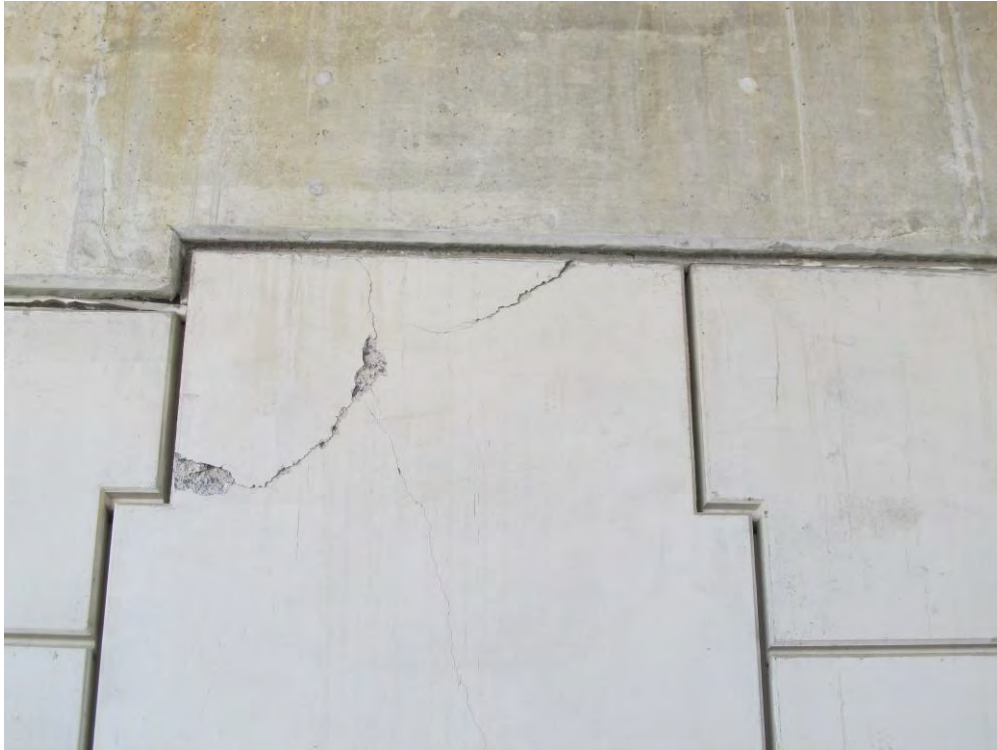
- Impact damage on Southeast guiderail/barrier wall connection
- Delamination and cracks on South abutment

Exhibit 15 – Kennedy Rd – 407ETR Overpass
Delamination on Southeast Abutment (view from North)

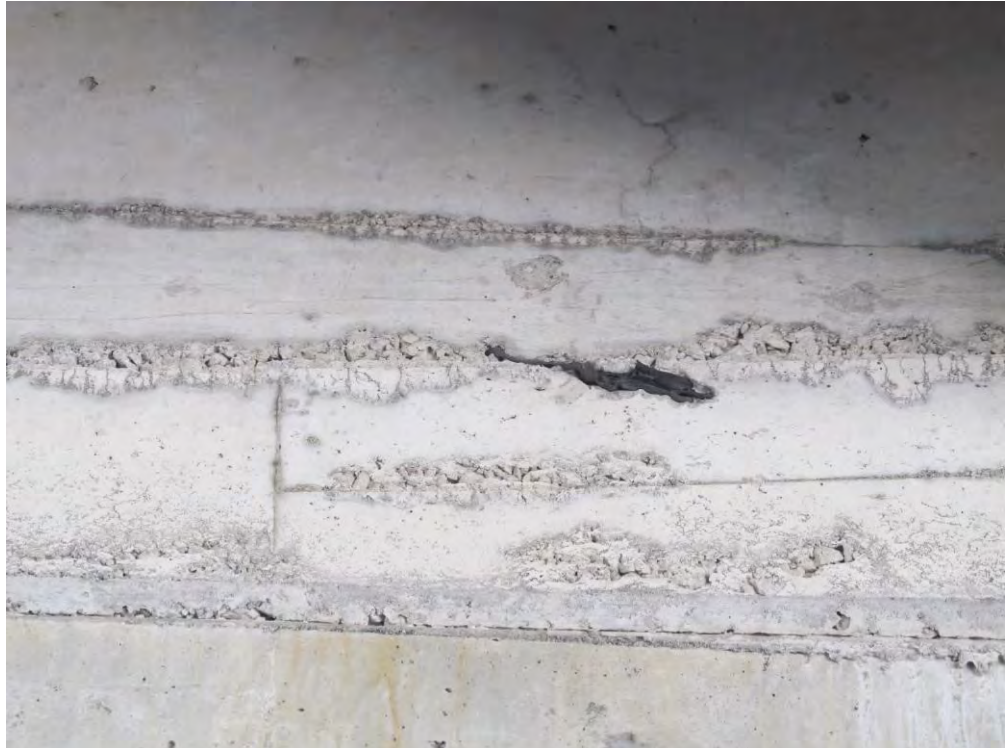
Exhibit 16 – Kennedy Rd – 407ETR Overpass
Concrete Segregation on North Abutment, Top of Middle Portion (view from South)

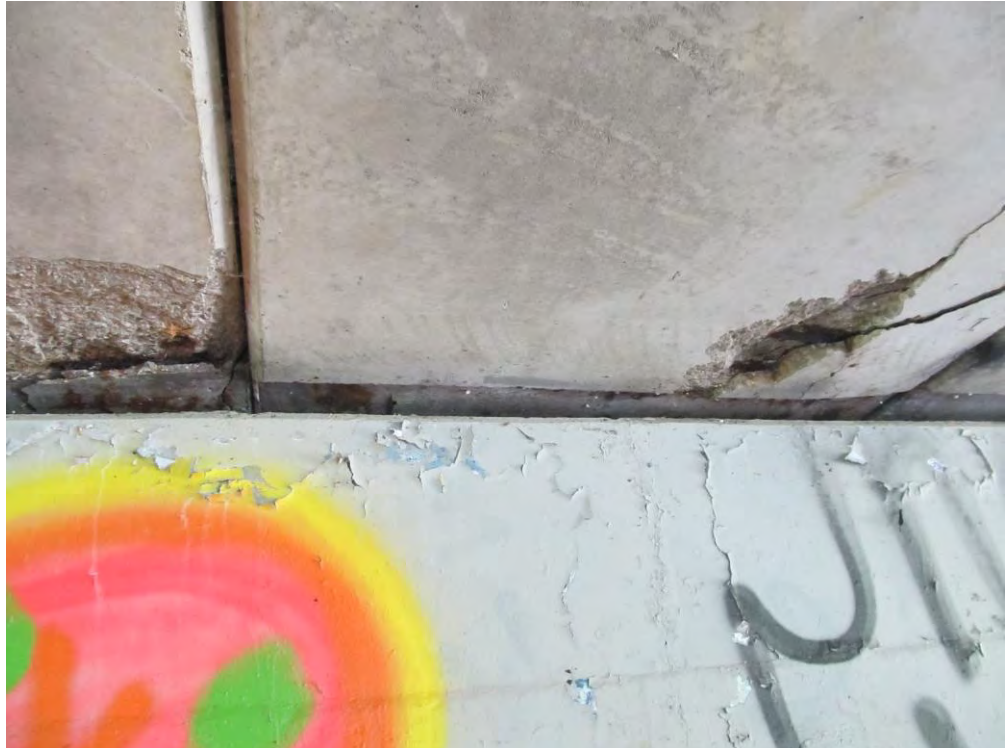
Exhibit 30 – Kennedy Rd – Rouge River Bridge
Delamination & Exposed Rebar on North End of Soffit (view from South)

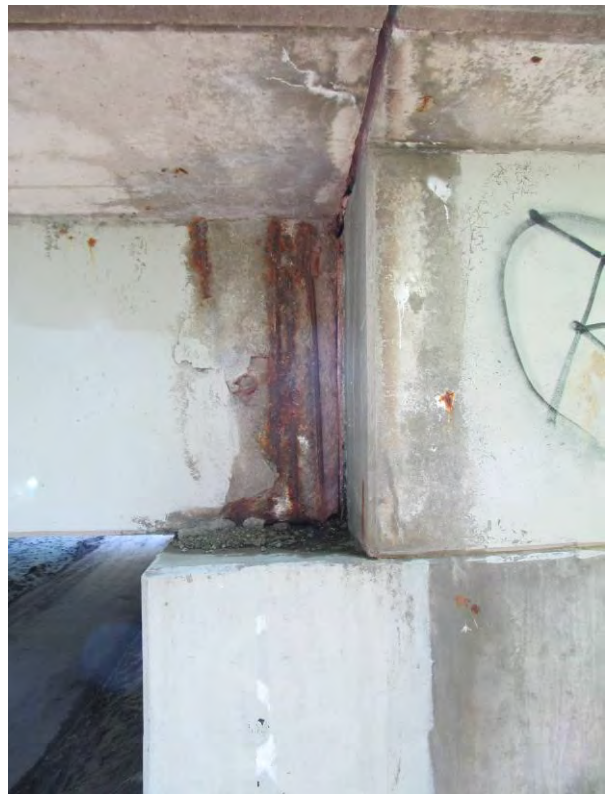
Exhibit 32 – Kennedy Rd – Rouge River Bridge
Exposed Rebar on Southwest Girder End (view from West)

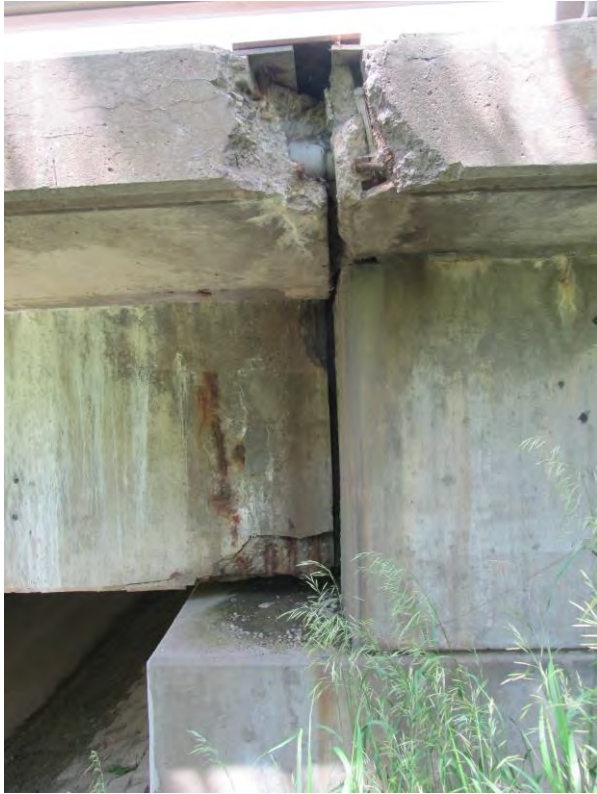
- Dents on Northeast, Northwest, and Southwest guiderails
- Loss of concrete at underside of Northeast expansion joint
- Spalling of guiderail connections at Southwest, Northwest, and Northeast concrete end posts
- Exposed tie rod anchor at Southeast girder end
- Recommendation to replace existing handrails with new PL2 concrete barrier walls with railings
- Bridge found to be in moderate condition

Exhibit 33 – Kennedy Rd – Rouge River Bridge
Loss of Concrete under Northeast Expansion Joint (view from East)

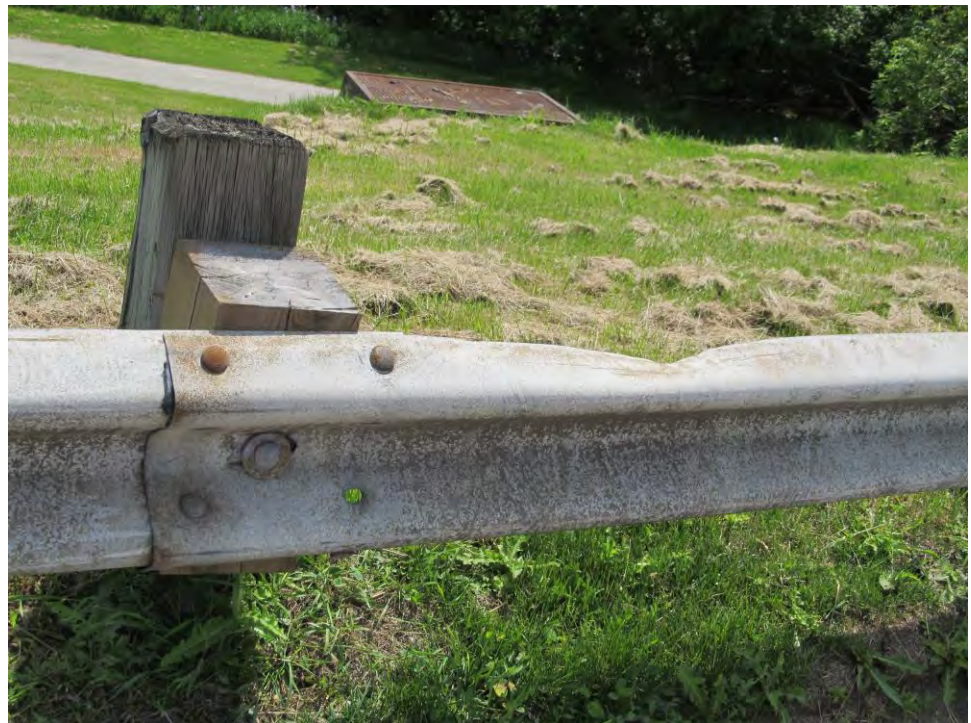
Exhibit 40 – Kennedy Rd – Rouge River Bridge
Dent & Missing Bolt on Northeast Guiderail (view from West)

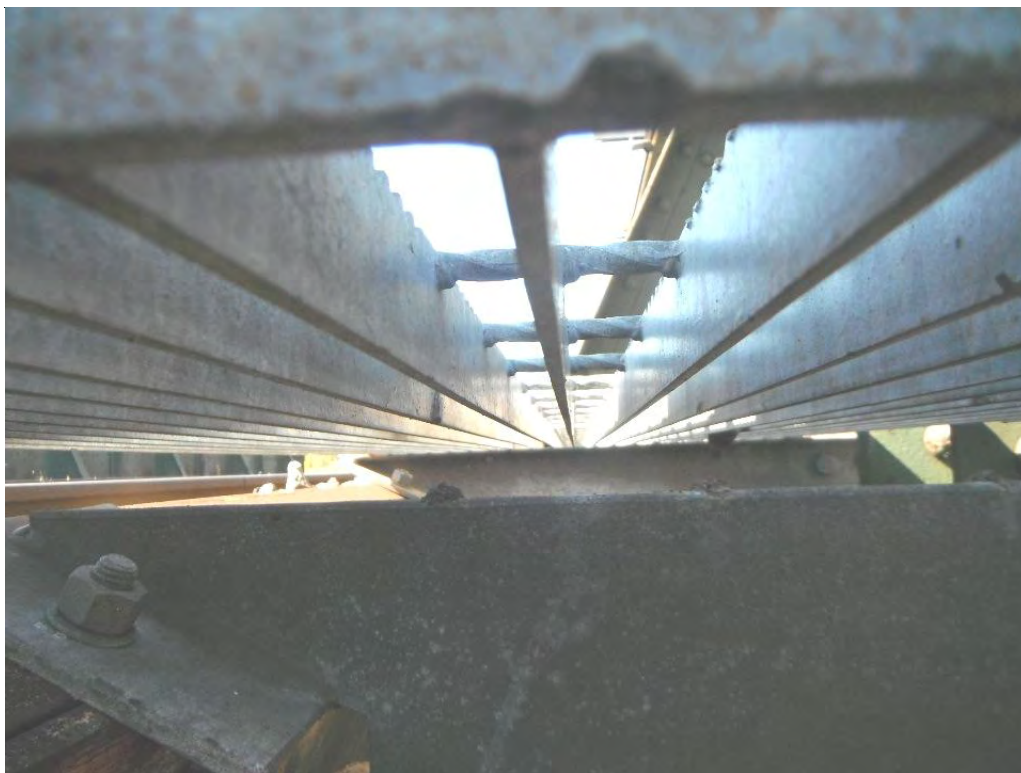
Trainmans Walk not Welded Down

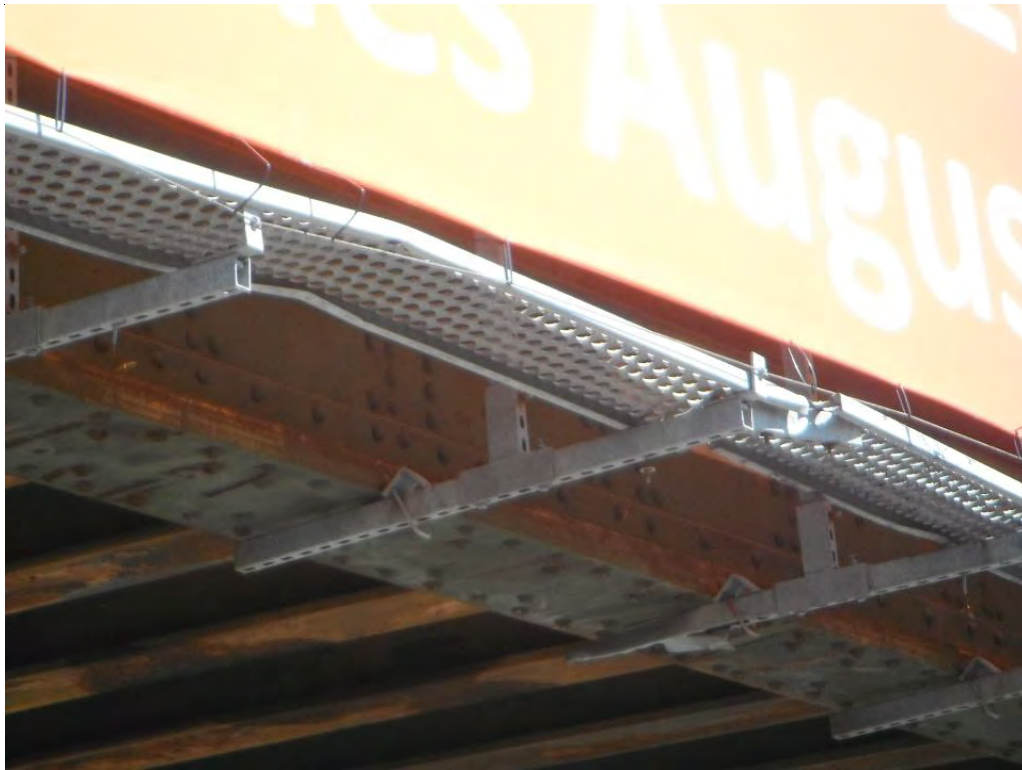
Vehicle Strike Damage on Exterior Sign

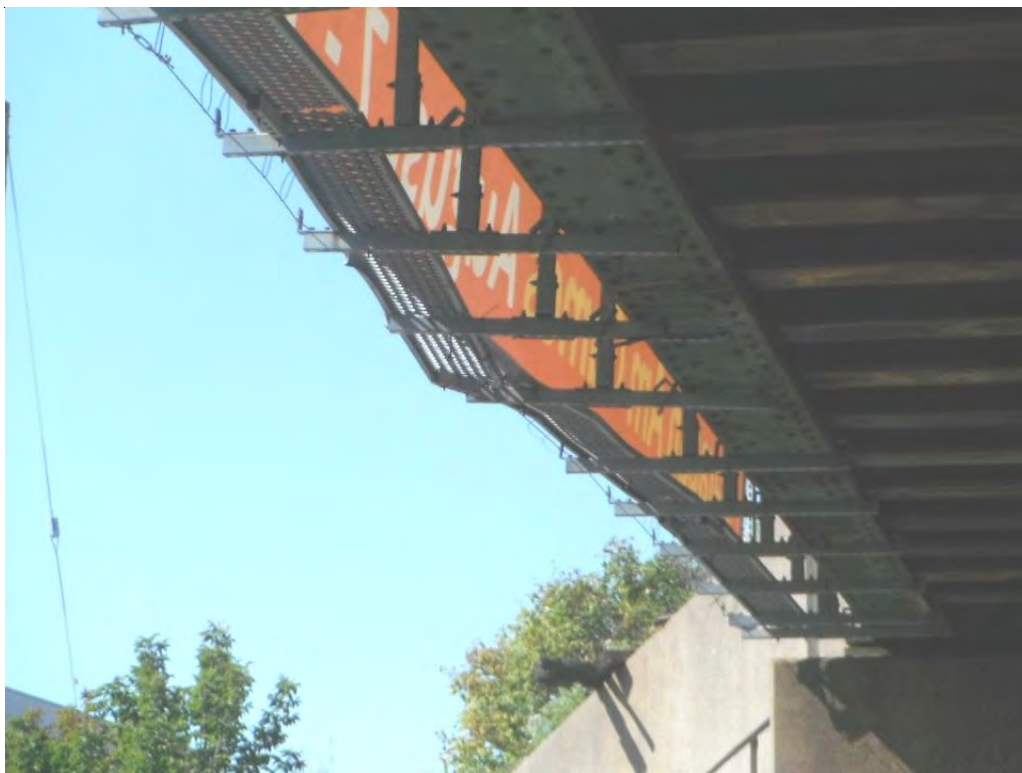
Vehicle Strike Damage on Sign

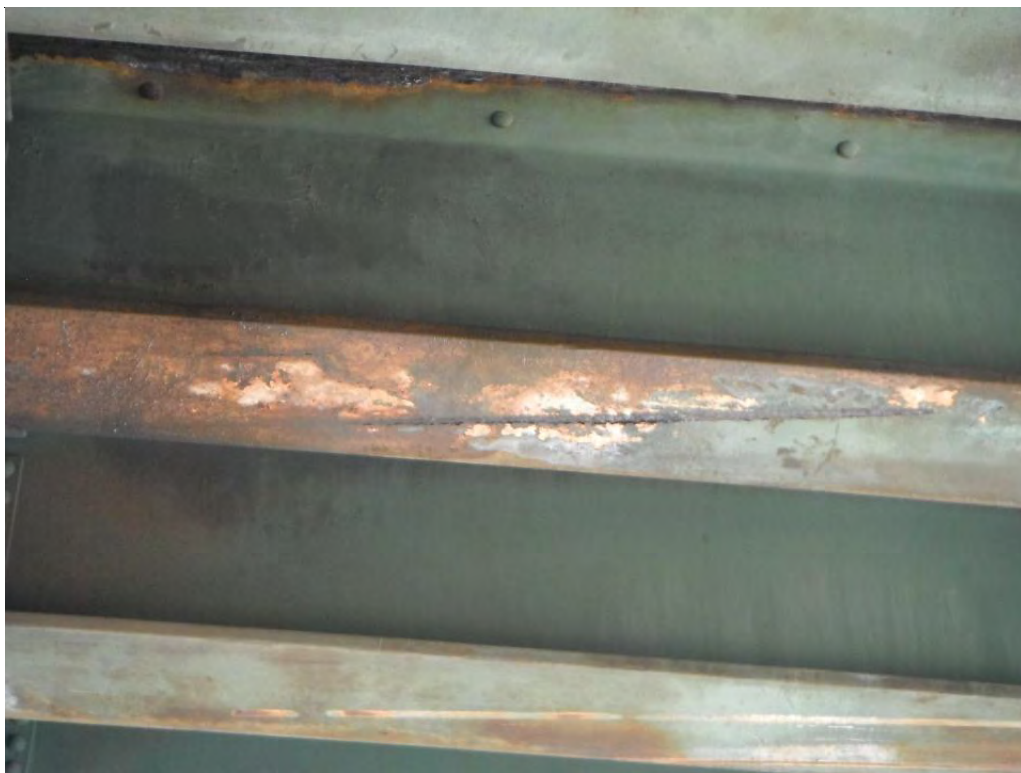
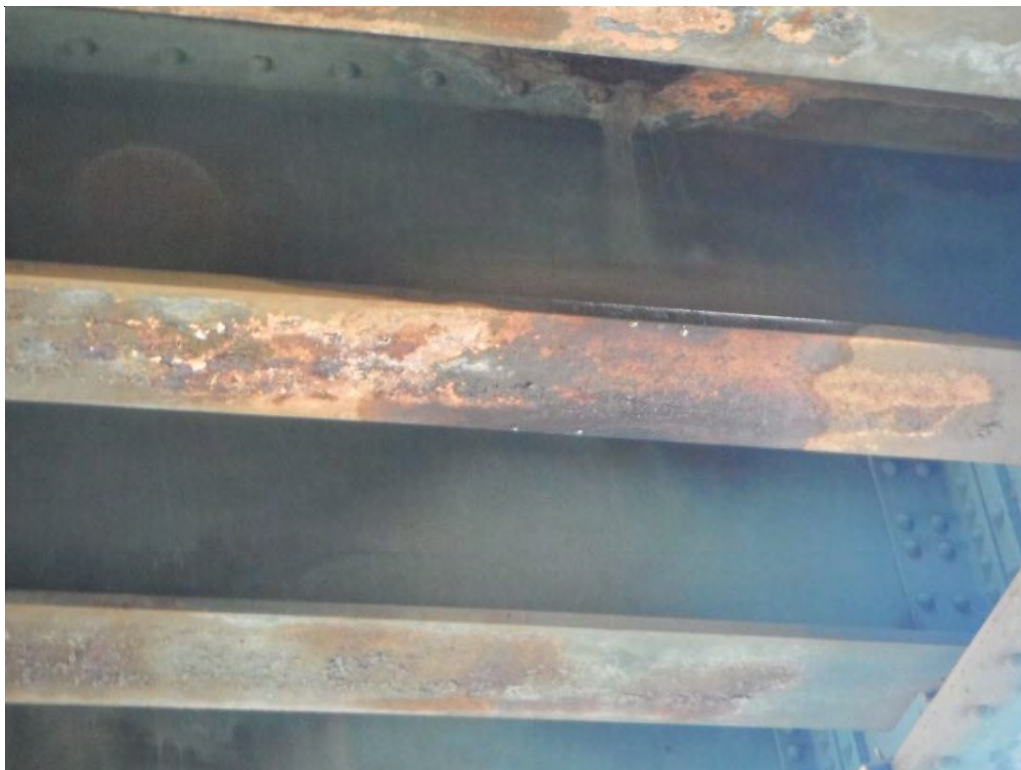
Corrosion on Girder

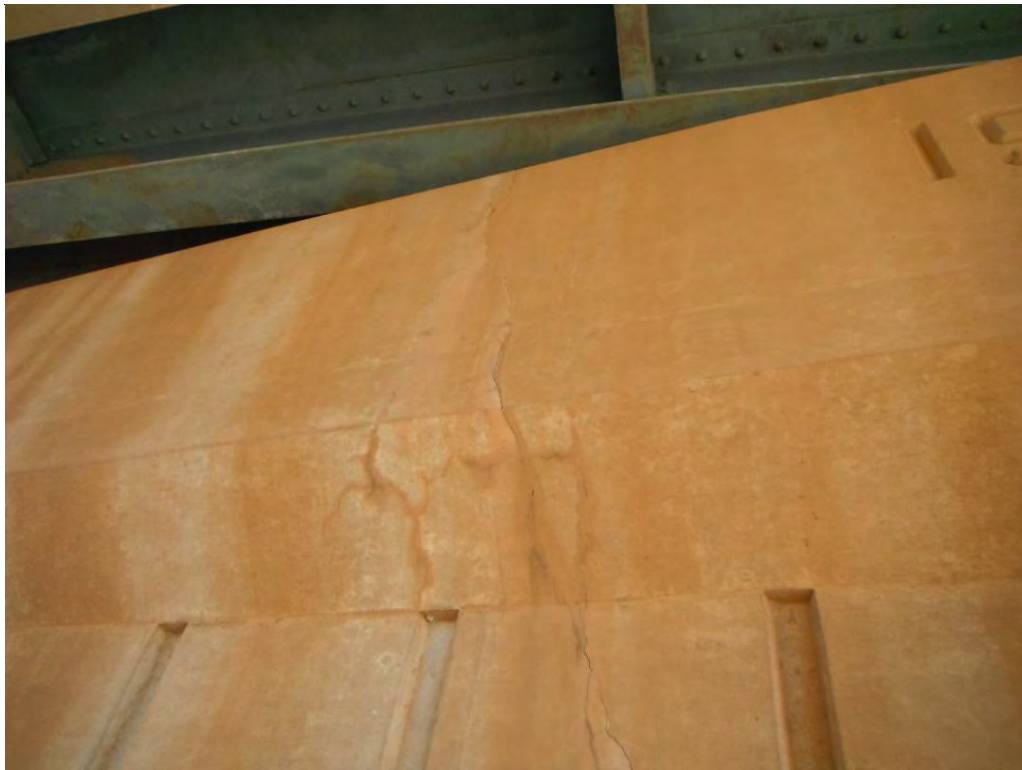
Crack on Abutment

Seal cracks in abutment.

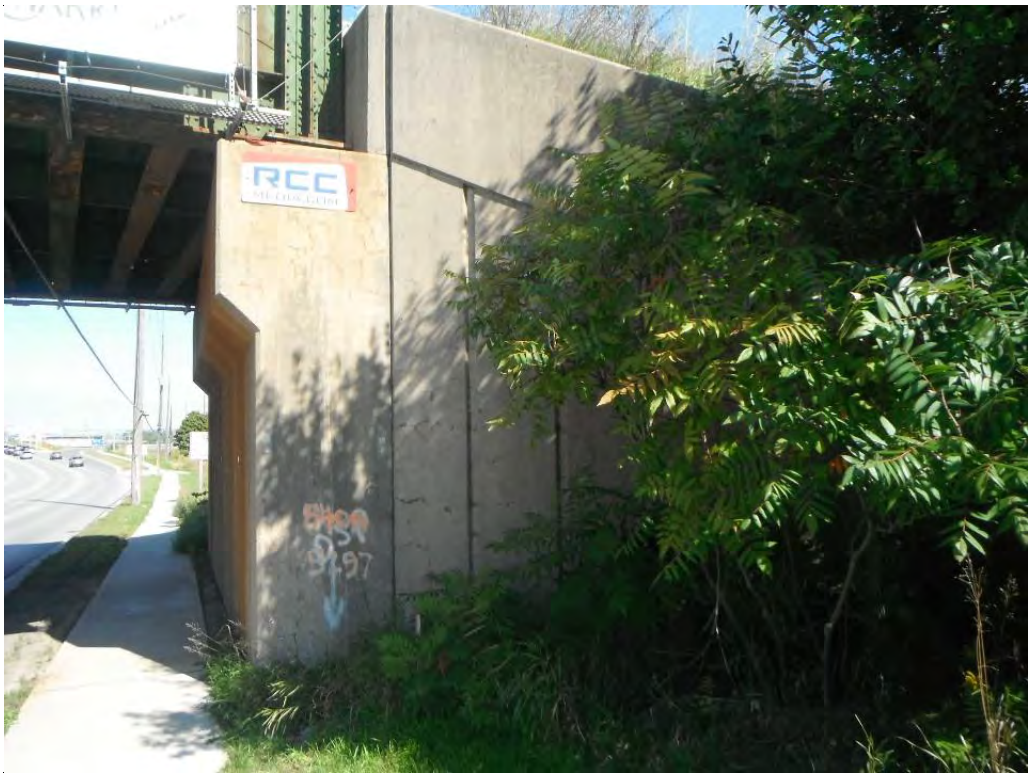
Typical Wingwall

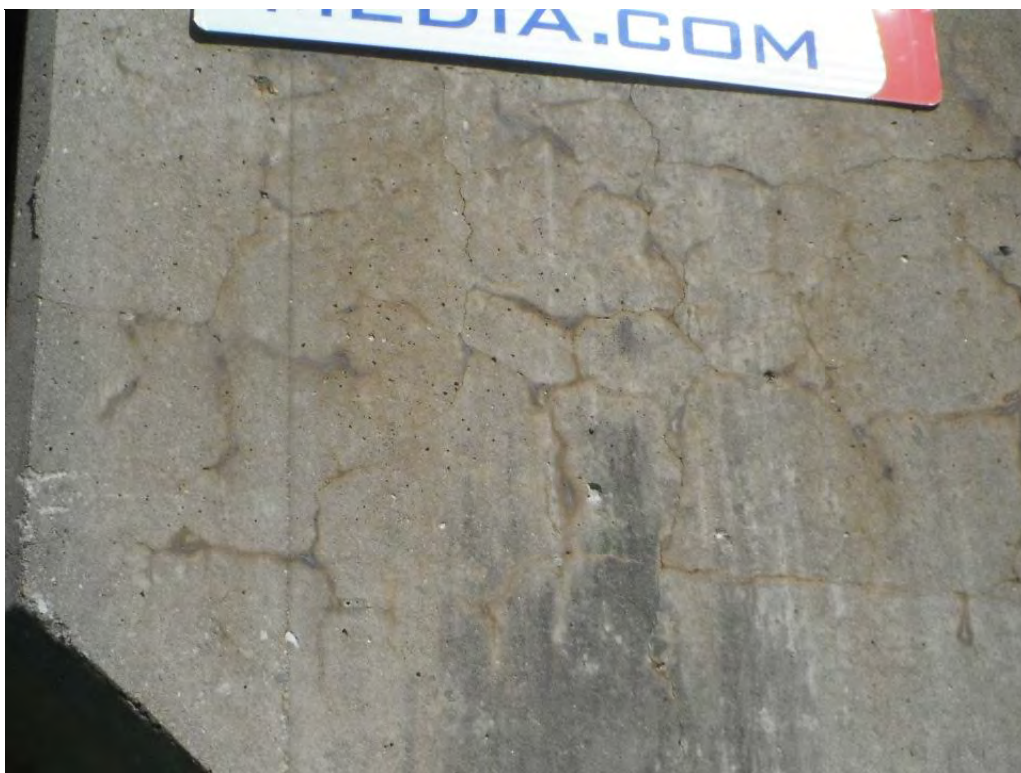
Map Cracking on Wingwall

Narrow map cracking.

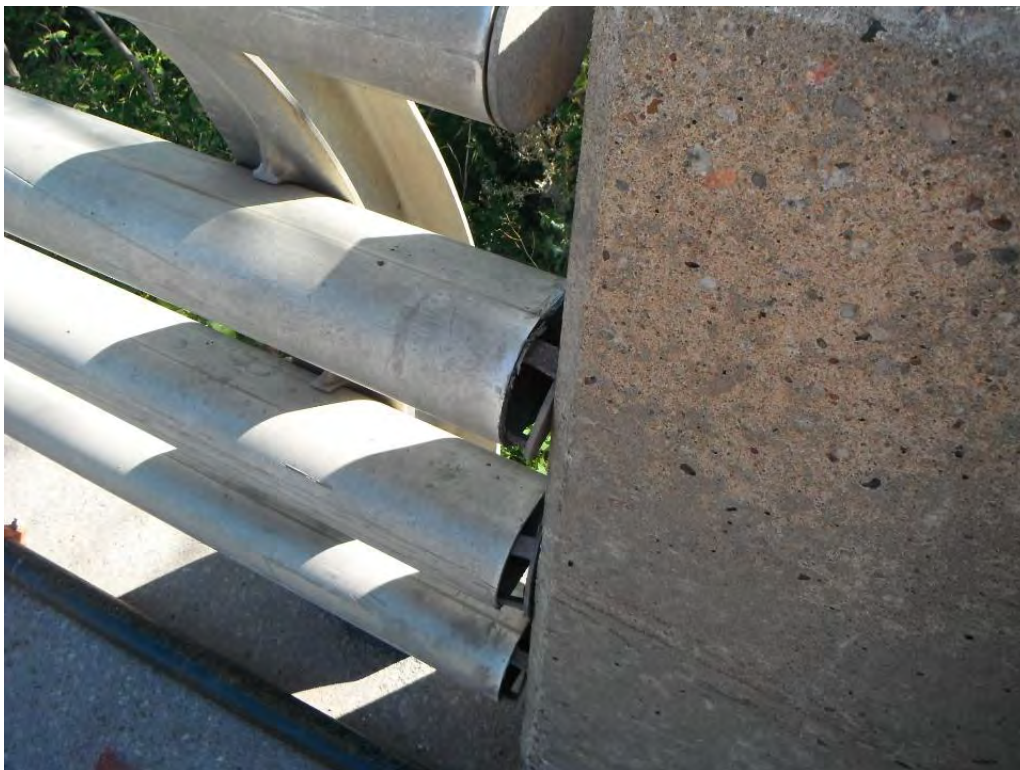
Bent and Broken End Caps

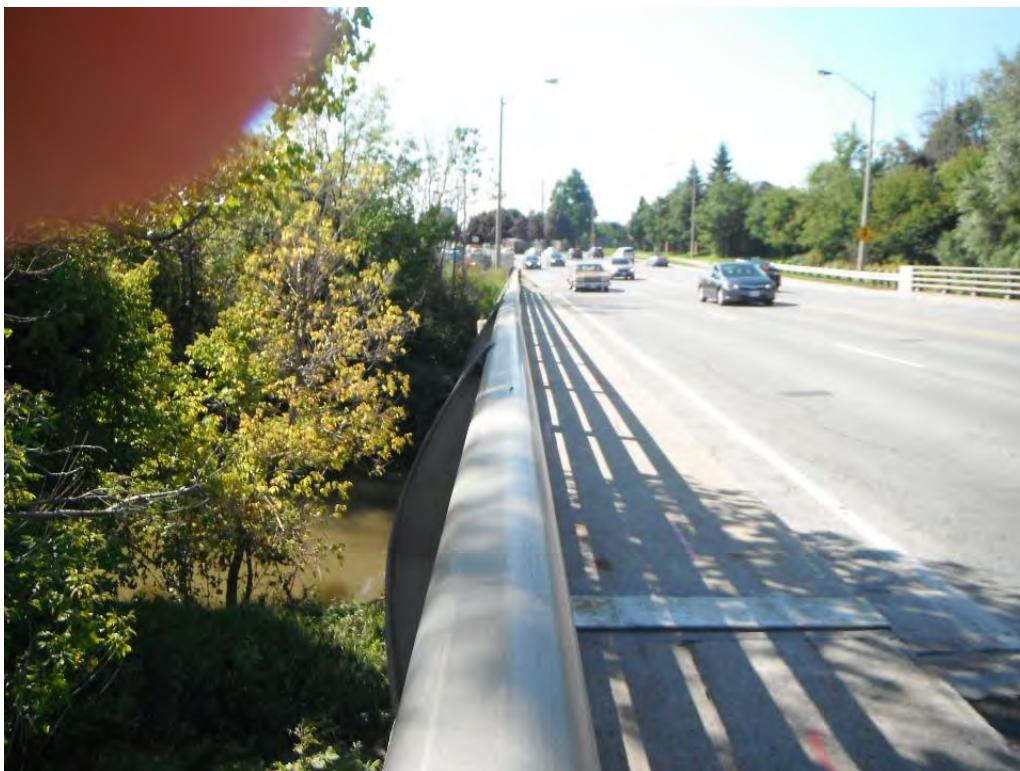
Bent Hand Rail

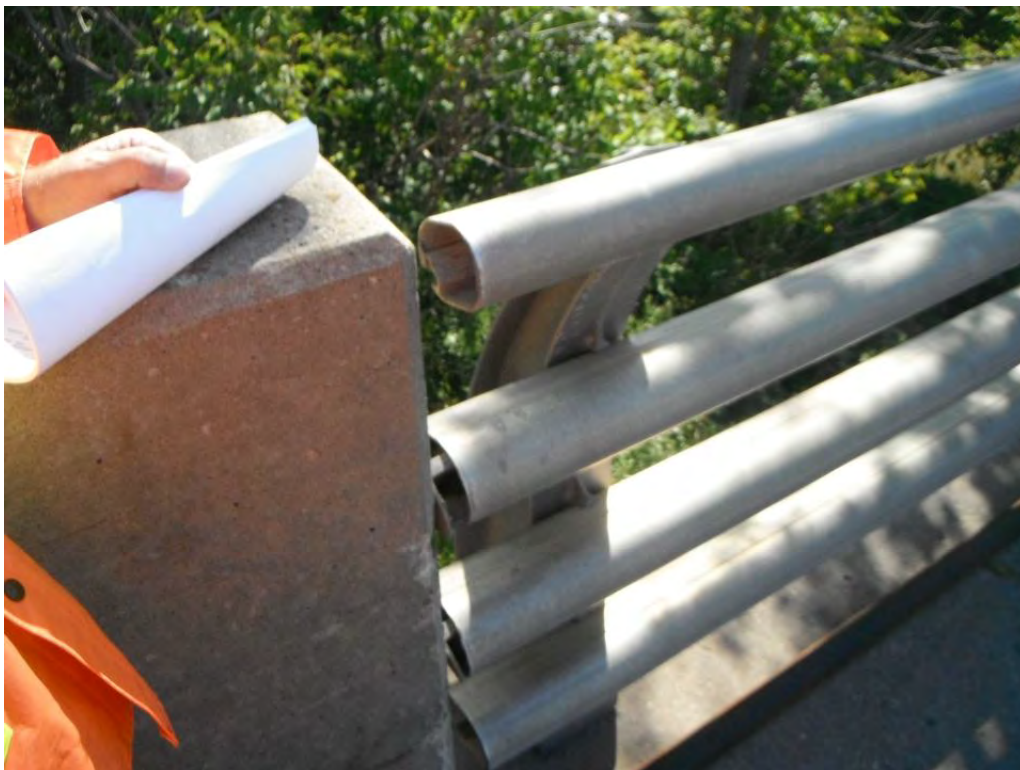
Missing End Caps

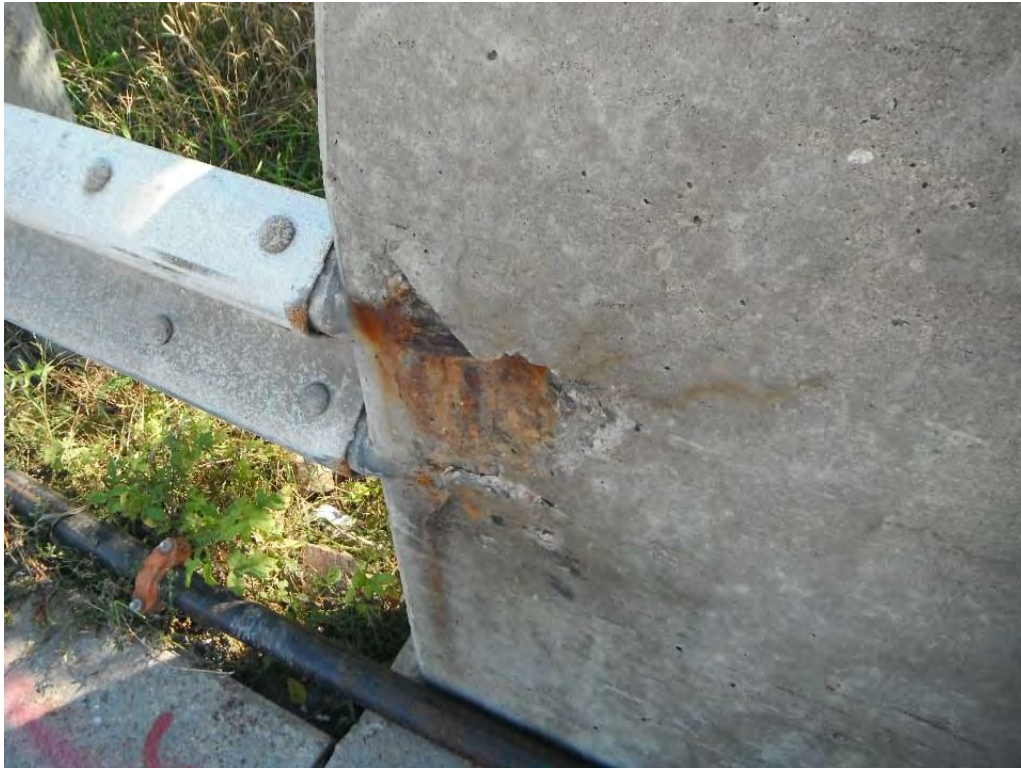
Spall on Interior Barrier Wall

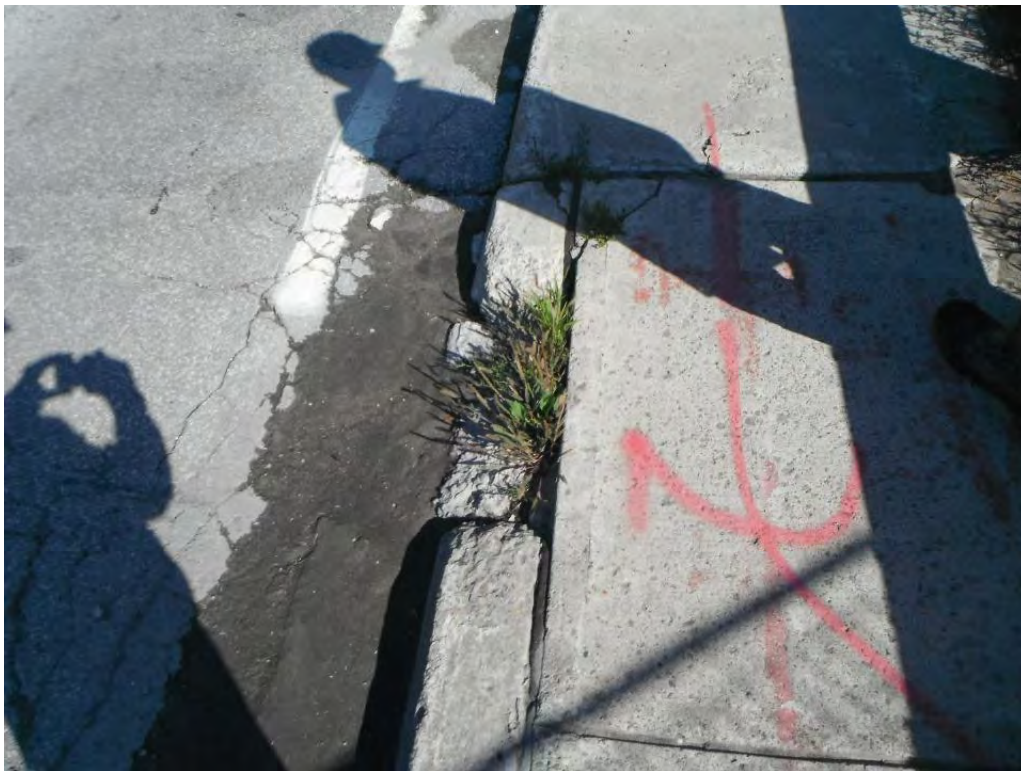
Severe Spall on Curb

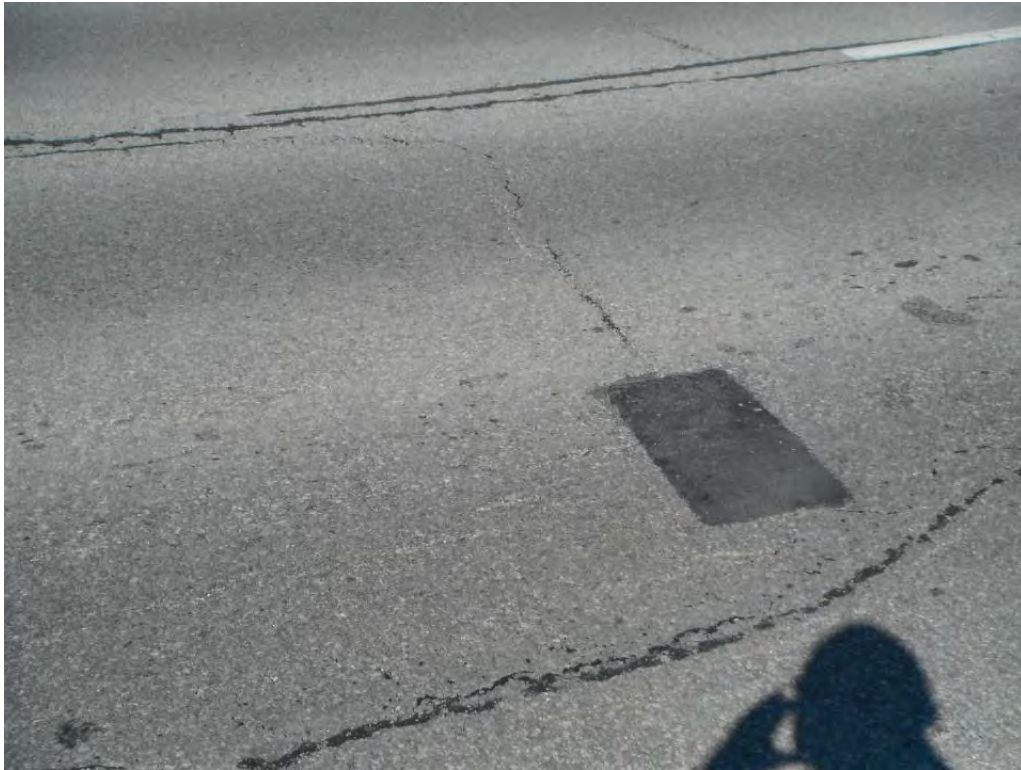
Sealed and Unsealed Cracks on Surface

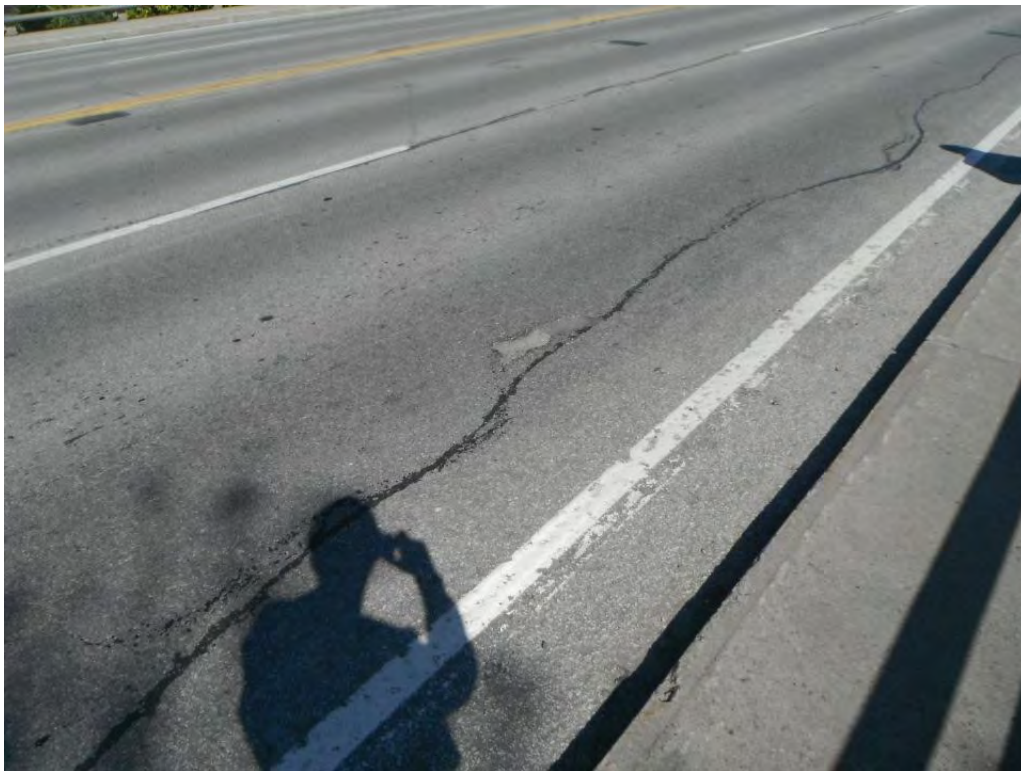
Sealed Crack on Deck Surface

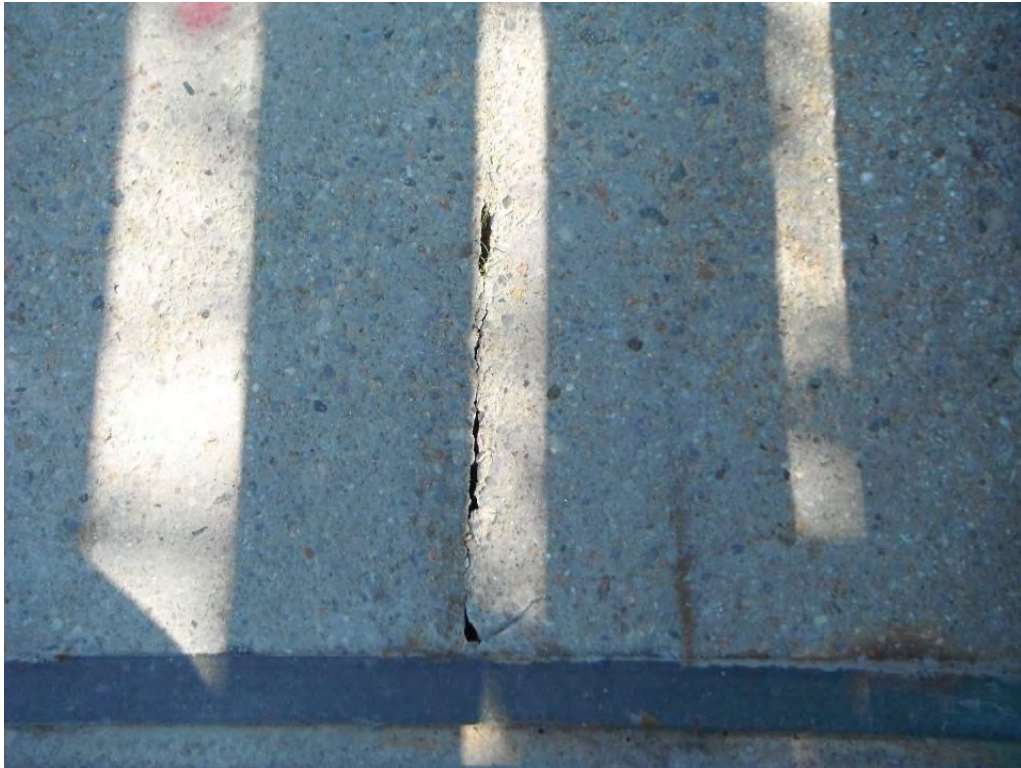
Medium Crack on Concrete End Dam

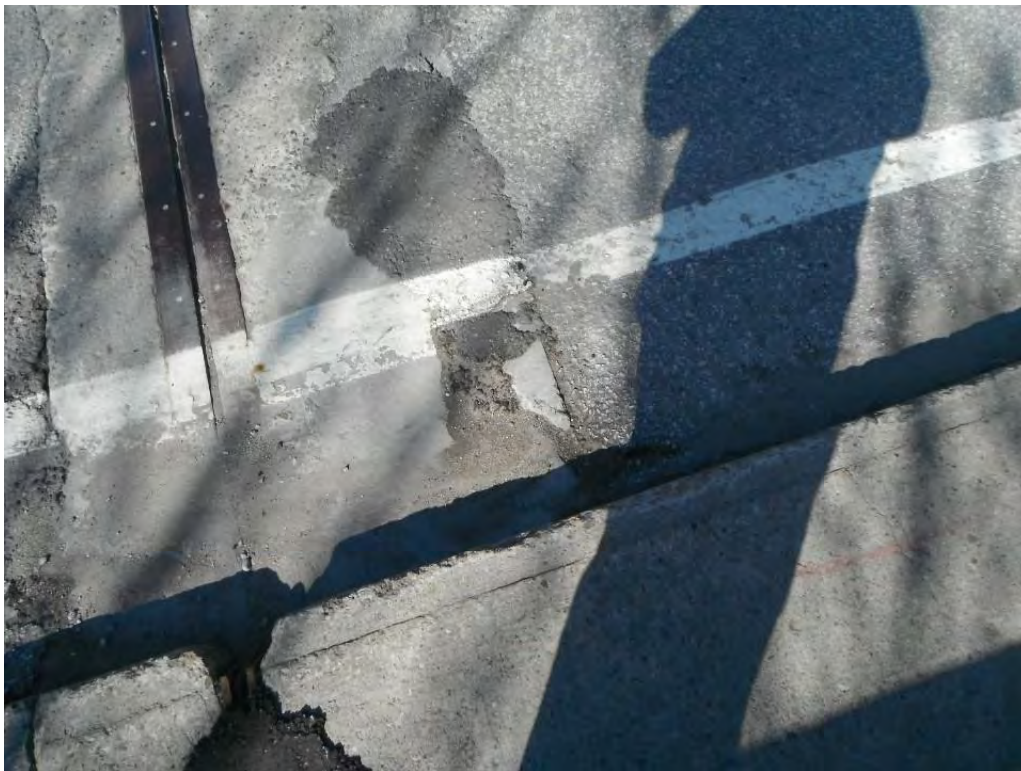
Asphalt Adjacent to Expansion Joint

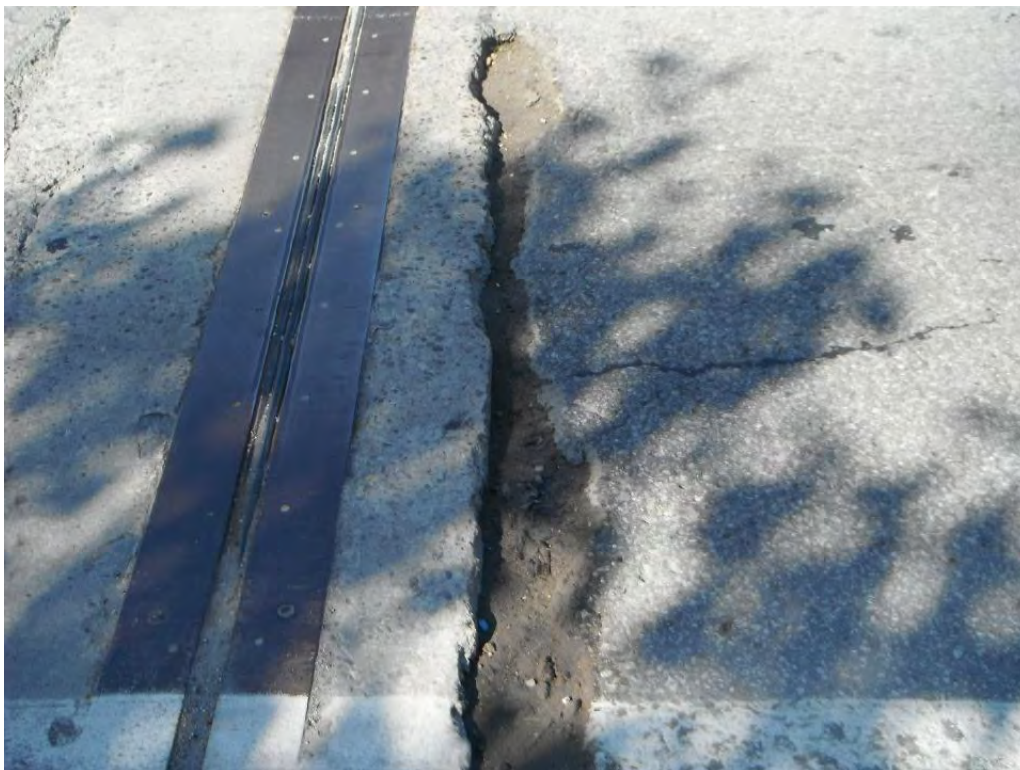
Pot Hole Adjacent to North Expansion Joint

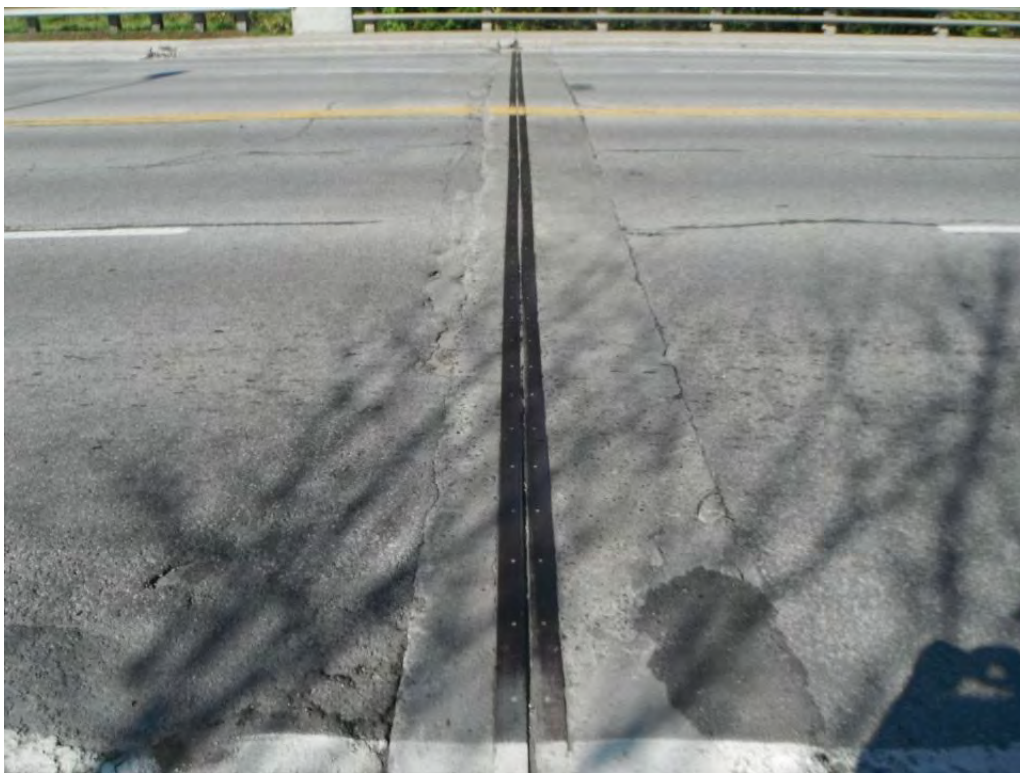
Pot Holes at South Expansion Joint

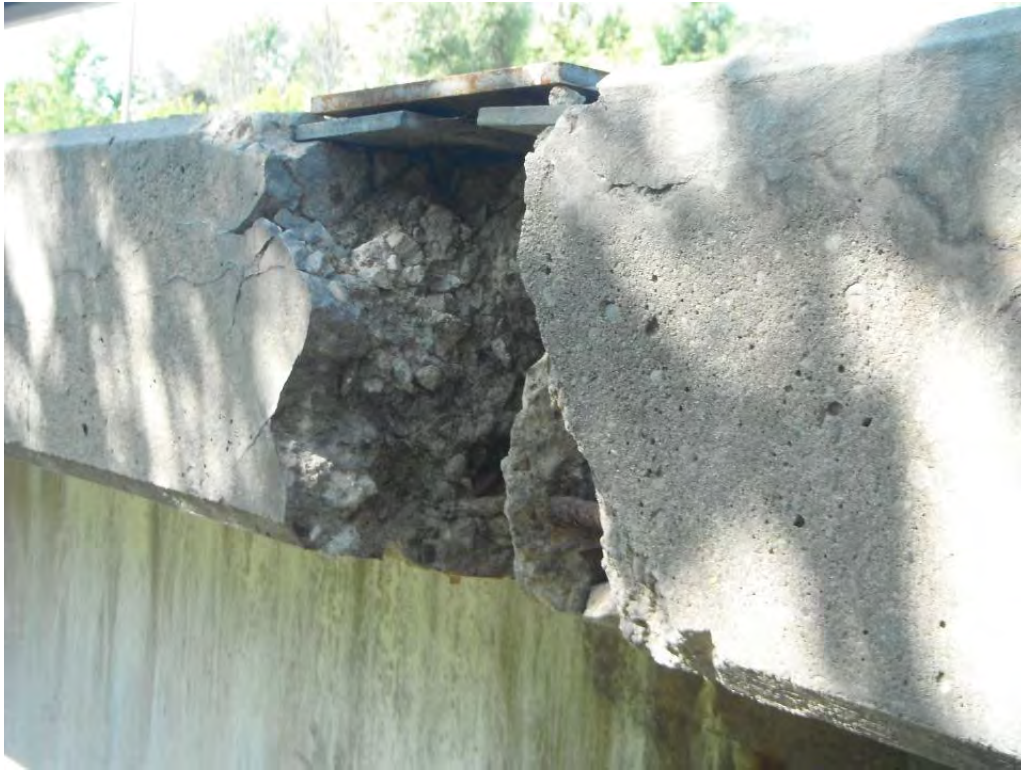
Spall and Exposed Rebar at Expansion Joint

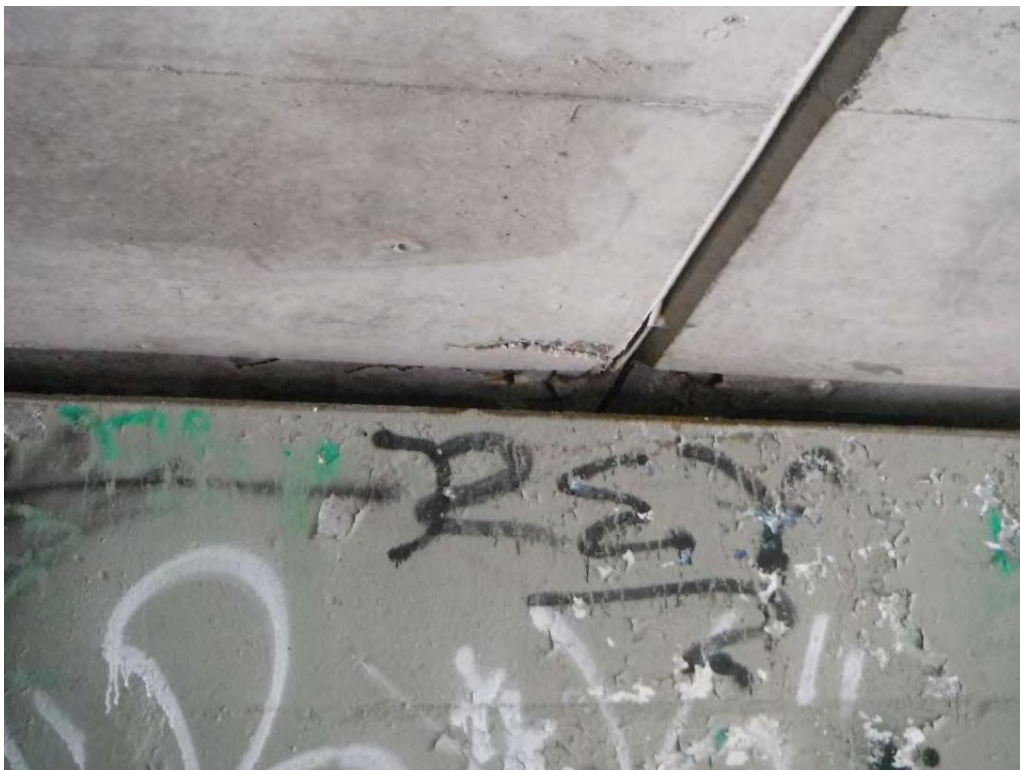
Delamination on Girder End

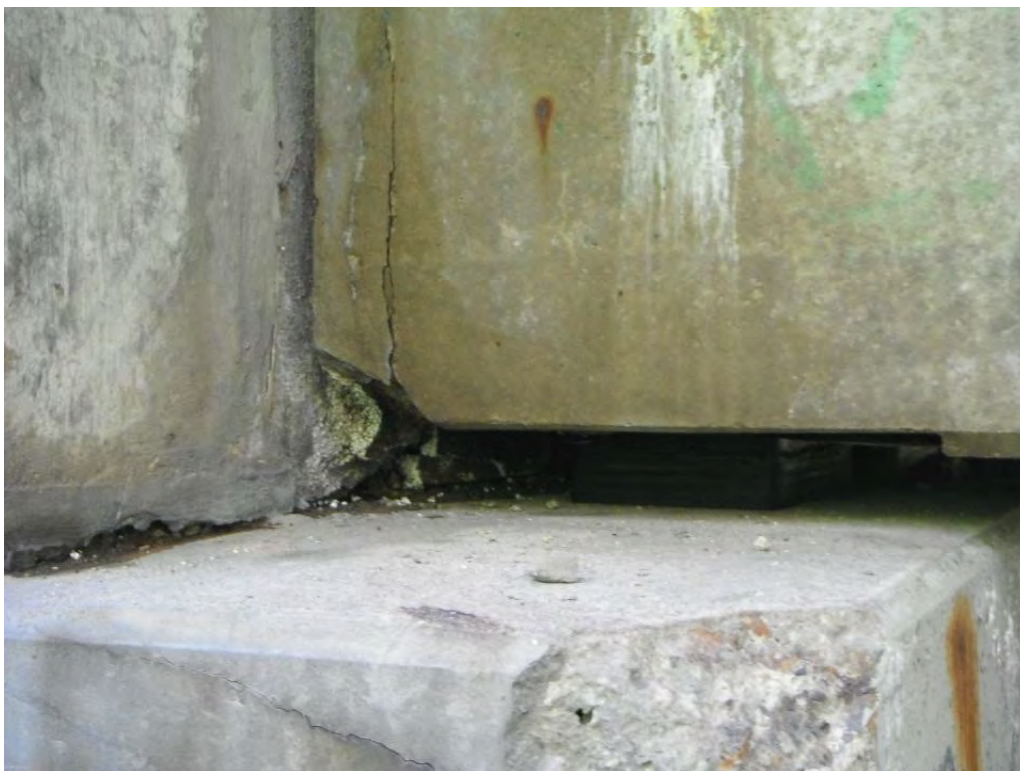
Spall on Girder End

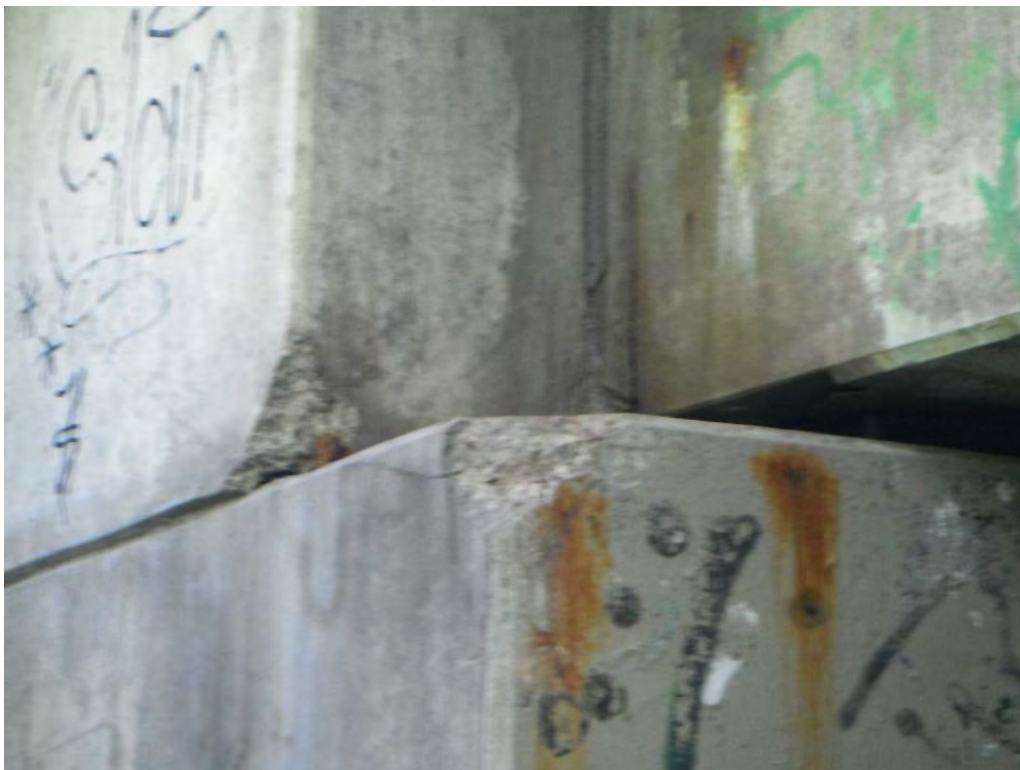
Spall on Abutment and Ballast Wall

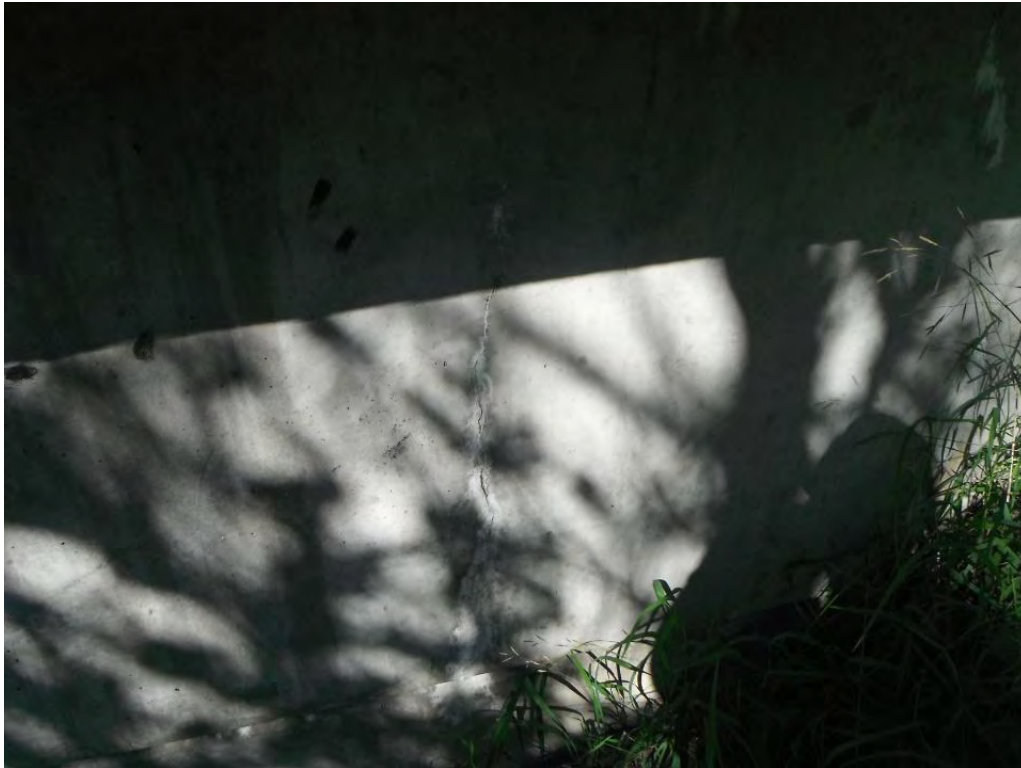
Crack on Northeast Wingwall
