Appendix N.1 – Structural Inspection Report

*Kennedy Road Environmental Assessment between
Steeles Avenue and Major Mackenzie Drive*

Structural Inspection Report

Class Environmental Assessment for Kennedy
Road from Steeles Avenue to Major Mackenzie
Drive

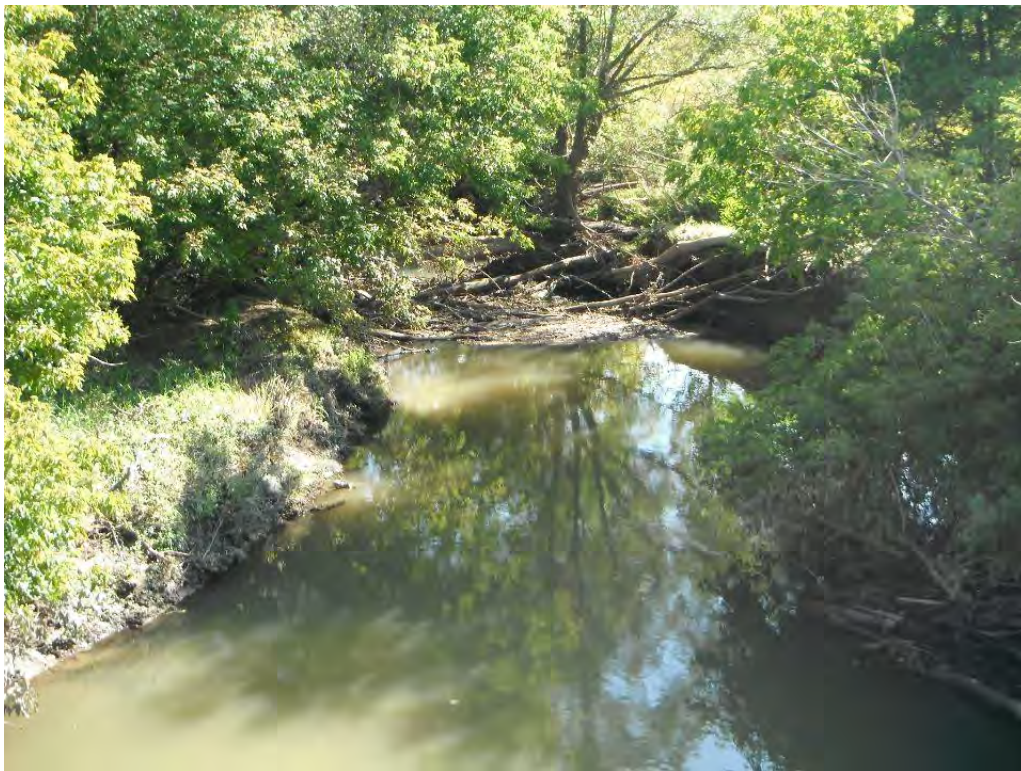
Looking East at Dam

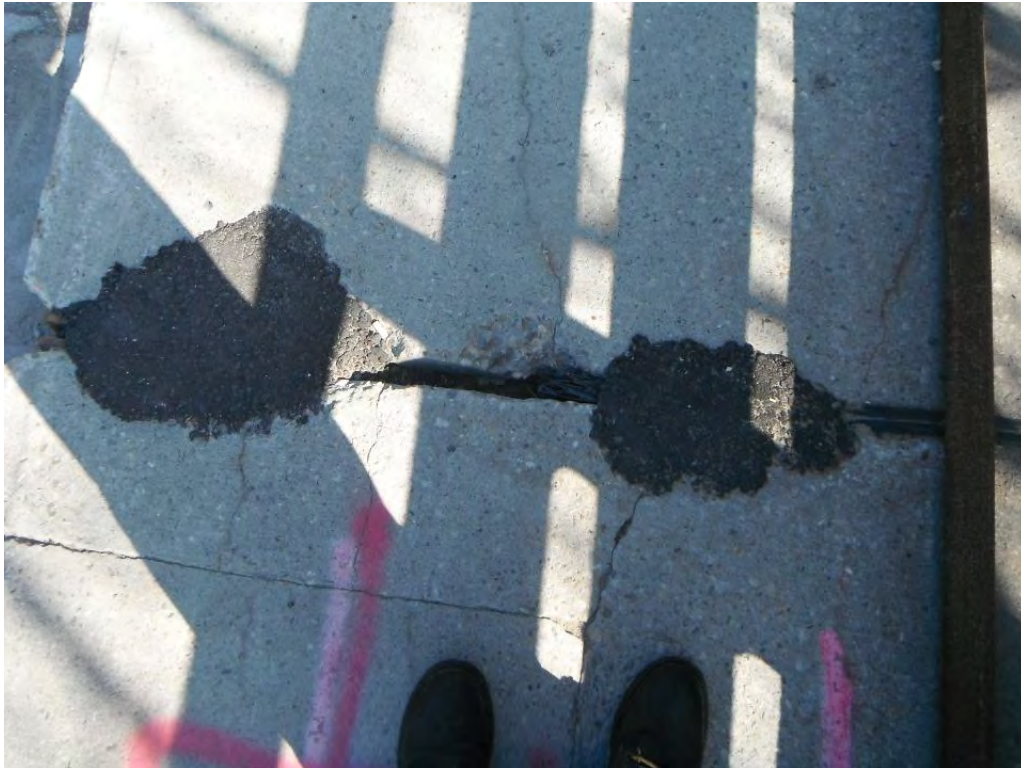
Spall on Sidewalk

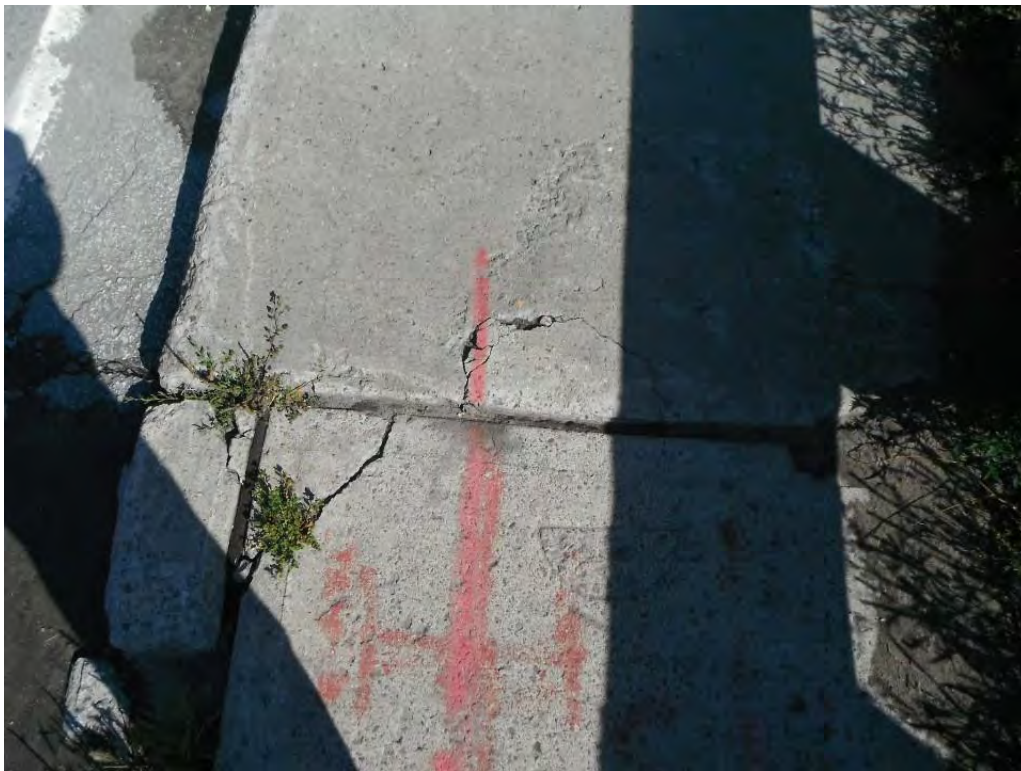
Medium Cracks on Sidewalk

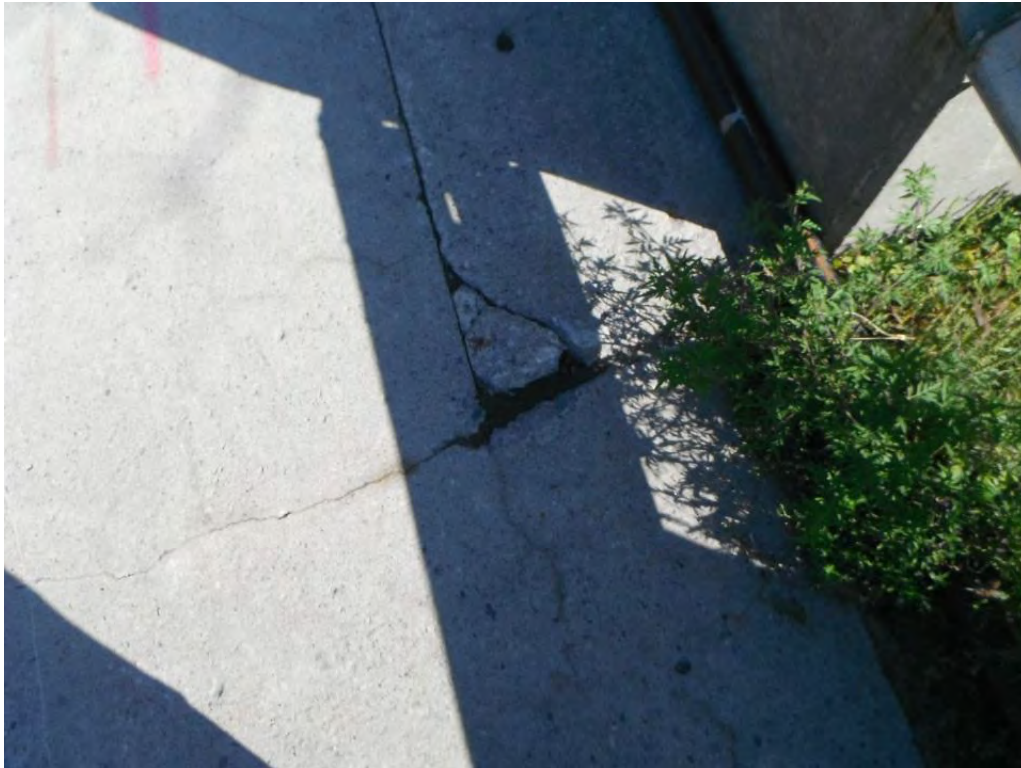
Spall on Sidewalk
